# Thermal Buckling Behavior of Open Cylindrical Oil Storage Tanks under Fire

Jean C. Batista-Abreu<sup>1</sup> and Luis A. Godoy, M.ASCE<sup>2</sup>

## Summary of the 2009 Accident in Bayamon

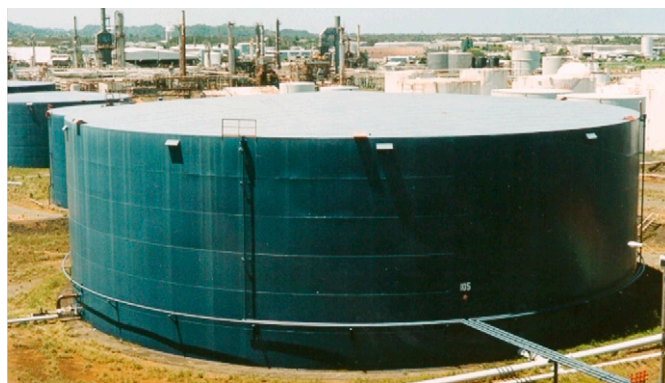
**Fig. 2.** Tank 105 in the CAPECO Bayamon tank farm before the 2009 accident; it is believed that the accident started in this tank

This was a cylindrical tank with fixed external roof located in the southeastern region of the storage farm; it had a diameter of 45 m and a height of 18 m. It is believed that a failure in the security system devices of Tank 105 unleashed a chain of events that resulted in the catastrophe. Notice that an almost identical triggering effect was also present in the Buncefield accident in the United Kingdom (Buncefield Major Incident Investigation Board 2008; Batista-Abreu and Godoy 2009).

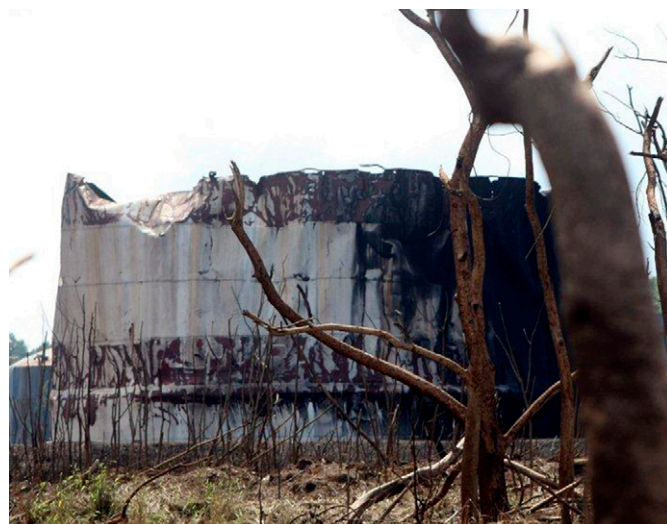
This paper addresses modeling of the first group mentioned above, i.e., tanks without a fixed roof, and some examples of tanks damaged in this way during the Bayamon fire are shown in Figs. 3–6. Those tanks show a significant curvature in the vertical direction. There is a wavy pattern of deformations in the upper zone of the cylindrical shell, but the lower zone is almost undisturbed.

**Fig. 3.** Deformed configuration of a tank without external fixed roof after the Bayamon accident occurred in 2009 (with permission from GFR Media, LLC)

Fig. 3 shows a tank affected by the Bayamon fire. Models A-7–A-10 have a configuration similar to the tank for which large deformations are observed along the free boundary at the top. From the modes at buckling shown in Fig. 9, such a displacement shape is more closely associated to scenarios in which there is a thermal gradient across the shell thickness rather than situations in which the temperature remains uniform in the thickness.

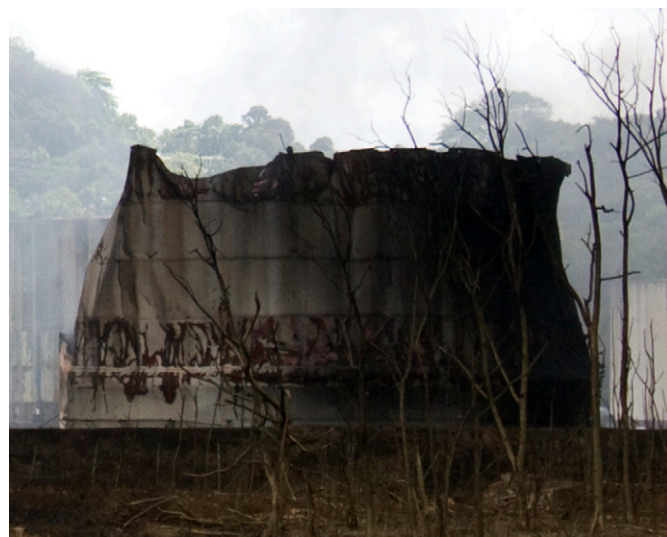
**Fig. 4.** Deformed configuration of a tank without external fixed roof after the Bayamon accident occurred in 2009

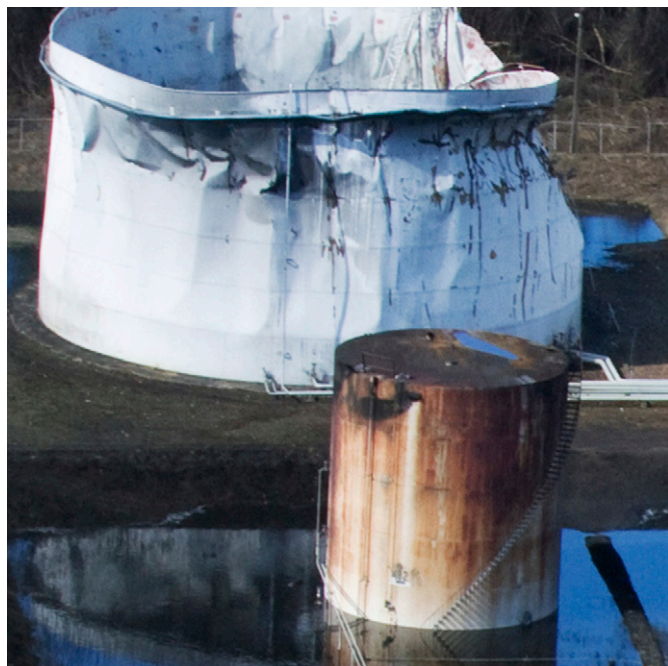
**Fig. 5.** Deformed configuration of a tank without external fixed roof after the Bayamon accident occurred in 2009

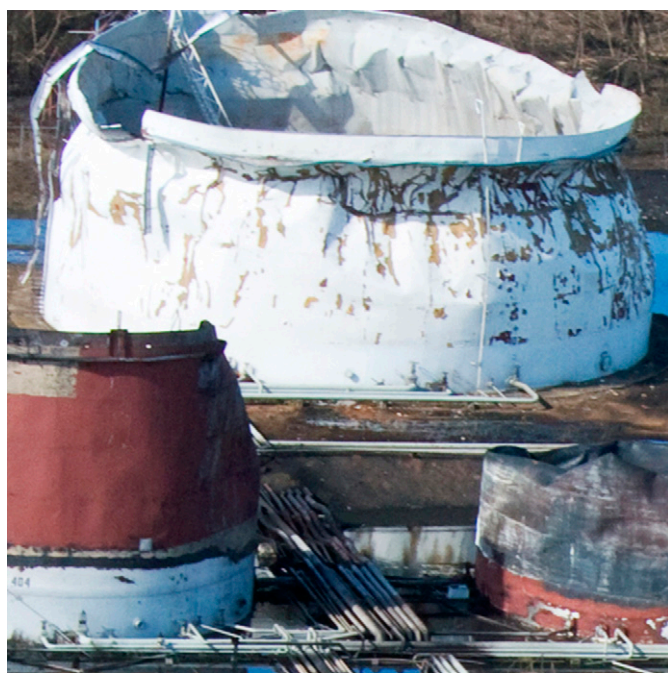
**Fig. 6.** Deformed configuration of a tank without external fixed roof after the Bayamon accident occurred in 2009
