Engineering Failure Analysis

Two competing crack growth mechanisms in very high pressures tubes

This work addresses the influence of autofrettage in the occurrence of repeated leaks of thick wall straight and curved 4333M4 steel tubes from a high pressure petrochemical reactor, comprised by straight and curved tubes subjected to autofrettage. Recent leaks in straight tubes are due to fatigue transgranular growth of cracks initiating from machining grooves in the inner surface, driven by pressure cycles during many years of normal operation. Experimental measurement of residual stresses verified that high temperature service relieved most of the compressive residual stresses imposed by the autofrettage. Previous failures in curved tubes were found to be due to metallurgical susceptibility to intergranular cracking, related to a phenomenon similar to Temper Embrittlement. Repeating autofrettage to mitigate fatigue failures would reproduce the deformation mechanisms that favored intergranular cracking of the tubes. Recently developed life extension strategies include early detection of leaks by acoustic emission and an improved manufacturing method of replacement bends.

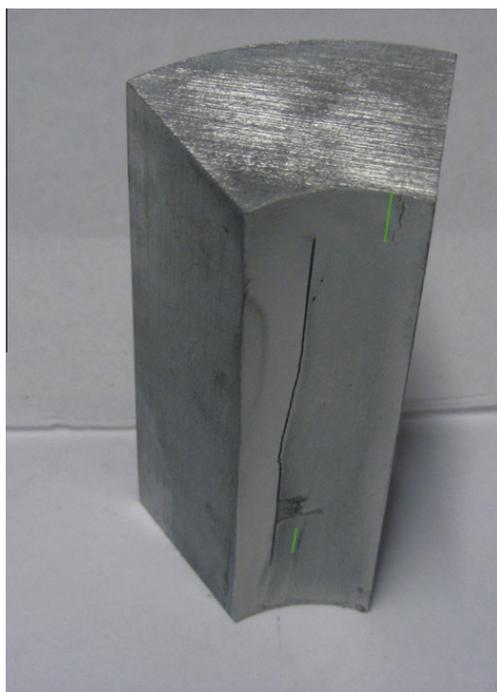
Fig. 1. Sample taken from first fatigue crack, crack path along inner surface of thick walled tube.

the crack towards the outside of the tube, see Figs. 1 and 2. This zone is a manufacture defect of the material, probably a lamination defect. River patterns indicated by arrows in Fig. 3 reflect changes of initiation planes from this preexisting defect.

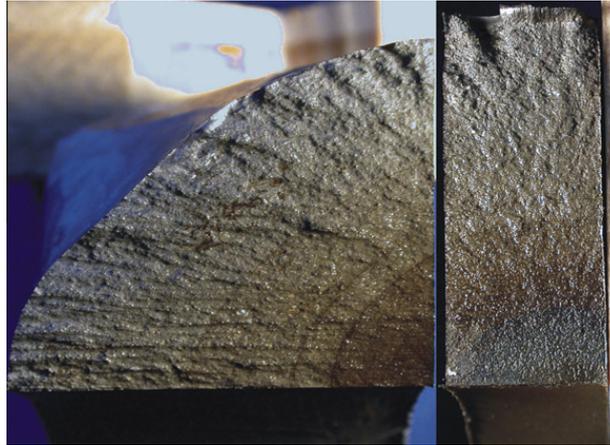
Fig. 2. Surface of first fatigue crack, after cryogenic opening and cleaning, note initiation from inner surface (bottom of photo).

opening and cleaning. Note initiation from the inner surface and beach marks, clearly denoting successive crack fronts during in-service propagation.

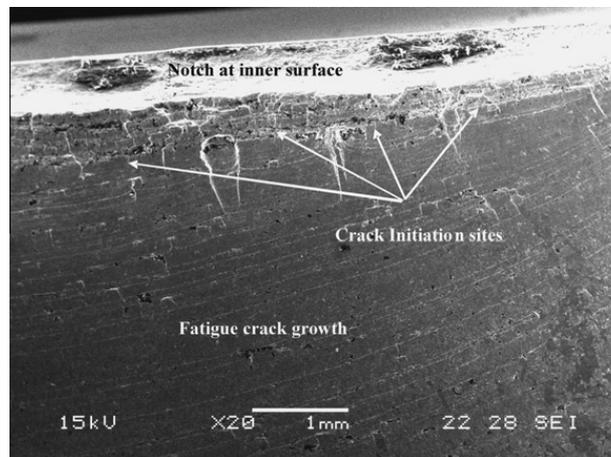
Fig. 3. Crack growth from preexisting defect (20 \times).

Fig. 3 (20 \times) shows a scanning electron microscope (SEM) fractography. The crack shows typical propagation from multiple initiation sites, at the bottom of a notch at the inner surface of the pipe wall. Most relevant is the distance of the multiple initiation sites, at the bottom of the notch, there is a 0.3 mm deep band from which the fatigue cracks start. Fig. 4 shows the shape of typical preexisting notches at the inner surface of tube (150 \times , 2000 \times). These machining notches are normal for this type of component. The micrographs show the acicular characteristic of a tempered martensitic microstructure. Note that not only the preexisting notches at the inner surface create stress raisers, some inclusions at the bottom of these notches would become very effective fatigue initiation sites.

The material presents high density of inhomogeneities that create susceptible zones for the nucleation and propagation of cracks. The mechanism of propagation by fatigue rarely leaves in martensitic steel the indicative microscopic striations during crack advance, but clear beach marks show the evolution of the crack, see Figs. 2 and 3. Fracture surfaces present squashed regions, Fig. 3, that allow considering that the cyclic component of stresses presents a compressive part.

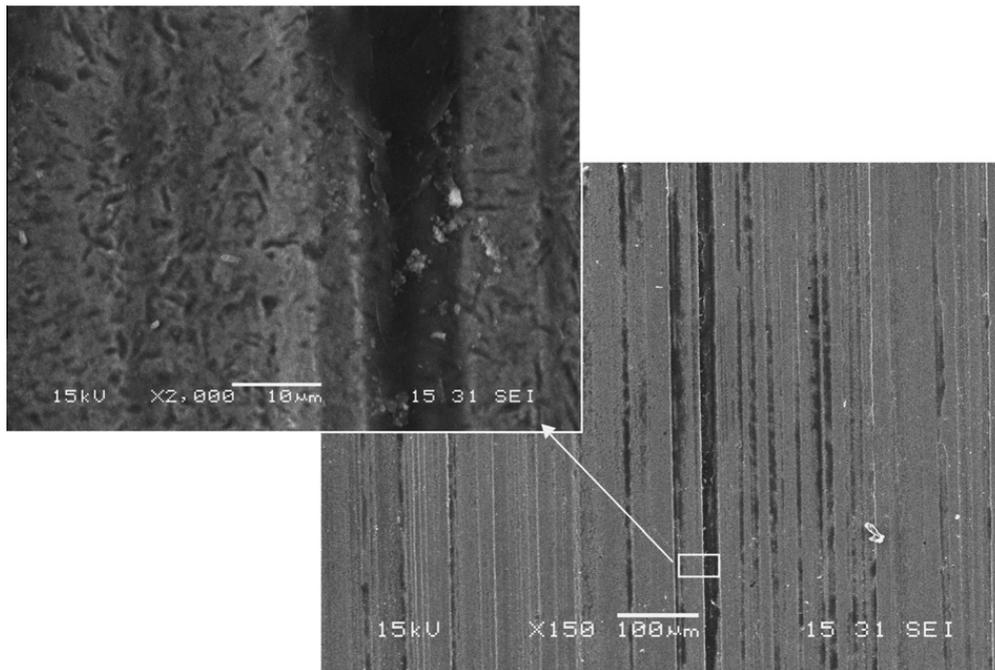
Fig. 4. Preexisting notches at inner surface of tube (150×, 2000×).

Depth of machining marks, around 10 μm, was not enough by themselves to initiate the cracks. Machining grooves and nonmetallic inclusions were combined to form longitudinal defects up to 0.3 mm defects in the ID, from where fatigue cracks initiated. In both cracks investigated, a zone immediately underneath the groove is distinguished by fatigue propagation of

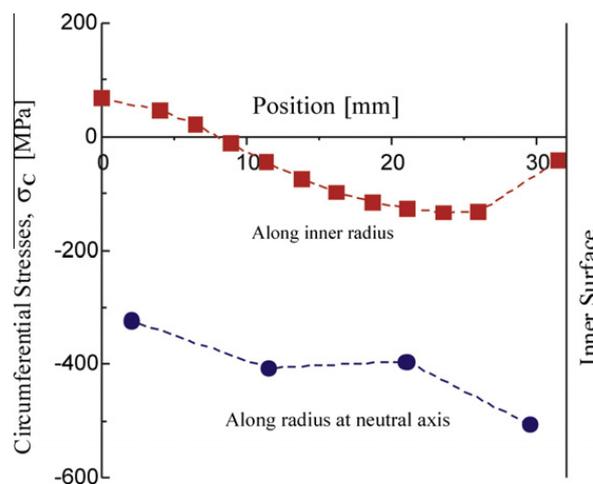
One possible cause for the observed failures is that long service times at high service temperatures would severely reduce the compressive circumferential residual stresses introduced during manufacturing with the autofrettage process. Residual stress analyses at bends were discussed in a previous work by the authors [4]. Fig. 5 shows the measured circumferential residual stresses along the pipe thickness. Maximum circumferential residual stresses near the inner pipe surface are up to 400 MPa in compression, in the plane of the curve. Tensile maximum is only 70 MPa. But residual stress measured at a 90 $^\circ$ position along the pipe perimeter is much lower. In any case, this experimental evidence is not conclusive as whether or not the residual stress field has been destroyed by service temperature.

Fig. 5. Circumferential residual stresses.

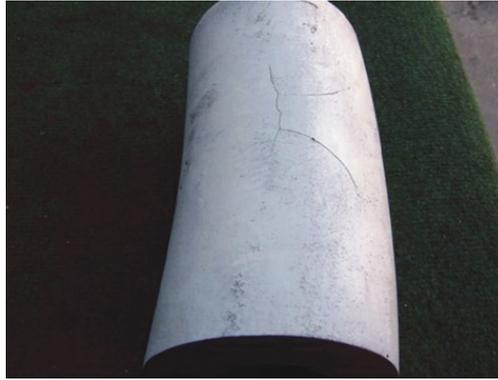
Failures at bends are characterized by intergranular and branched cracks propagation. Before 2004, cracks initiated at the outer surface (water side). Fig. 6 shows a typical H-shaped branched crack, as seen when testing with black on white magnetic particles the outer surface of the thick walled tube. Subsequent ultrasonic mapping allowed to recognize typical crack branching and propagation in the pipe wall, with many smaller secondary cracks. Stresses due to internal pressure, pipe sup-

Fig. 6. Typical H-shaped, branched crack, as seen in the outer surface of the thick walled tube.

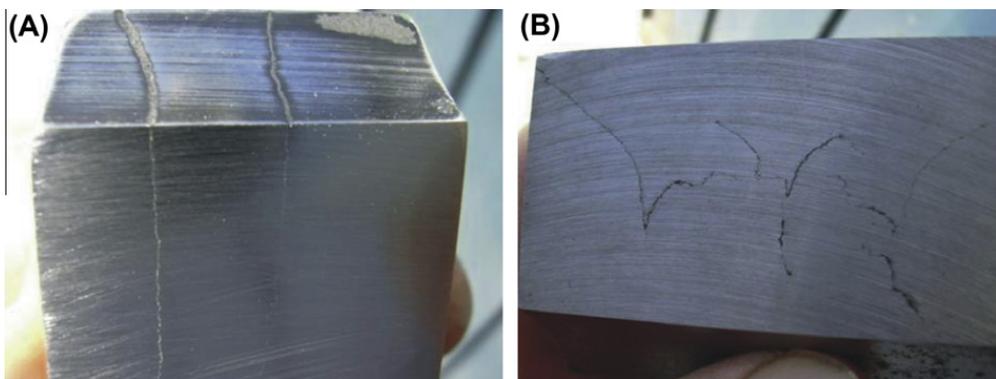
Fig. 7. Cracks corresponding to different failures, initiated: (a) at the inner surface and (b) at mid-thickness.

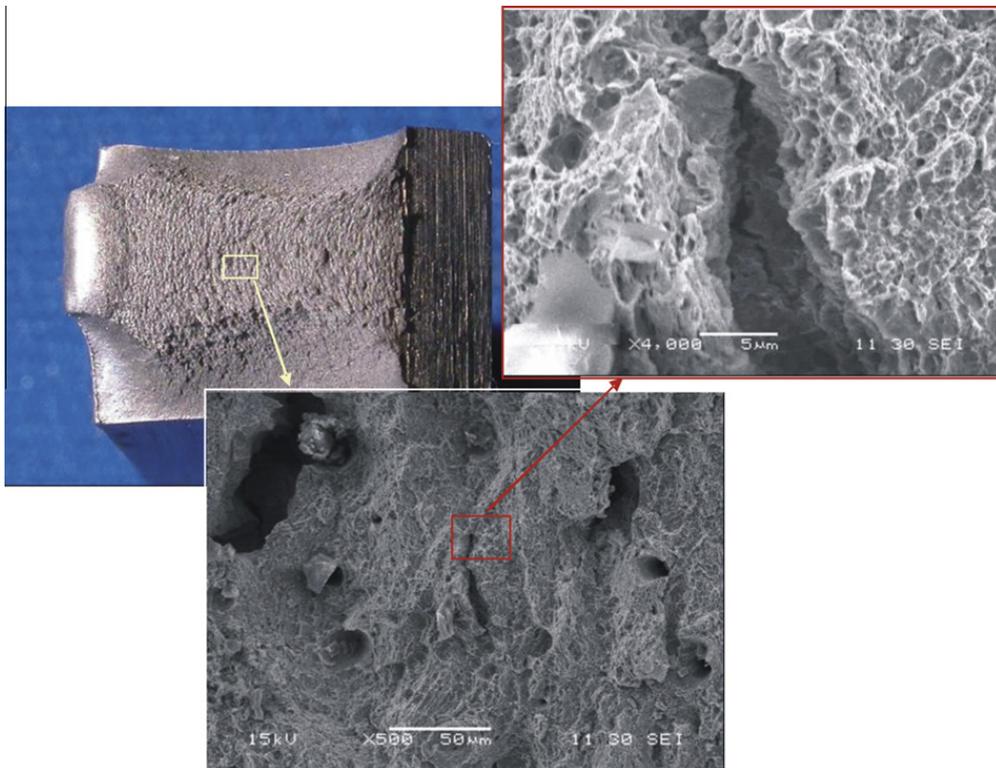
The possible incidence of embrittlement effects was investigated by means of Charpy impact tests at room temperature on ex-service samples. Freshly broken fracture surfaces were then inspected in the SEM. Fig. 8 shows a typical fracture sur-

Fig. 8. Typical fracture surface of a specimen from a cracked curve (250×, 2000×).

face of a specimen from a cracked curve. All specimens show well developed shear lips close to three free surfaces, which justify high values of impact energy, see Table 3, and which are apparently unaffected by any embrittlement. In the 30% inner area, however, the fracture propagated in a wavy pattern, that reveals a specific crack path related to the weakest microstructural features. The upper inlet in Fig. 8 (4000×) shows a micro void ductile fracture mechanism, within many secondary cracks produced by the impact.

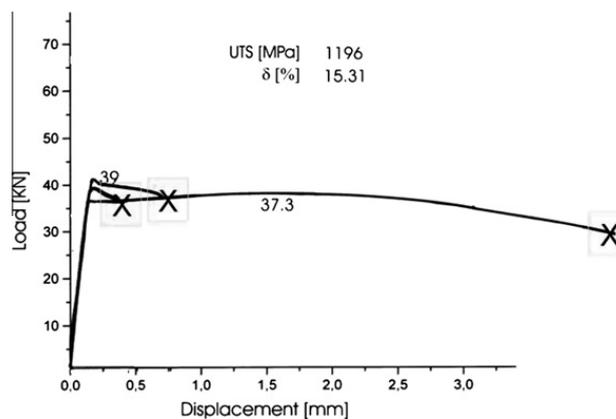
Fig. 9. Tensile test curves of the material in its original state, and with thermal–mechanical embrittlement.

The influence that previous plastic deformation exercises upon the toughness of the tempered martensite was evaluated by subjecting the martensitic structure of the tubes to plastic deformation and temperatures similar to those found in normal service, and evaluating their influence on mechanical properties. Tensile specimens were deformed 3% and 5%, then subjected to temperatures of 300, 325, 350 and 375 °C during 24 h, and finally broken. Tensile tests with notched specimens were also carried out. Fig. 9 shows load–deformation curves for the material in its original state (specimen #1). The material shows low strain hardening, what is translated in an ultimate tensile stress (UTS) very close to the yielding. The specimens deformed 3% and 5% present larger yield stress, as expected, but also showed some unexpected behaviour.

For all maintenance temperatures, when reaching the yielding load the specimens destabilized, that is to say, yielding coincides with the peak load and in that point necking takes place. The decrease of load evidences that the plastic deformation of the specimens is minimum, and all the deformation is due to necking. This behaviour would be critical if for some reason the material is imposed to a restriction of plastic flow, as happens in the middle area of the cross section. When imposing a restriction to necking the specimens break practically without plastic deformation (0.8%). It is possible to conclude that the evidenced phenomenon of embrittlement is due to a combination of both parameters: plastic deformation and maintenance to temperature.

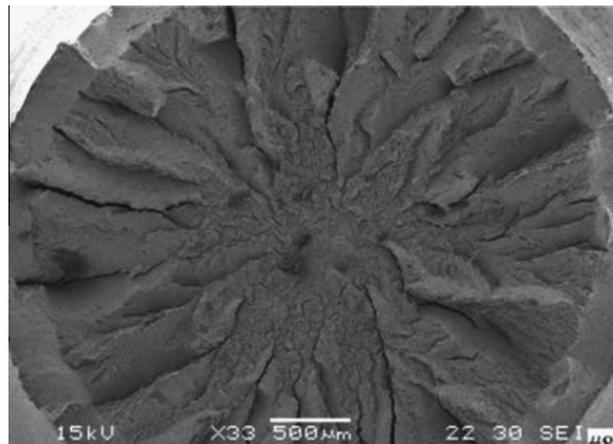
A fractographic characterization was carried out after testing, in samples from original and embrittled materials. Fracture surfaces in original material show a rosette fracture type, typical in steels subjected to tension. The fibrous central area is where the fracture originates; it has an appearance of fibres at random with micro voids in the whole surface. The fracture surfaces of the embrittled samples do not present marked differences related with the amount of deformation or the maintenance temperature. In all cases the fracture continues being of the rosette type. These deformed samples have a radial area with a great quantity of longitudinal cracks that define a more irregular fracture path, with more crests and valleys. Fracture surfaces change in the case of the notched tensile specimens. Fig. 10 shows the fracture surface of specimen #9, with a previous 5% plastic deformation and a temperature of 325 °C during 24 h. Circumferential waves are observed in the propagation direction, inside the intergranular cracking, microvoids have been observed.

Fig. 10. Typical rosette type fracture surfaces in notched embrittled tensile specimens.
