Engineering Failure Analysis

Failure analysis of a GFRP pipe for oil transport

The study was conducted on a pipe sample of GFRP. There was widespread damage in the internal structure of the tube. The flow area was blocked due to landslides helical fibers. The matrix was an epoxy–anhydride system (Diglycidyl Ether of Bisphenol A). There was an advanced state of diffusive processes that reduced the glass transition temperature (T_g) of the material to critical levels. The material showed a major irreversible hydrolytic attack. The mechanical behavior would indicate a considerable degree of structural compromise. The sample showed an advanced state of degradation, with clear signals of processes activated at temperatures close to T_g and catalyzed by the diffusion of low molecular weight organic species. The irreversible chemical degradation process especially attacked the fiber–matrix interface reducing the mechanical performance.

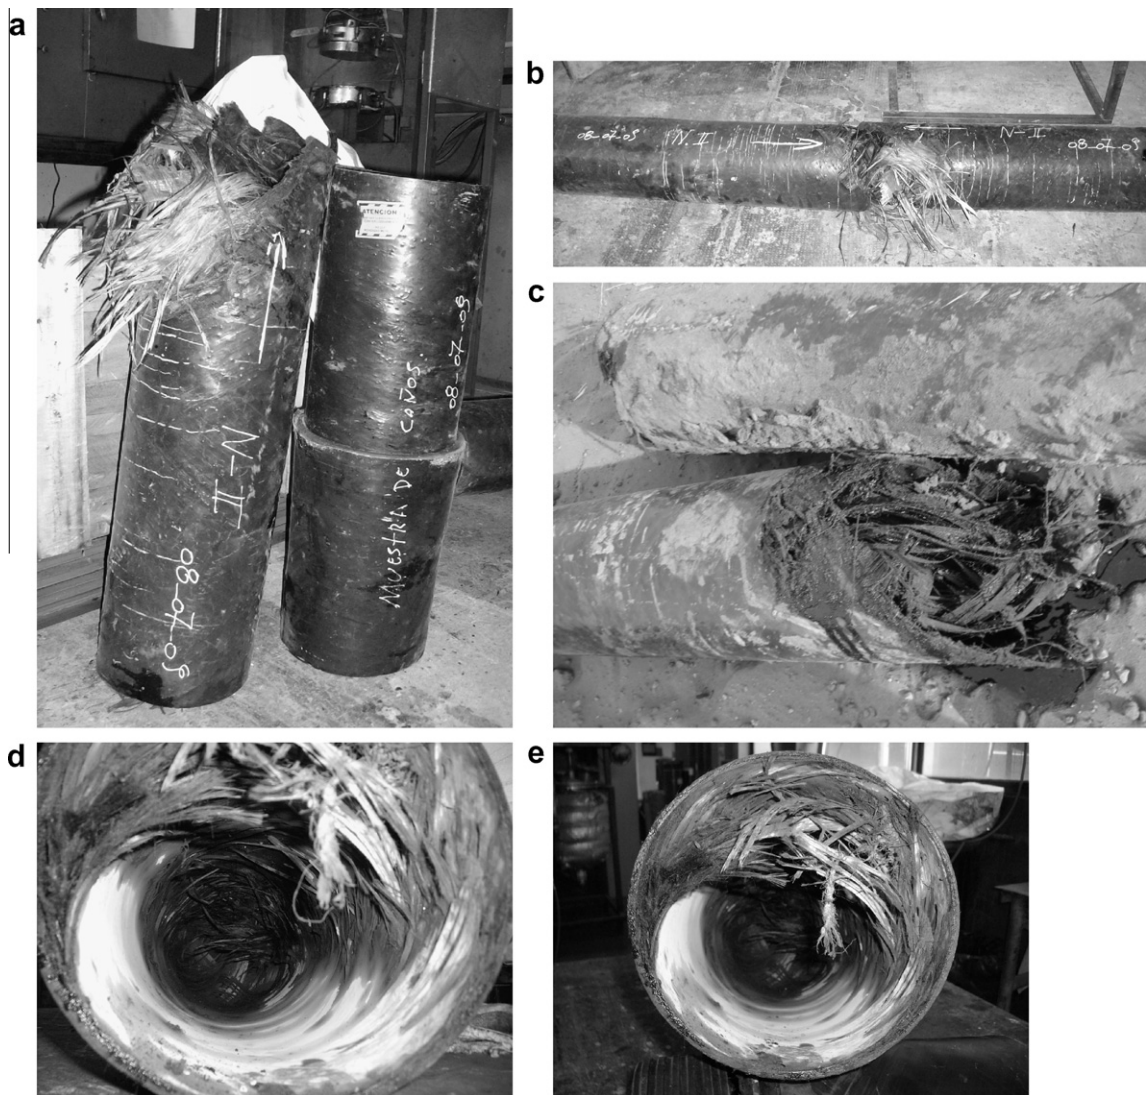
- The general condition of the surface was acceptable. No damage was observed considered due to the interaction with the external environment, as can be seen in Fig. 1a and b. Fig. 1c shows a pictured obtained in field.
- The flow area was blocked due to displacement of successive layers (fiber/matrix) of the material (Fig. 1d).
- A significant portion of the thickness of the pipe wall has been lost due to detachment of the inner layers (Fig. 1e).
- After removing loose material proceeded to take samples for make the characterization of the remaining wall. Unless otherwise stated, is called inner surface of the product to one that was obtained after removing the loose material that can be seen in Fig. 1d and e.
- When cutting interlaminar cracks were not observed in any of the surfaces exposed.

Fig. 1. Photograph of received pipe: (a) and (b) global view; (c) image obtained from field; (d) blocked flow area; (e) reduction in thickness due to detachment of fibers.

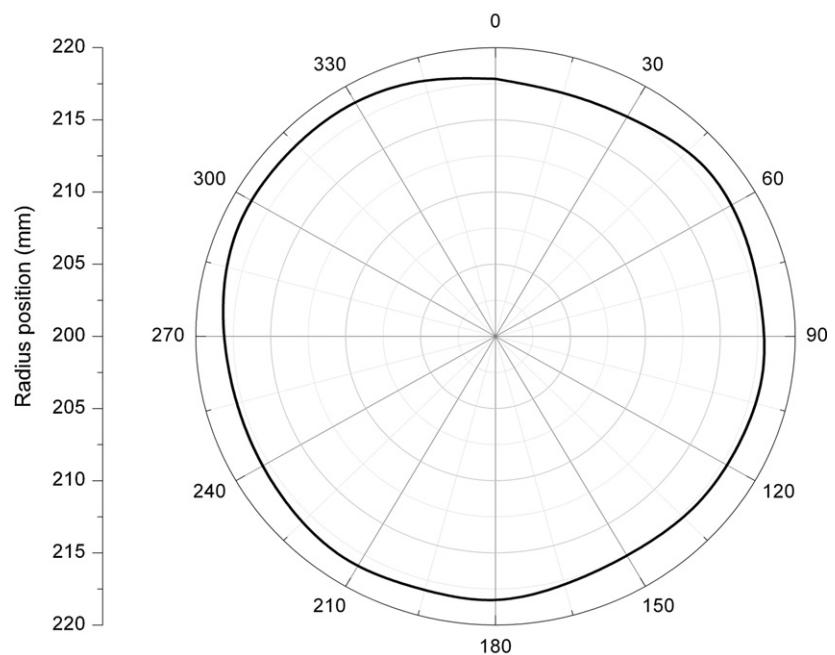
Table 1 presents the information gathered in field and from the pipe customer about the operation conditions and main geometrical characteristics. In order to check the actual dimensions of the tube, the thickness along the perimeter and the outside diameter were measured. The results are presented in Fig. 2, and summarized in Table 2. Fig. 2 shows that the thickness has high variations along the perimeter, in part attributable to the fabrication process but also due to loss of material caused by the degradation process. The reduction of the wall thickness is often the beginning of failure events, since it produces local stress concentration.

Fig. 2. Wall thickness at different points in of pipe perimeter.

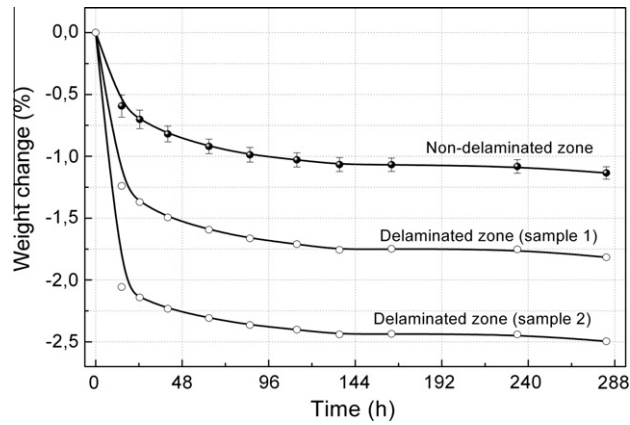
Fig. 3 presents the results of the desorption tests. It can be seen a clear different behavior between the samples from the delaminated area and the samples from the no delaminated zone. The equilibrium values obtained for the specimens of 6.9 mm in thickness are close to 1.2%. For samples of 4.0 mm nominal thickness values of 1.8% to 2.5% were reached. These values indicate very high content of low molecular weight species that spread in and plasticize the epoxy matrix composite, reducing the glass transition temperature and accelerating the relaxation processes that catalyze dissemination. Volatile contents above 0.75% can only be achieved at temperatures near T_g . It should be noted that according to our experience, and in agreement with other authors [2,3], at temperatures above 70 °C the hydrolytic degradation processes that affect

Fig. 3. Curves of weight variation as a function of time (desorption in an oven). The upper curve shows the average of 3 samples taken from the non-delaminated area. The two lower curves correspond to individual samples in the delaminated area (it is seen that the values are averages).

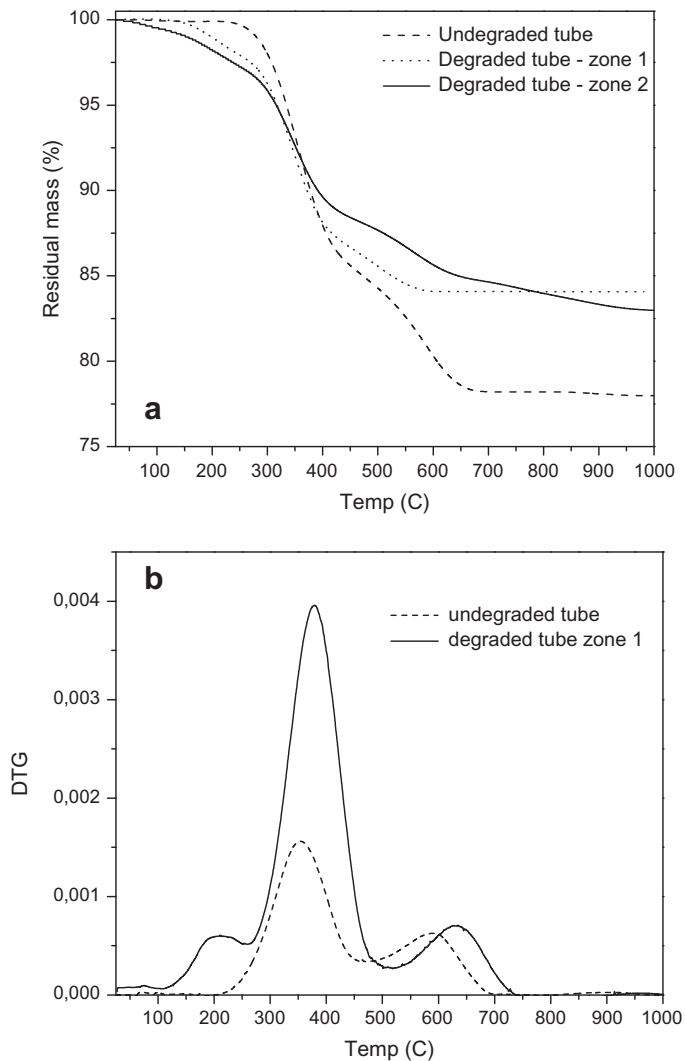
Fig. 4. (a) TGA curves for an undegraded epoxy–anhydride composite pipe and for different zones around the failure in the degraded pipe. (b) DTG curves for the same materials.

the matrix and fiber–matrix interface are accelerated considerably. The analysis of thick samples indicates that the diffusive processes extend throughout the thickness of material which could reduce significantly the mechanical behavior of the product. In order to have a better understanding of the kind of species that diffused in the polymer matrix, TGA studies were conducted. Fig. 4a shows the mass loss as a function of temperature for two zones near the failure in the used pipe and also for an unused pipe. The degradation of the epoxy–anhydride resin takes place in two steps, from 200 to 400 °C and from 500 to 700 °C. The main degradation peaks can be seen also in the DTGA curves (Fig. 4b). When comparing the undegraded and degraded pipes, a third peak arises in TGA analysis of the second one, which can be attributed to desorption of low molecular weight organic species. This process occurs from 100 to 200 °C and is different from the moisture evaporation that takes place below 100 °C.

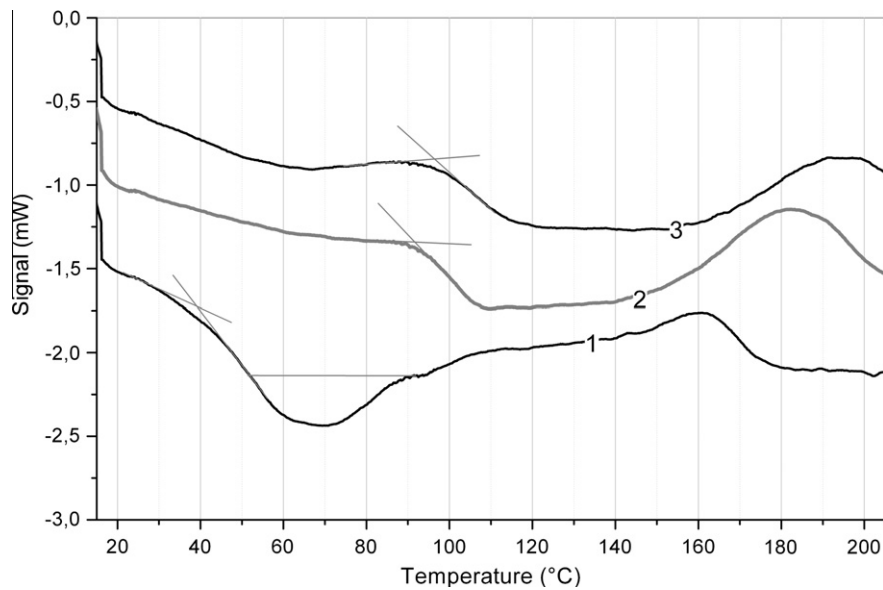
Fig. 5 shows the thermograms obtained from the first, second and third run on the outside of the product (similar curves were obtained for the inside part of pipe). The curves obtained for samples from the outside pipeline exhibit the presence of an exothermic peak (Fig. 5) that could be an evidence of residual heat. The samples studied showed a low transition temperature, in the order of 50–60 °C, which could be attributed to the plasticizing effect produced by the diffusion of low

Fig. 5. Curve of signal (mW) as a function of temperature obtained by Differential Scanning Calorimetry (DSC) of the outside of the duct. Determination of glass transition temperature (T_g). The numbers (1, 2 and 3) indicate the run.

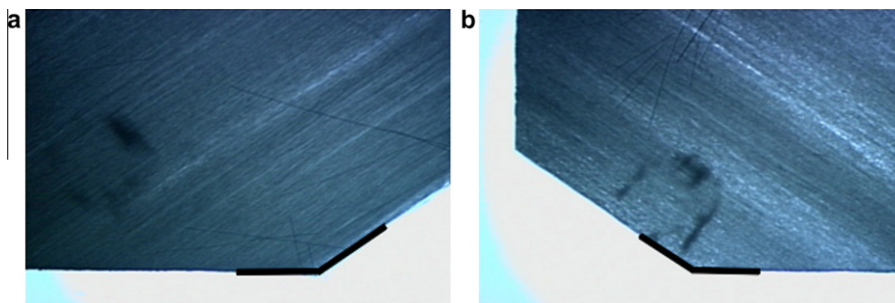
Fig. 6. (a) and (b) Micrographs showing the winding angle of two successive layers of fiber.

From the burning of samples taken from the pipe, winding angles and fiber content were obtained. The average fiber content measured was 69.52%. Winding angles are listed in Table 3. Fig. 6 a and b show examples of the winding angles of two successive layers con the composite. The fiber content obtained is less than the nominal value of 75%. The reduction of the fiber volume fraction seems to be caused by variations in the manufacturing process, but is in the range of acceptable values for oil transport GFRP pipes. For his part, the winding angle showed no significant differences between delaminated and not delaminated areas. In both cases it remains close to the optimal value ($\pm 55^\circ$). This theoretical angle can be obtained by netting analysis, and it is based on the assumption that a simply pressurized structure is subjected to twice as much hoop stress as it is to axial stress, which is a design approach common in industry [12].

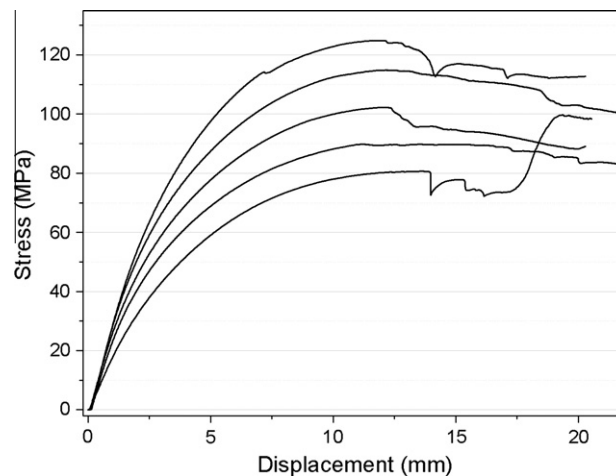
Mechanical properties obtained from flexural tests are summarized in Tables 4 and 5. The stress–displacement curves of the samples without desorption are shown in Fig. 7. It is difficult to establish a level of damage without the values obtained

Fig. 7. Stress–displacement curves obtained in the flexural tests of samples without desorption.

on the evaluation of material at the beginning of its service life. A good approximation can be considering the deviation of the values registered for similar chemical systems. The obtained values of modulus ($E = 7.58$ GPa) are lower even in comparison with that expected for a product in extended service. Maximum strength values (102.4 MPa) also seem to indicate that the behavior at large deformation degrees has been worsened. The dispersion of results indicates a lack of homogeneity in the material. Some of the values obtained indicate the presence of highly degraded areas. The results obtained for desorpted samples evidence the combined effect of diffusive processes and chemical degradation. As it can be seen, after losing volatile components, the material did not recover their mechanical properties showing similar values than the original samples. This is confirmed by a statistical analysis (paired sample student's t -test) that reveals that there is no significant difference in the population means of the flexural strength for the as-received and desorpted samples ($P = 0.51$ which is beyond the limit of $p < 0.05$ for statistical significance).

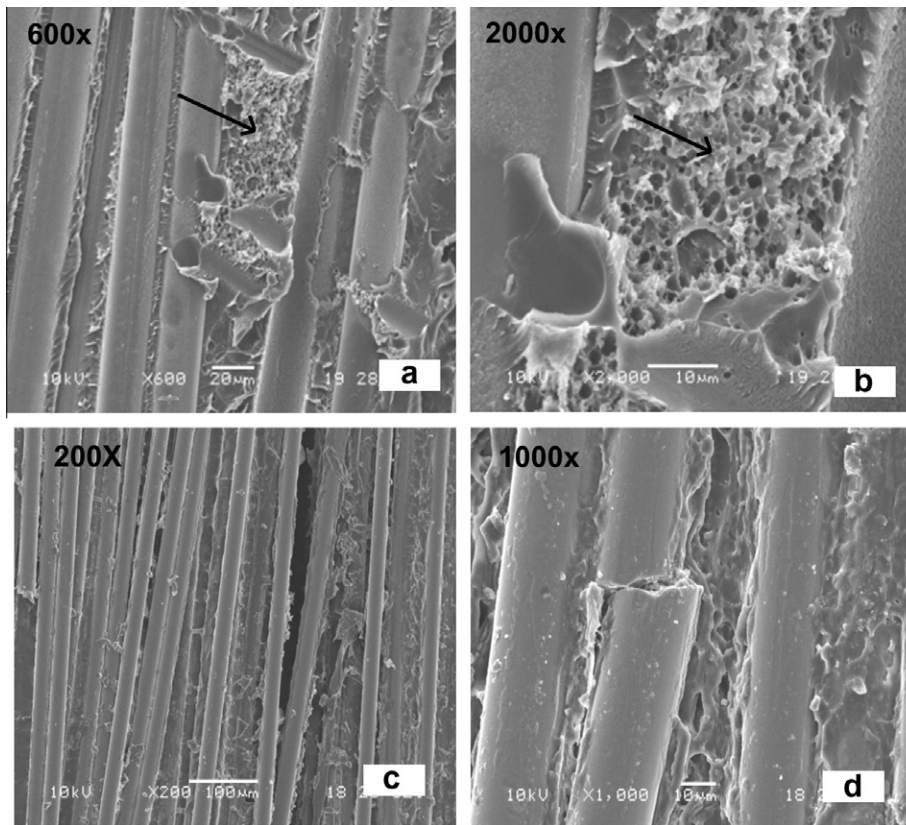
Fig. 8. SEM micrographs of the different layers of pipe: (a) and (b) fluid contact layer; (c) and (d) layer after layer fluid contact (closer to the outer surface).

Fig. 8 shows the images obtained by SEM. In all cases are images of the inner surface of the pipe, or layers near this. Fig. 8a and b are pictures obtained from a layer that was in direct contact with the transported fluid. They show signs attributable to hydrolytic degradation which comprises relatively widespread areas of the sample. Observed gaps in the matrix due to the removal of material and loss of fiber–matrix interface can also be observed. The presence of widespread areas of chemical degradation could significantly affect the mechanical behavior of the product (as is clearly demonstrated by the values obtained in the flexural tests). In Fig. 8c and d can be seen images of an inner layer (the following to the one in contact with the fluid). The damage that can be observed is minor, indicating that the degradation process starts inside the duct and progresses outward.
