Loss of a 30" directional crossing due to pipeline collapse during pullback

Janine Booman^a, Hernan Kunert^b, José Luis Otegui^{c,*}

This article concerns the loss of a Horizontal Directional Drilling crossing due to a failure that took place during pullback of the pipeline. The more than 500 m long drilling was meant to lodge a 30" pipeline that crossed a large river. The failure caused the total loss of the crossing, and the necessity to repeat the entire process in another, less favorable location. Root causes involved a difficult soil composition, and constraints at a populated bank that led to engineering solutions not proved before on a pipe of such diameter. Discontinuities on the tunnel and the use of a sacrifice pipe at the front end of the pipe column, which was related to the need for more pipes than originally calculated because of a series of problems at the beginning of the perforation, were also defined as root causes. Lessons learned are highlighted.

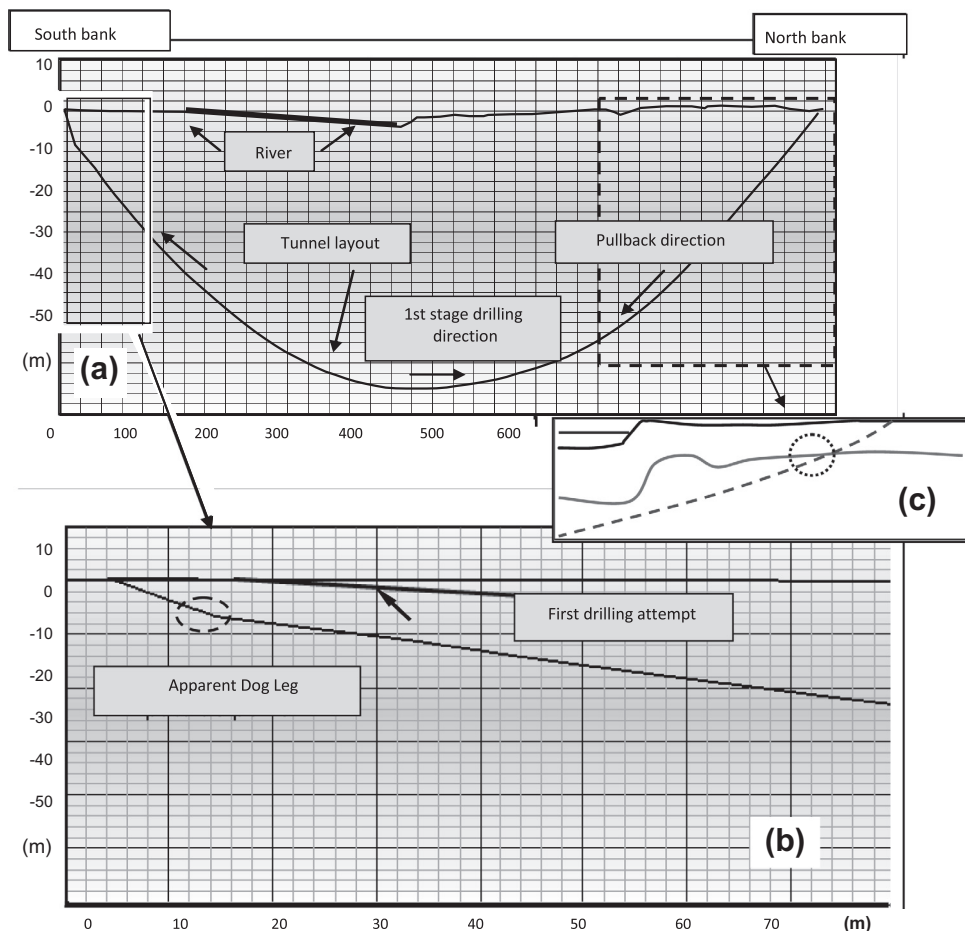
Fig. 2. (a) Sketch in elevation of the HDD tunnel under the river (scales in m), (b) detail at south bank, (c) detail at north bank.

Circled in Fig. 2b and c are the boundaries between the surface gravel layer and the underlying clay soil. Despite all precautions, after the tunnel was completed it was apparent that a change in slope was produced at the interlayer in the south bank (Fig. 2b). This bending of the pipeline is called “dog leg”. As discussed before, this could lead to higher than expected

stressed in the pipe when being pulled along the tunnel. No apparent dog leg was found in the northern bank, from where the pipe pull back would start (Fig. 2c).

An emergency failure analysis was carried out. The geo-referenced data strongly suggested that the apparent dogleg near the end of the tunnel at the south bank could have been responsible for the problem (see Fig. 2b). This position was also compatible with the position of the reamer at the time of increased axial load and mud pressure. Although not serious increase of torque was detected at this location, it was concluded that buckling of the pipe could probably have started when the pipe head reached the dogleg.

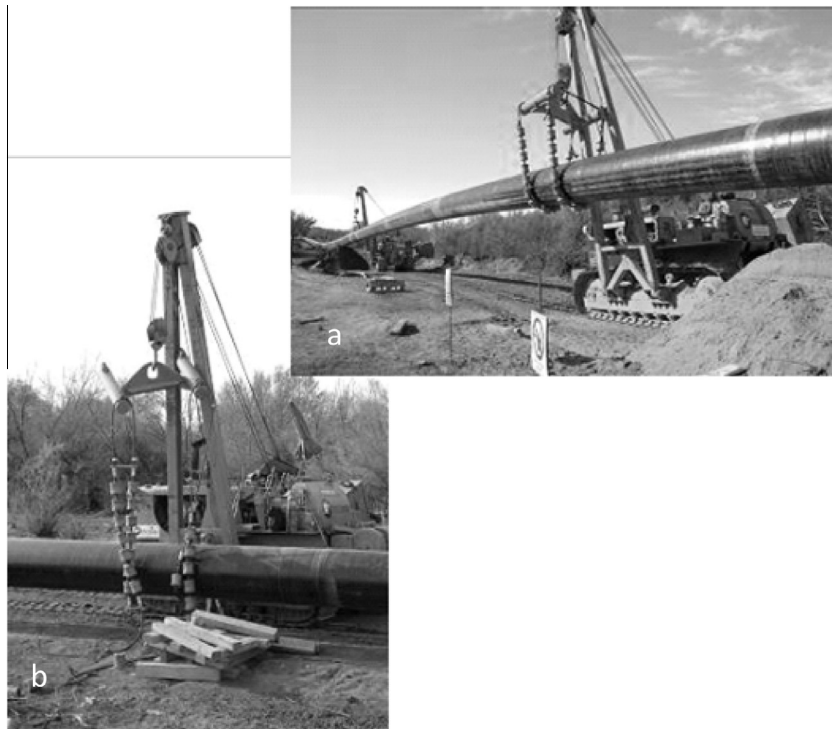
Fig. 4. (a) Pipe string at north bank waiting for pullback. (b) Failure of pipe raiser at beginning of pullback.

After analyzing the geometry of the tunnel, maximum expected stress levels at the pipeline were calculated. Then it was decided to proceed to pipe pullback. Fig. 4a shows the pipe string hanging from raisers in the north bank, waiting for pullback. When the pipe string was about to be inserted on the tunnel, one of the sliders broke and the pipe string fell from a height of about 3 m (Fig. 4b). This incident caused a minor collapse of the tunnel entrance, see Fig. 5. Preventively, a cleaning gauge was passed from the southern margin, to ensure there was no internal collapse on the tunnel. Since the gauge found collapsed parts, it was re-inserted into the tunnel, this time from the northern margin. Special attention was kept to go through the gravel layer by reaching more than 13 m depth (see detail in Fig. 2c). The gauge was left in this position until it was removed the next day, through the same side it had been inserted the last time (north bank).

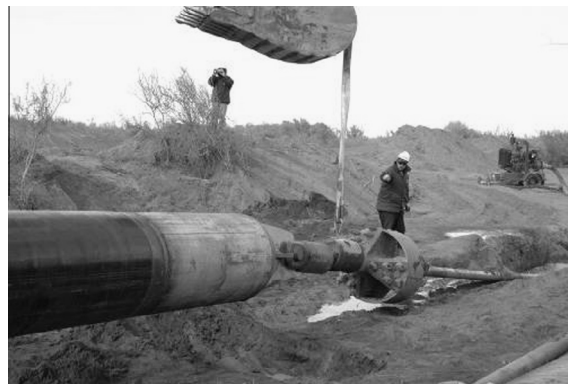
Fig. 5. Minor collapse of the tunnel entrance.

The second failed decision, not so obvious but also important, was to pass the reamer along a short length of the tunnel, after the small collapse at the entrance. It is clear now and should have been clear then, that any debris pushed by the reamer would accumulate at the site where the reamer would be stopped. Once launched, the reaming should always be pushed all the way through the other side.

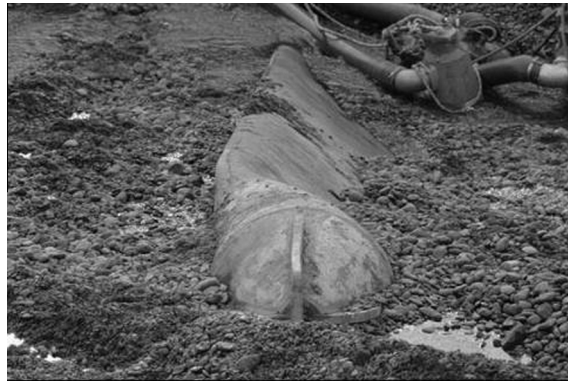
Fig. 6. The undesired event: collapse by lateral buckling seen at the front end of the pipe string.

It was decided to make an excavation in order to uncover pulling rod up to the pipe head. Fig. 6 shows the undesired event: collapse by lateral buckling readily evident at the front end of the pipe string. Collapse started in the first pipe, near the head joint, between diameter reinforcements in the head. This is the least stiff zone to external pressure. Only two pipes and the beginning of a third one could be further uncovered without compromising the stability of the trench. All these pipes had collapsed by lateral buckling, see Fig. 7.

It is concluded that the thinner walled (8.14 mm thick.) leading pipe at the front of the string collapsed during the pullback process, since in this case combined stresses surpassed critical buckling conditions. Once the initial collapse of the thinner leading pipe occurred downhole, the failure propagated longitudinally to the thicker walled pipe and extended to the point at which the pigging mechanism would no longer advance through the 30-inch-diameter section of pipe. The collapse was not immediately detected by an increase over the permissible pull back force, mud pressure and torque, because the lubrication and mud conditions were very good.

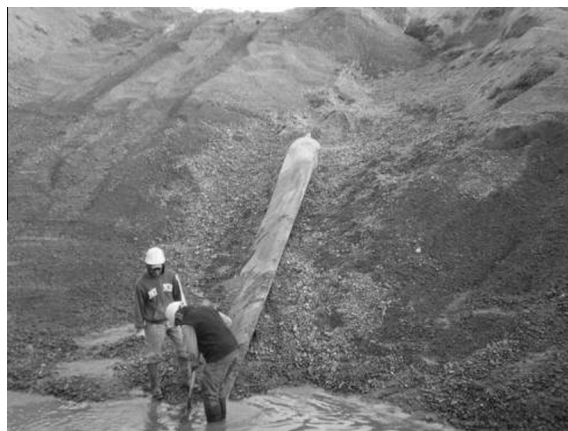
Fig. 7. Digging at the south bank confirm extended lateral buckling of the pipe.

The proximity of an in-service gas pipeline, risks of erosion and flood from the river were practical limitations that discouraged to continue digging in order to recover more pipes for further analysis. Only one pipe and a portion of the second one were extracted. No damage was observed on the teeth and other parts of the reamer that was heading the pipeline. By comparing the positions of the beginning and the end of the pipe string, it was verified that the pipe string underwent a 90° rotation under the tunnel.

If the buckling collapse of the pipeline had indeed been initiated at the “dog leg” near the south end, (detail in Fig. 2b), then the HDD could have been recovered by digging until reaching the “dog leg”. A further attempt was made to determine the extension of the collapse in the pipe length. A gauge (a “caliper pig”) was introduced inside the pipe from the end at the opposite bank (north), and it got stuck in a position near the deepest point of the tunnel. The depth of the stuck point (about 58 m) made it not possible to dig a trench in order to visually evaluate the nature of the problem. At this moment, the HDD crossing had to be abandoned, and restarted in a new location.

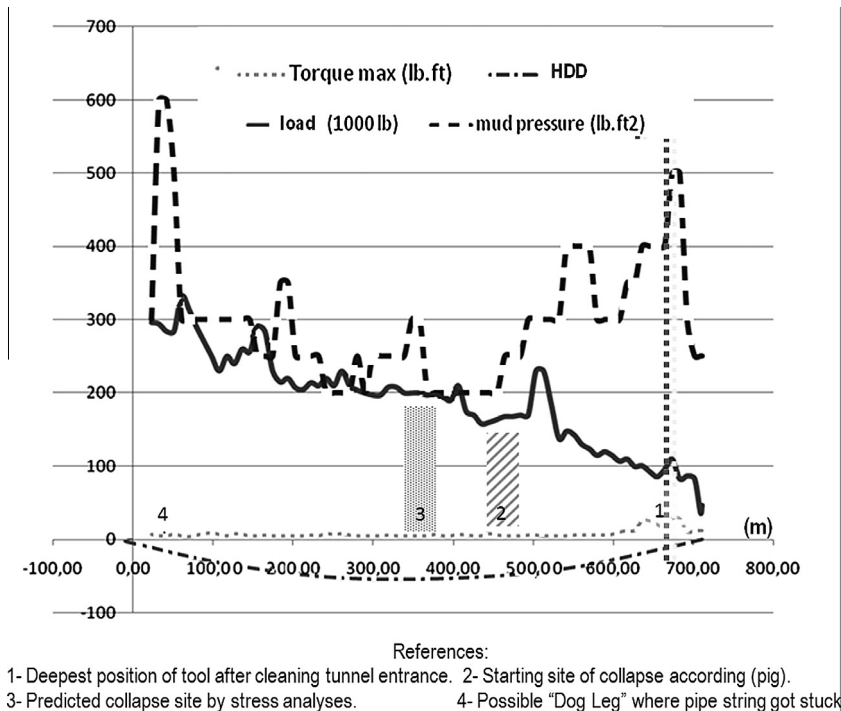
Fig. 8. Measured traction load, mud pressure and torque during pullback of pipe string into tunnel. Southern river bank is on the left, horizontal distances in meters.

The first step in the RCA was to check construction data. The sketch in Fig. 8 shows the evolution of the recorded parameters in the drill report. Indicated in vertical axes are measured traction load, mud pressure and torque during pullback of the pipe string into the tunnel, which took place from right to left in the sketch. Southern river bank is on the left, horizontal distances are shown in meters in the horizontal axis. The dotted vertical line (1) indicates the position where the cleaning pig had been left for a whole day, near the northern bank of the river. It is worth noticing that it corresponds to the position where a slug pressure peak was recorded and with a relative load peak. Position (2) indicates the starting site of the buckling collapse of the pipe, according to the evidence given by the internal inspection tool (pig). Position (4), near the south end of the HDD, depicts the possible “dog leg” where the pipe string got stuck.

The evidences observed at the crossing site and mechanical models allowed defining the collapse of the pipe by the combined effect of external pressure and bending and traction loads in a localized pipe bending, as the immediate cause of the incident. Although the tunnel does not present physical evidence (the tunnel and the pipe had to be abandoned), it is considered that the entire length of the pipe, to the south (left) of point (3) indicated in Fig. 8, collapsed.

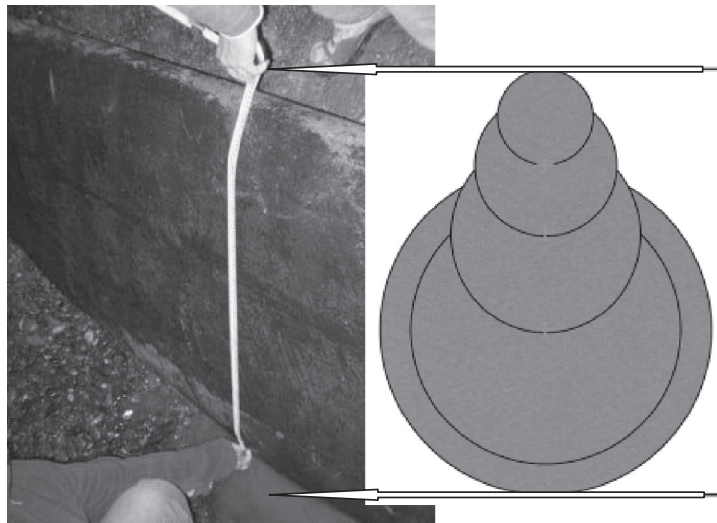
Fig. 9. Width of collapsed pipe (1.2 m) is less than estimated height of the tunnel (1.4 m).

Nominal diameter of the tunnel was 42" (1.0 m), while the major diameter of the deformed pipe was over 46" (1.2 m). It was not possible that the deformed pipe had travelled nearly the whole length of the tunnel and that the parameters recorded had not showed any significant increments. However, as it was already mentioned, only the last drilling stage used a centering device. This could have lead to an ovalization of the tunnel, since the axis of the following stage would rest in the lower point of the hole drilled by the previous tool, as shown in Fig. 9. The estimated major diameter (height) of the tunnel is 54" (1.4 m). Under these conditions, it is possible that the pipe collapse took place early on the pullback process and then rotated until it was accommodated on the major diameter of the pipeline to keep traveling with no further resistance to pullback.

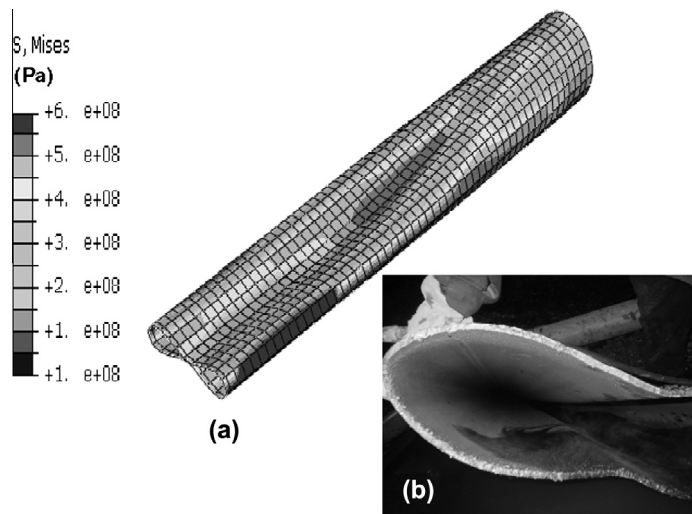
Fig. 11. (a) Numerical model with local bending and post-collapse propagation and (b) actual pattern in the pipe.

A Finite Element Model (FEM) was carried out using Shell type elements, in order to reproduce the onset of buckling in the front end of the pipe during pullback [20]. The model includes geometric and material nonlinearity (plasticity), and contact conditions in the inner wall surface of the pipeline. A 1.6% initial ovalization was introduced, to force onset of buckling. The model was fixed on one end; on the other end all rotations and translations (except axial) were restricted, outer pressures are 5.33×10^5 for $t = 8.14$ mm and 16.9×10^5 for $t = 11.9$ mm. Fig. 11 shows results from the numerical model, with local bending and post-collapse propagation. Insert in Fig. 11 compares the numerical prediction with the actual pattern in the pipe. A thickness reduction of 32% implies an elastically determined reduction in collapse pressure of 68%.

The reduction in thickness of the first pipe in the column lead to a stress state twice and a half more critical than for the rest of the column. Results of the numerical modeling also show that the influence of the thinner pipe in the collapse pressure, if the thin tube is more than 6 m long, is such that the strength of the pipe string is similar to that of the whole pipe string made with thin pipe. This is the present case (each pipe is about 12 m long).
