Engineering Failure Analysis 16 (2009) 187–199

Self-ignition of natural gas inside pipes at a regulation station

Pablo G. Fazzini^{a,*}, Jose Luis Otegui^b

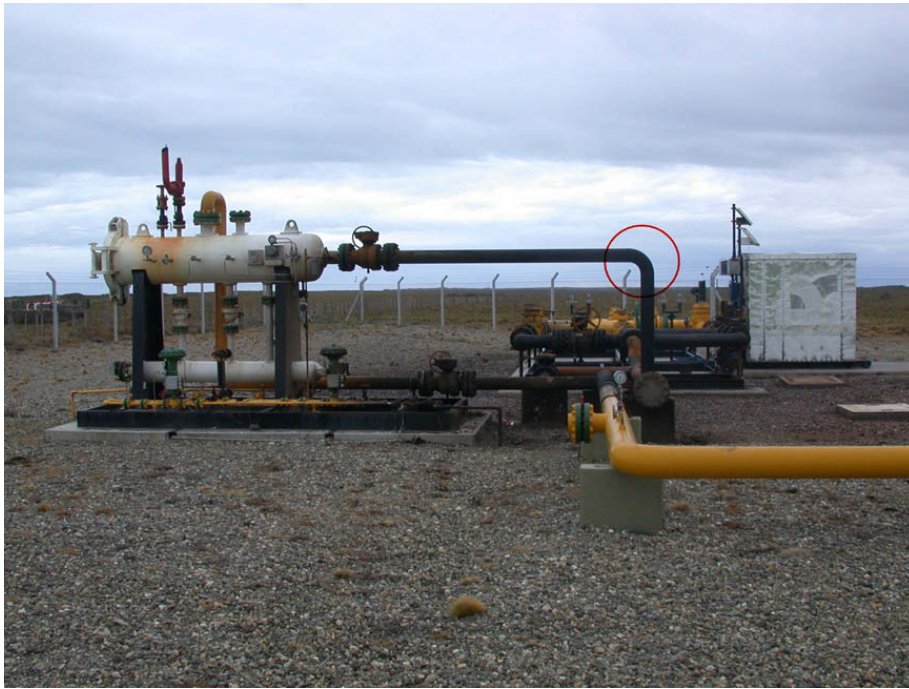
Fig. 1 shows the container of the separating filter, and the first horizontal and vertical portions of the suction pipe. The first bend is indicated, the vertical pipe ends in a Tee to the 8 in. collector pipe, see detail (A) in Fig. 2. Also indicated in this figure are (B) the end flange, (C) strongly deformed intermediate pipe tract, (D)

Fig. 1. Separating filter and upper suction pipe.

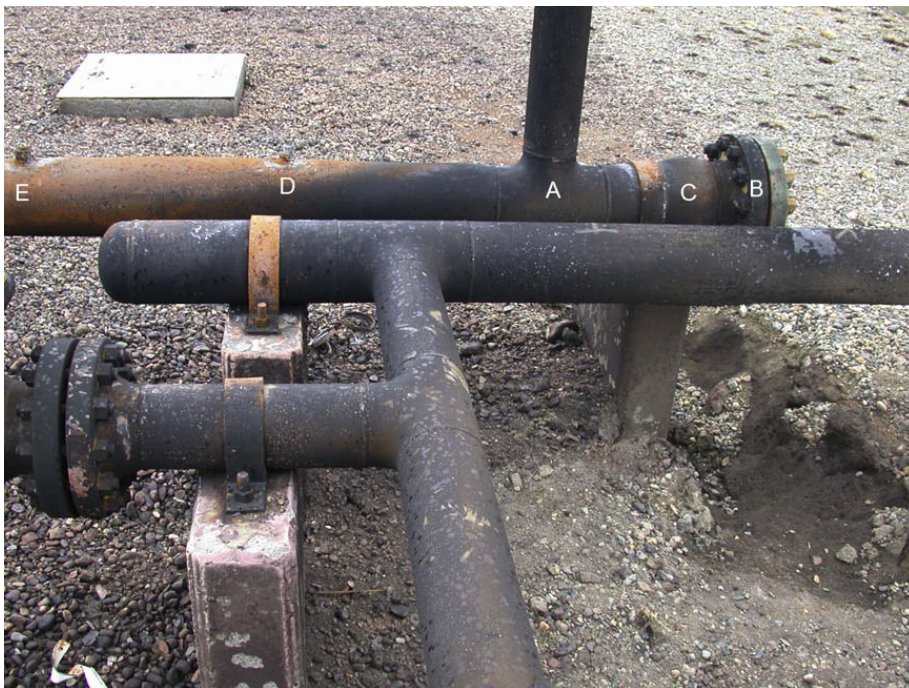
Fig. 2. 8 in. lower suction pipe. (A) End Tee for vertical pipe, (B) end flange, (C) strong deformation, (D) cap to thermometer, (E) cap to manometer.

joint to a thermometer, and (E) joint to manometer, whose clock was taken off. The gas leak from the end flange B caused the small hole seen at the bottom right of the picture.

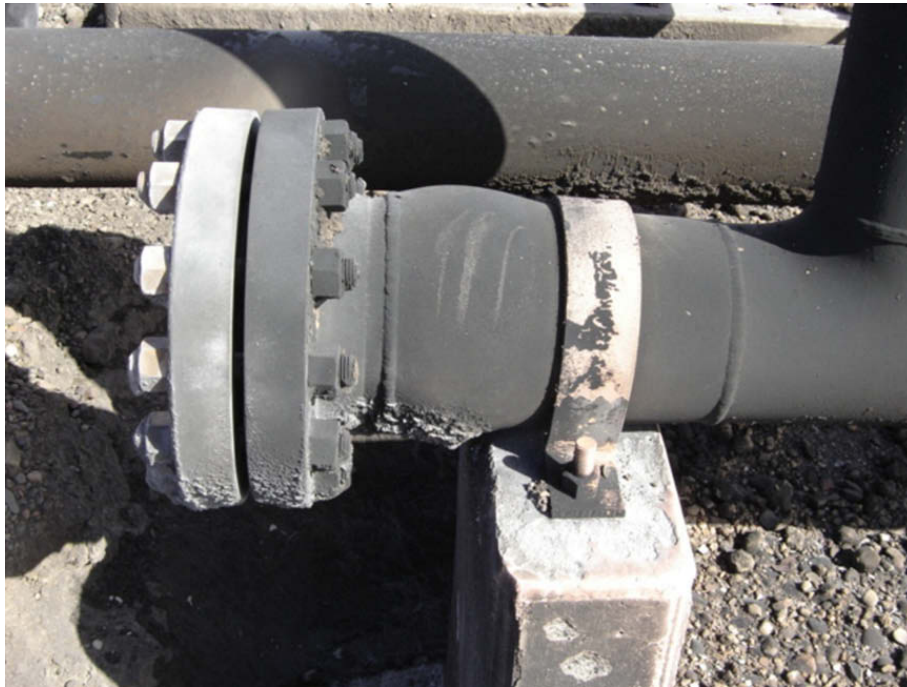
Diameter variations due to plastic deformation are seen in tube section between the Tee and the end flange, and in the section between manometer and thermocouple. Fig. 3 shows the strongly deformed tract C, as seen

Fig. 3. Deformed tract (detail C in Fig. 2), as seen immediately after the fire.

immediately after the fire was extinguished. Dark parts correspond to burned coating. Atmospheric corrosion soon turned into orange color all parts seen white in this picture, in which the coating was totally destroyed by the fire.

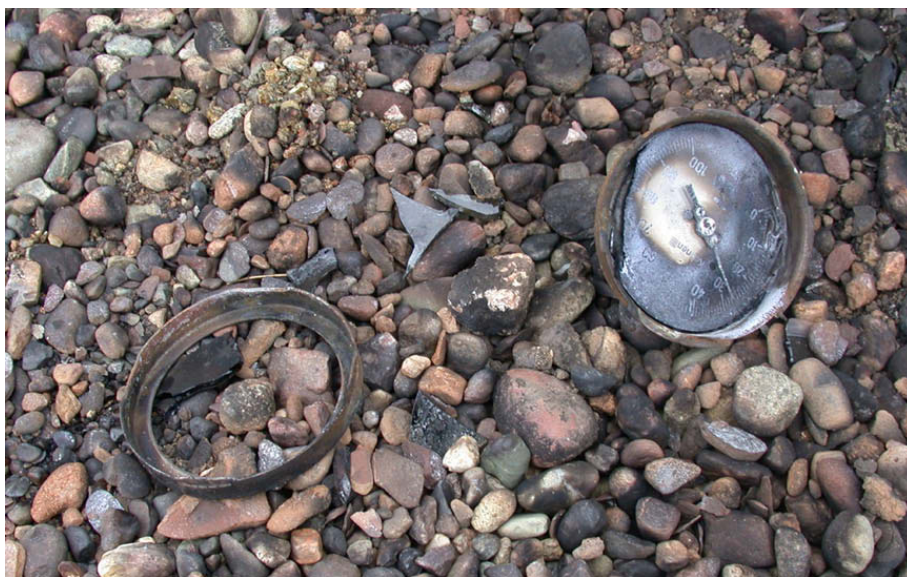
The damages due to the overpressure in the \varnothing 8 in. pipe not only include increased diameter. The threaded connection of the manometer broke and the gauge flew almost 20 m. Its gauge got stuck in 28 bar, see Fig. 4. The needle was stopped by a rivet when pressure dropped.

Fig. 4. The manometer flew 20 m, the needle was stopped by a rivet at 28 bar.

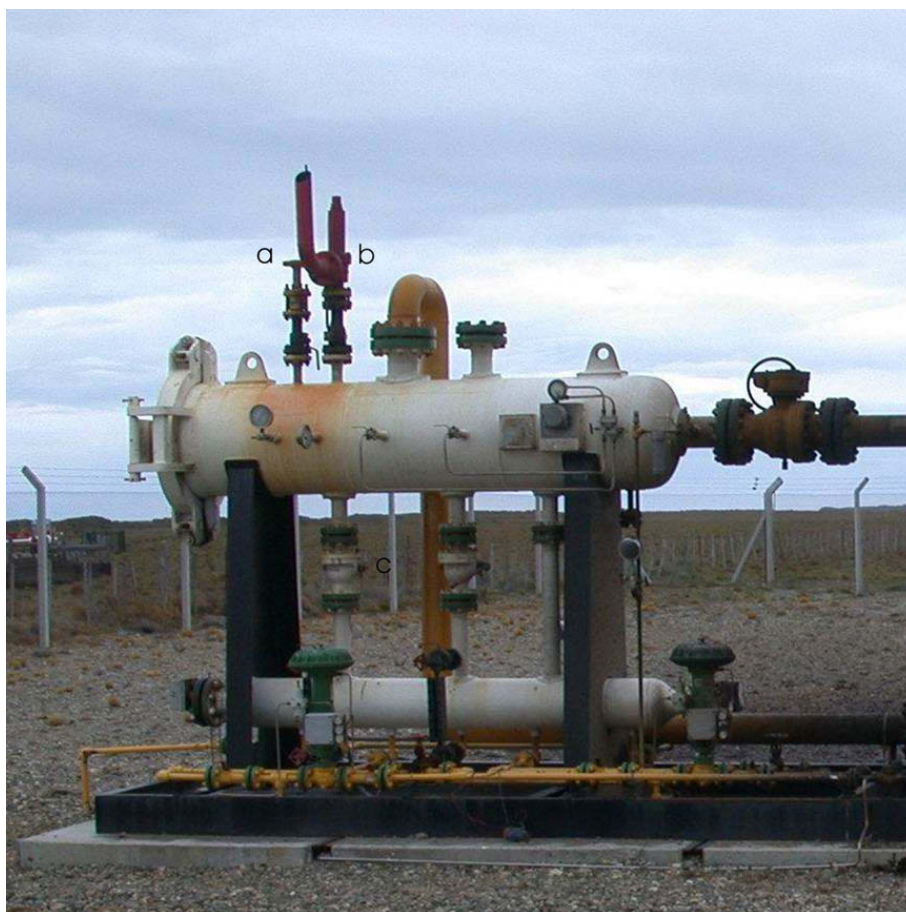
The possibility of an overpressure was discarded, since the pressure downstream the skid was 41 bar, much less than previous operating pressure (between 45 and 60 bar). The hypothesis of a leak in the end flange followed by outer explosion was originally considered unlikely. The burst disk in the filter was activated; its rupture pressure is 95 bar. The switch for high level of liquid in the filter also failed. Burst disk (a), safety valve (b) and switch (c) are shown in Fig. 5.

Fig. 5. Burst disk in the filter, safety valve and switch for high level of liquid.

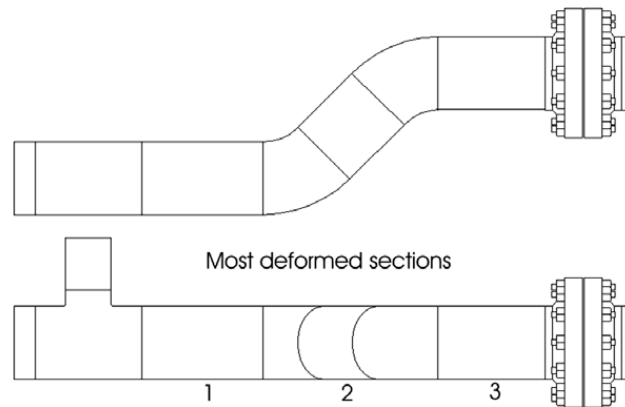
Fig. 6 shows the bent section of the line connecting the by-pass. Sections indicated in the sketch sustained symmetrical deformations, with radial displacements of 8.71, 8.4 and 5.37 mm for sections 1, 2 and 3, respectively. The straight sections are thinner than the accessories (curve and Tee), but these also sustained plastic deformations. The flat plate of the end flange also bent, indicating it also underwent important plastic deformations due to pressures above its yield strength. Its fixing bolts were also plastically bent, those in the lower

Fig. 6. Sketch of bent section of the line connecting the by-pass.

part of the end flange were more stretched than those in the upper part. This pattern is compatible with the occurrence of a leak in the lower part of the flange. In the middle region of the bolts are remnants of the seal, changes in thread color were due to different temperatures and environment during the fire.

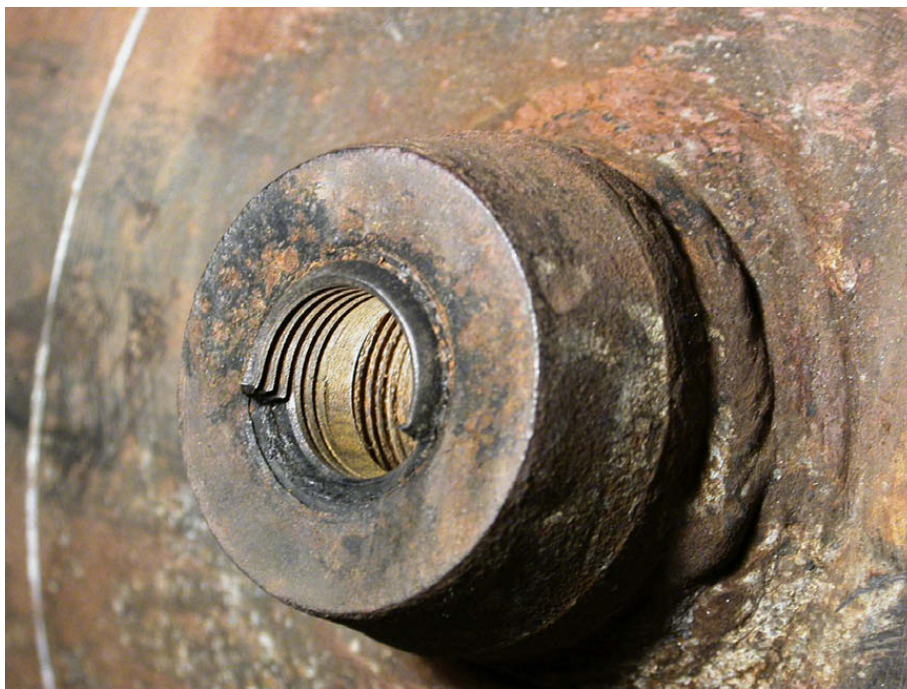
The threaded joint of the manometer was fractured at the weldolet. Fig. 7 shows that approximately half of the fracture took place in one thread within the weldolet, and the rest in another thread, outside the weldolet. The threads are worn away in the inner diameter of the female thread. These fracture surfaces do not show

Fig. 7. Fracture at thread in weldolet of manometer (E, Fig. 2).

indication of previous fatigue or corrosion defects. This uncommon flaw is related to the weldolet being too large, so that a male–female intermediary was placed. In spite of the poor quality of this accessory, its failure shows large plastic deformation, due probably to an important increase of internal pressure. This accessory is downstream the bent thermocouple tube (Fig. 2).

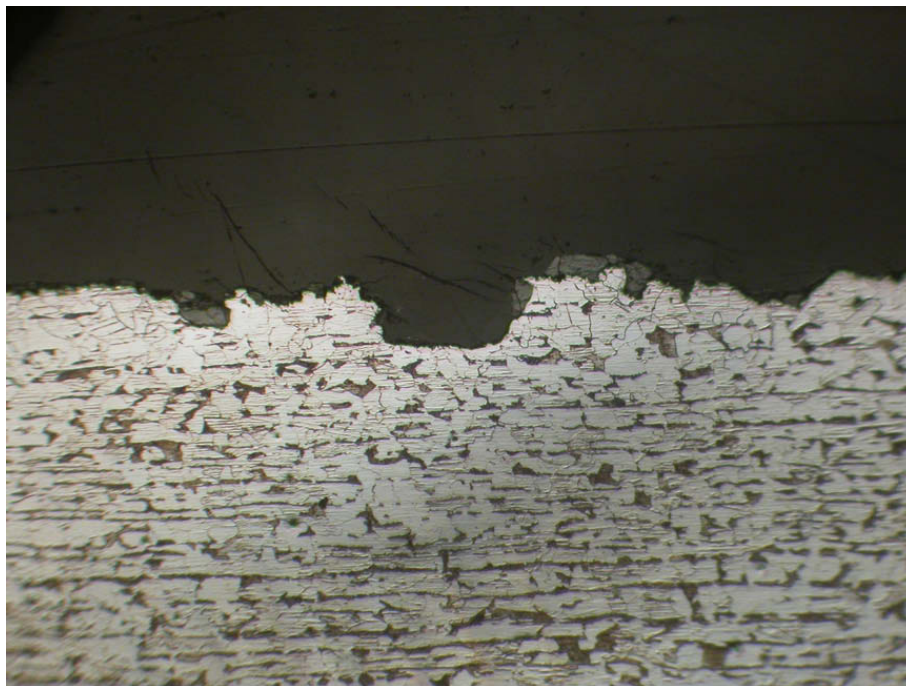
Fig. 8 (X250) shows as an example the microstructure near the inner surface of the deformed tract B (Fig. 2). The microstructure shows a ferrite matrix (clear) with reasonably equi-axial pearlite islands, with characteristic banding. There is no evidence of aligned nonmetallic inclusions. No relevant or unusual surface conditions were observed, except for a slight reduction of pearlite and de-carburization in the outer surface, probably due to the action of fire.

Fig. 8. (X250) microstructure near inner surface of deformed tract B (Fig. 2).
