Engineering Failure Analysis 8 (2001) 57–73

Weld failures in sleeve reinforcements of pipelines

Based on fractographic, metallurgical, mechanical and fracture mechanics analyses, the causes of three failures in welded full encirclement sleeve repairs in a 24 in gas pipeline were evaluated. These failures were related to poor manufacturing procedures. The material used to build the sleeves was old and had poor transverse strength. High heat input cellulosic electrodes were used to weld the field joints, which lead to hydrogen embrittlement in the HAZ, also helped by relatively high circumferential stresses and defects of lack of fusion. A series of changes were introduced, including improvements in the in-plant fabrication and the in-field installation of the repair sleeves. A low hydrogen weld procedure with controlled penetration, NDE specifications and epoxy fillers were introduced to minimize the risk of sleeve failures and plastic collapse of the pipe. © 2000 Elsevier Science Ltd. All rights reserved.

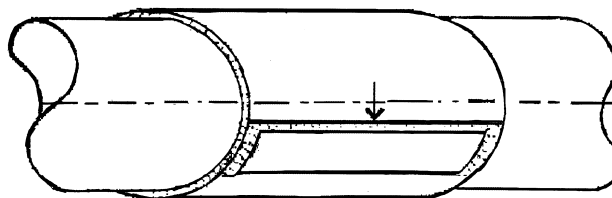
Fig. 1. Full encirclement sleeve repair of a 24 in. pipe.

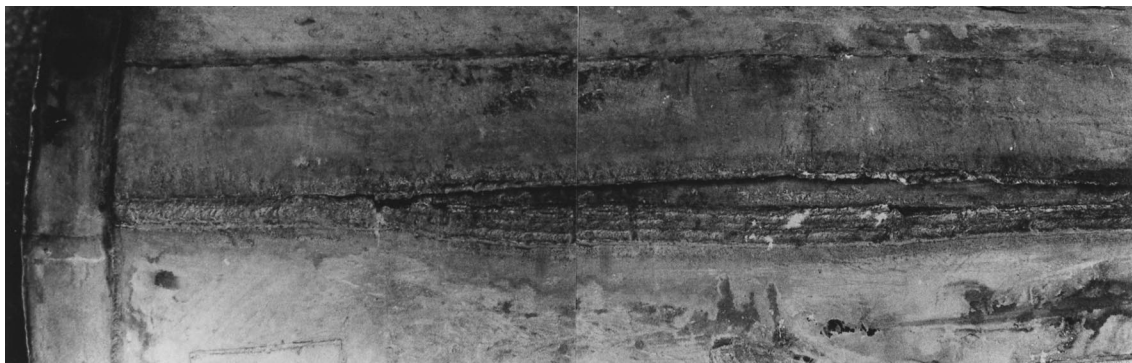
Figs. 2 and 3 show in detail the surface aspects of Failures 1 and 2, respectively. Note the longitudinal side plate, and the crack in the fillet weld. In both cases the full encirclement sleeve repair shows the central portion of the longitudinal weld wide open. Both cracks were produced in the field welded joint. Fractures in both specimens initiated around the central wide open section, and propagated longitudinally toward the ends of the sleeve, in the sleeve material. Both ends of the cracks stopped close to the circumferential weld (see Fig. 4).

In the first failure, the fracture runs along the longitudinal fillet weld. In Failure 2, both extremes of the propagating crack differ in that the left side propagates in the sleeve material, while the right side propagates into the material of the longitudinal side plate. Since both parts are separated by an uncracked ligament of weld metal, as shown in Fig. 3, it is concluded that the fracture initiated in two different sites. The first fracture was probably initiated in the wide open region seen in Fig. 3. Fig. 2 shows that the failed longitudinal weld in Failure 1 has at least four weld beads, while the rest of the sleeve is welded with only one bead (see Fig. 4). This longitudinal weld was probably repaired after a flaw in the original weld was detected. Welds in Failure 2 are all single-pass, including the failed one shown in Fig. 3.

Fig. 2. Failure 1: fracture of the fillet weld to the longitudinal side plate. Note the central portion of crack is wide open, due to relaxation of hoop stresses.

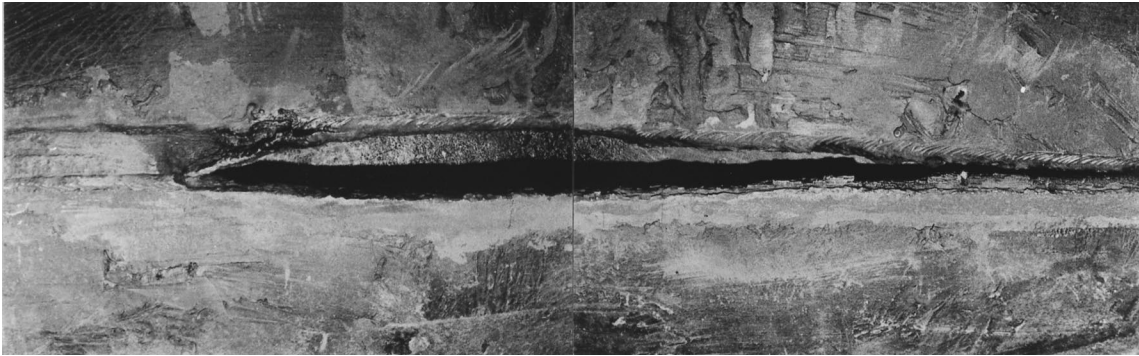
Fig. 3. Failure 2: fracture of the fillet weld to the longitudinal side plate. Note uncracked weld material to the left of the picture.

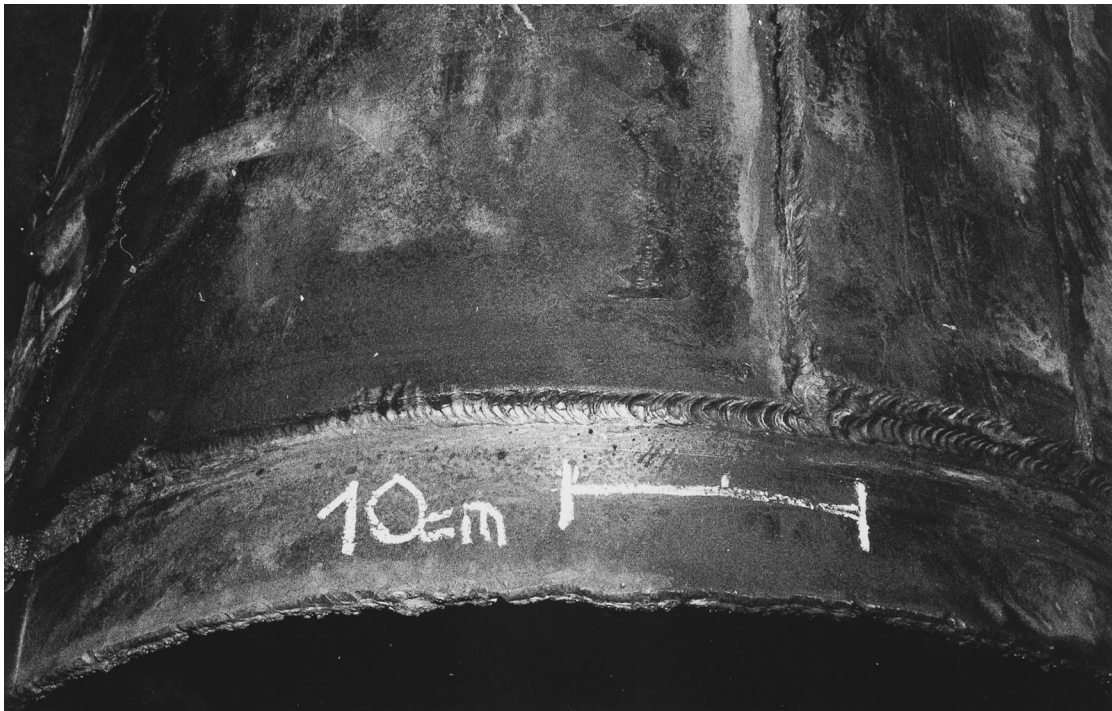
Fig. 4. Circumferential weld of fractured full encirclement repair. Note single pass fillet welds, and longitudinal crack ending close to the circumferential weld.

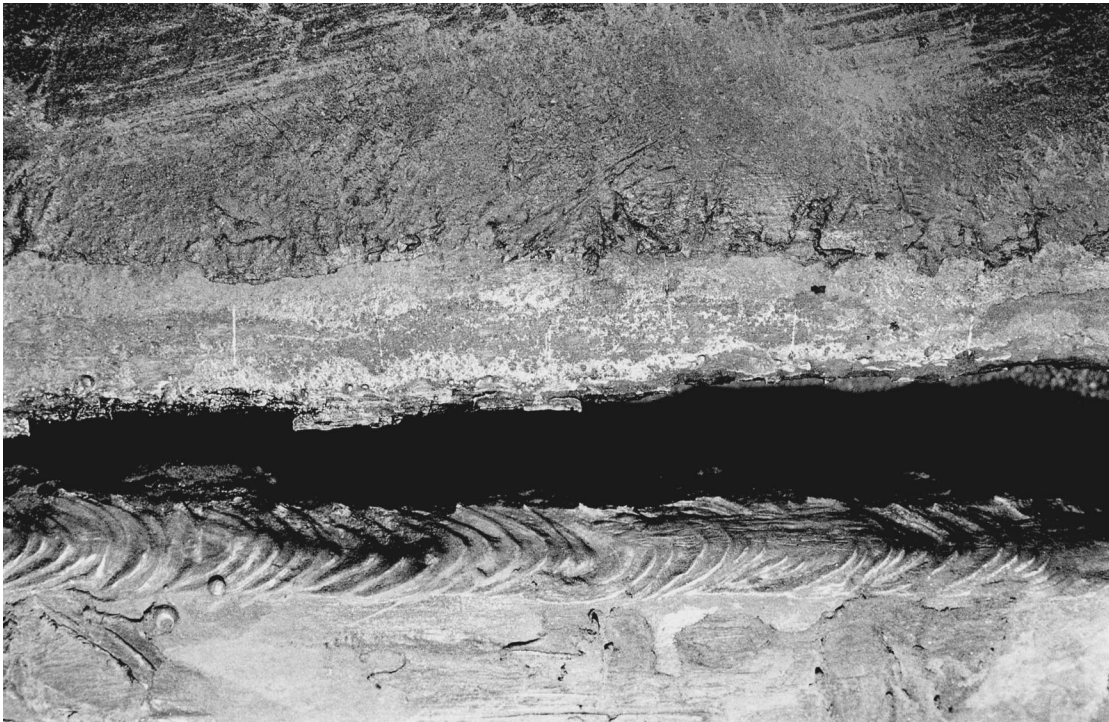
The left side part of the crack in Failure 2 has a stepped crack surface, of the type found in lamellar tearing, see Fig. 5. This same feature is seen in both failures. Cross sections of both fractures were cut, polished, and etched with Nital 5%. Fig. 5 shows the sleeve side of the fractured weld in Failure 1. Note the sleeve material at the bottom and the many weld beads on top. The crack runs between the weld and the side plate materials. Note that the crack surface is bent in order to follow the weld–base metal interface, especially evident in the area of the final bead, on top. This final bead broke several times and remained partially on both sides along the length of the fracture, giving the idea of a stepped outer crack surface, as seen in Fig. 2. Fig. 6 shows the fracture surface in the region of Fig. 5. Note the

Fig. 5. Typical stepped crack surface, in HAZ of sleeve base material.

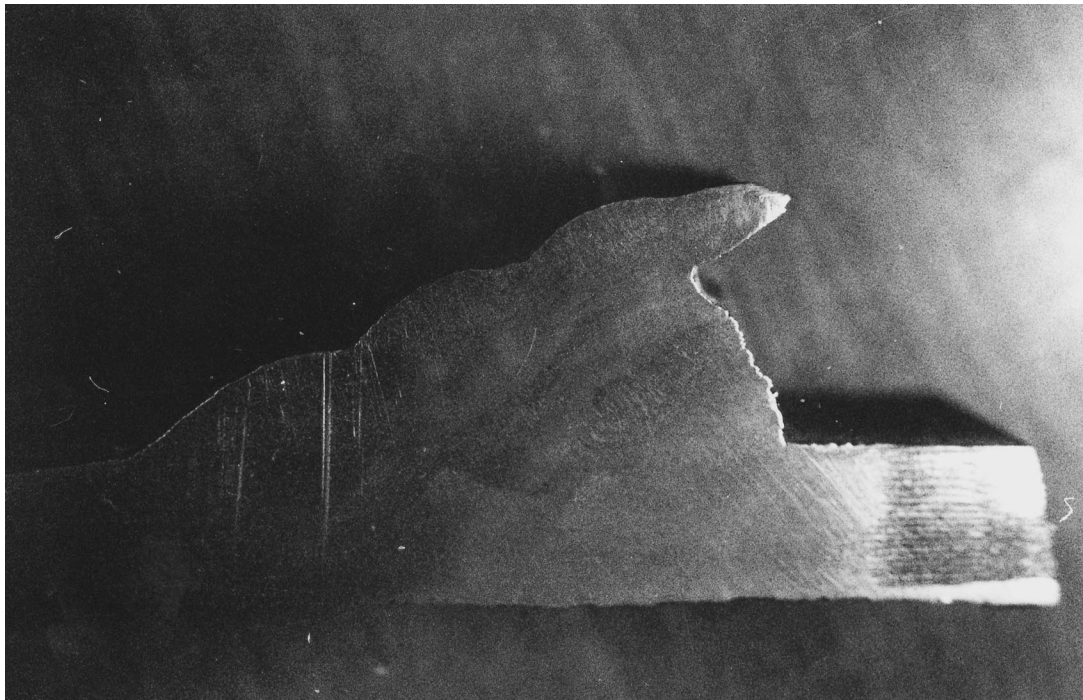
Fig. 6. Cross section of the sleeve side of fractured weld in Failure 1, polished and etched. The crack surface follows the weld–base metal interface. Note many weld passes.

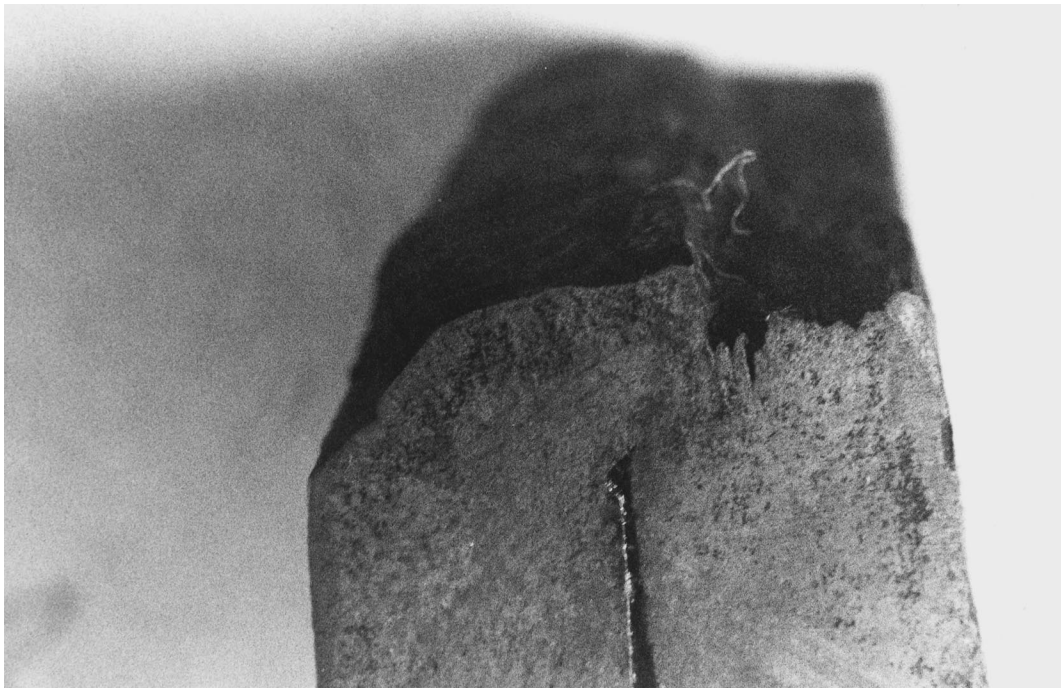
Fig. 7 shows the fractured weld in Failure 2. Note the sleeve material to the right, side plate material to the left, and the single weld bead at center. The crack runs in the sleeve base material, that is, corresponds to the right side of Fig. 3. Figs. 6 and 7 reveal the stepped nature of the fracture in both specimens. With a closer look, it can be seen that secondary cracks start from the inner part of the serrated irregularities of the main crack surfaces, and propagate normally into the sleeve base metal.

Fig. 7. Cross section of fractured weld in Failure 2. Note the stepped nature of the fracture, with perpendicular secondary cracks into sleeve base material.

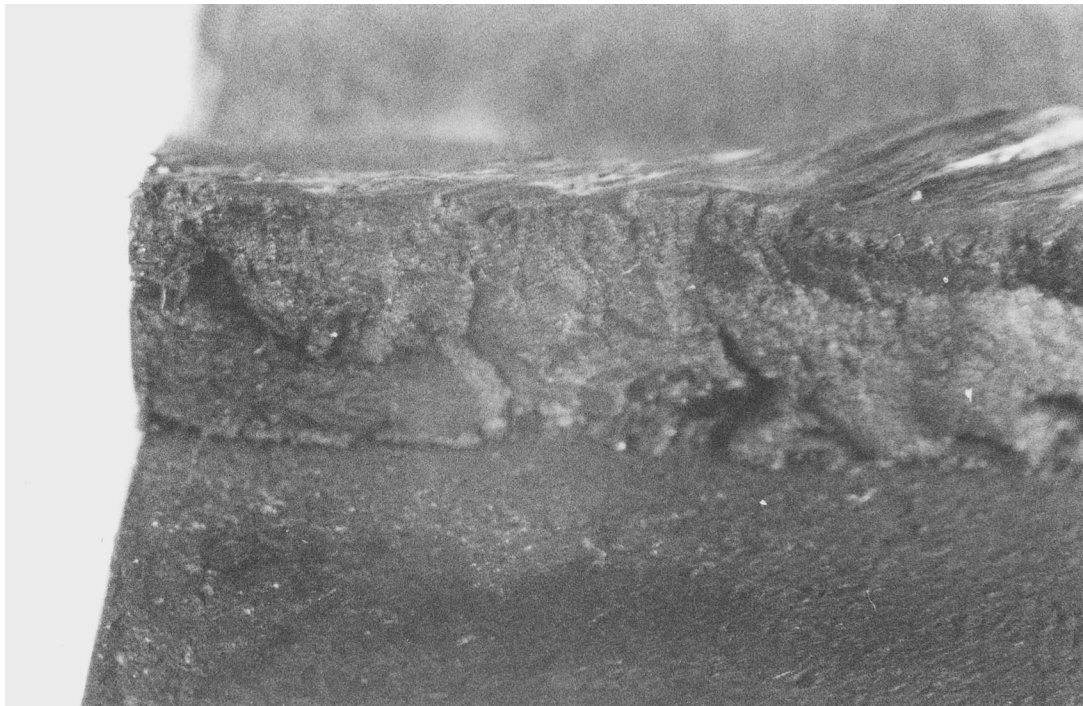
Fig. 9. Weld-side fracture surface, showing signs of lack of fusion.

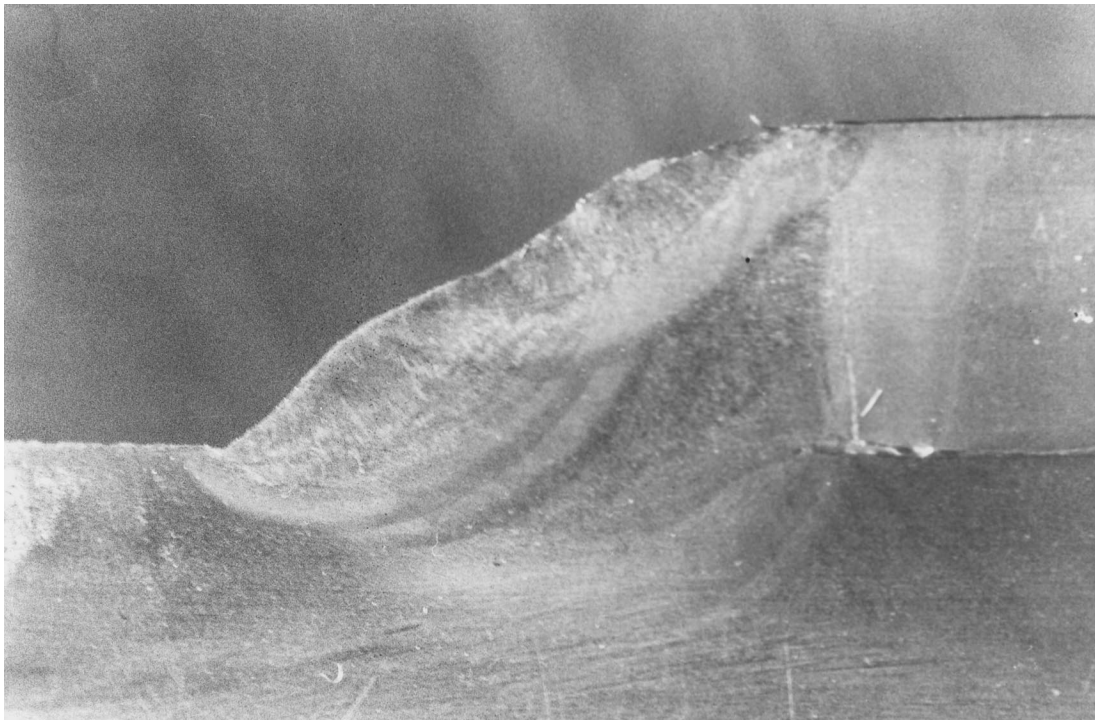
Fig. 10. Cross section of cracked region in Failure 3. Note at least five weld beads, a sign of possible repair after an original flaw.

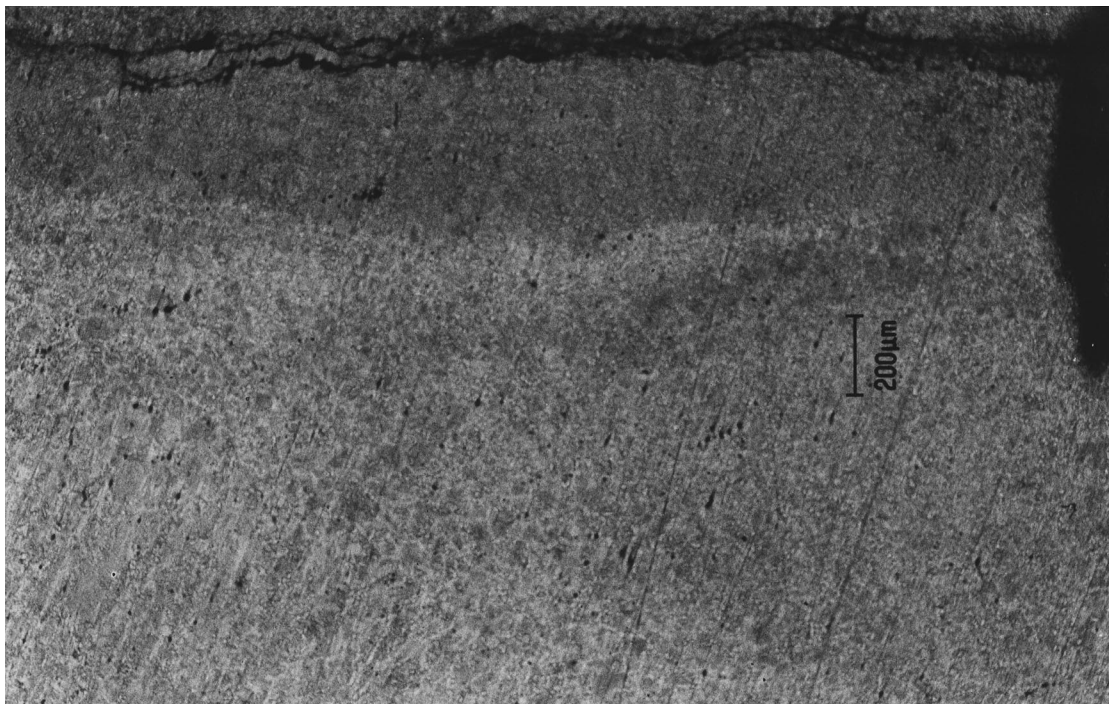
heat. Between the crack and the weld material at the left, there is a transition fine microstructure clearly differentiated.

Fig. 11. $\times 25$, root region of the cracked girth weld. At the right of the crack, base metal does not show signs of having been affected by the weld heat.

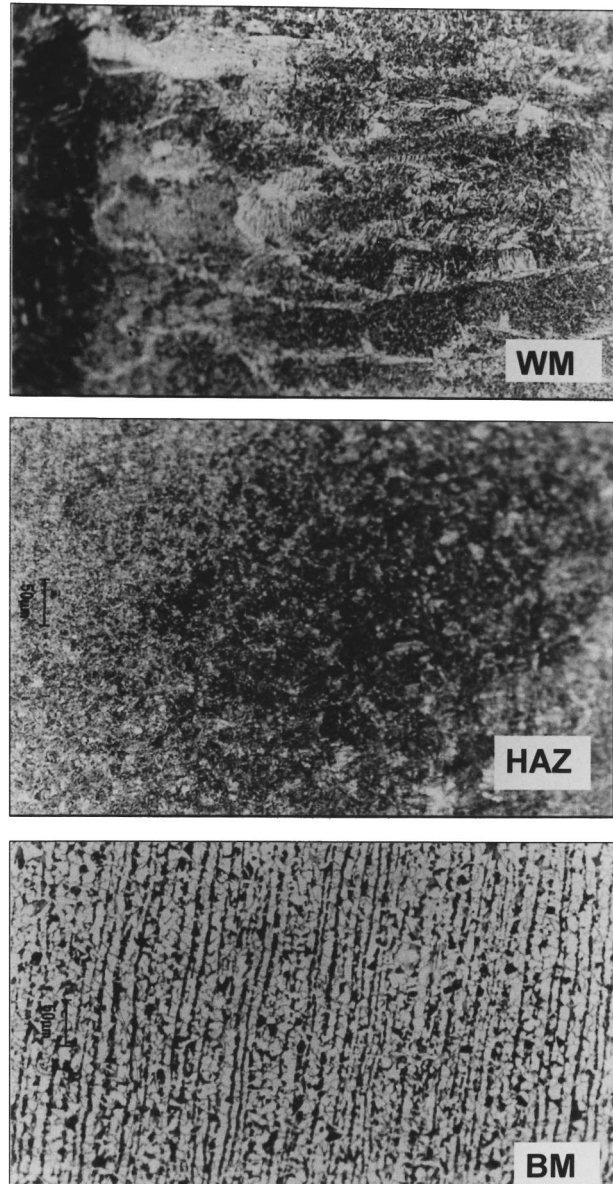
Metallographic specimens from each of the failures were prepared for microstructural examination. Fig. 12 shows typical microstructures of base metal, weld metal and HAZ. Note the severe microstructural banding of the base metal, running parallel to the sleeve surfaces. This banding is typical of pipes, and is due to the lamination process during the fabrication of the tube from plate material. Fig. 13 ($\times 100$) shows a micrograph of the microstructure close to the fracture surface shown in Fig. 8. A large number of inclusions are present in the material, which are also aligned. Some of these inclusions are very long and shallow. Elongated type II MnS and planar arrays of oxides or complex oxy-sulphide inclusions are preferential sites for initiation of hydrogen damage. This damage has been identified as a loss of mechanical properties in pipe line steels, where hydrogen accumulates at microvoids which have previously formed at the interfaces of non-metallic inclusions [12]. Some of them are actually parallel cracks running in the rolling plane of the plate, and tend to appear coalesced in front of the secondary cracks, as shown in Fig. 7.

Fig. 12. Typical microstructures of base metal (BM), weld metal (WM) and heat-affected zone (HAZ) ($\times 2000$).

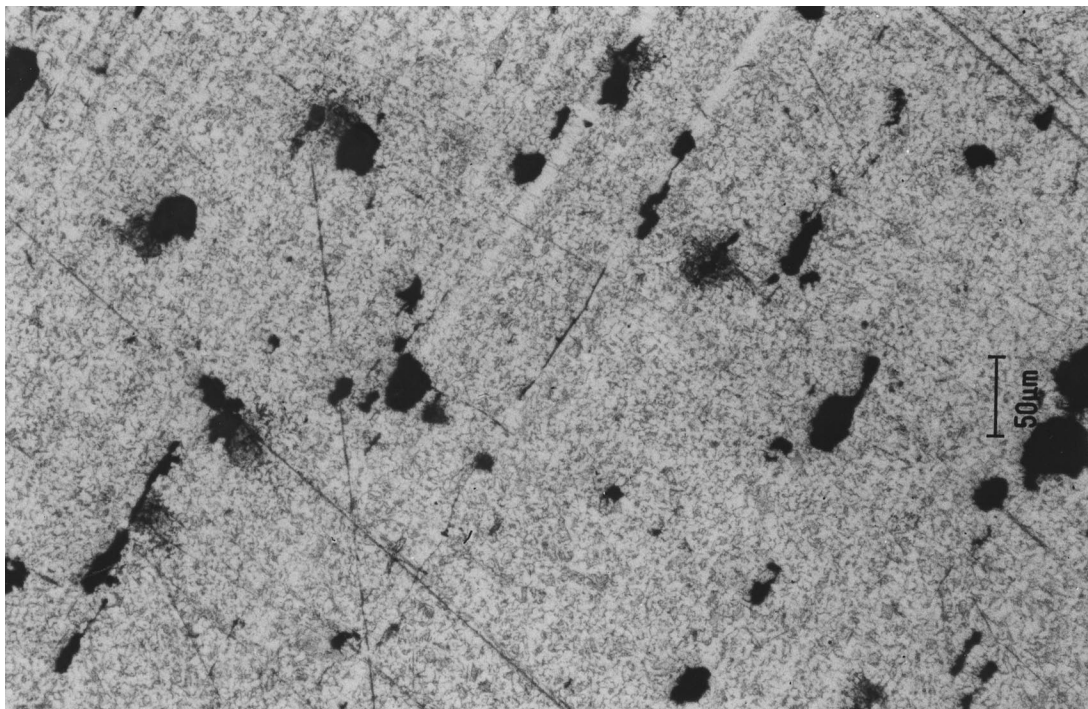
Fig. 13. $\times 100$ micrograph of the microstructure close to the fracture surface of Fig. 8. Note microstructural banding, aligned inclusions, and parallel microcracks.

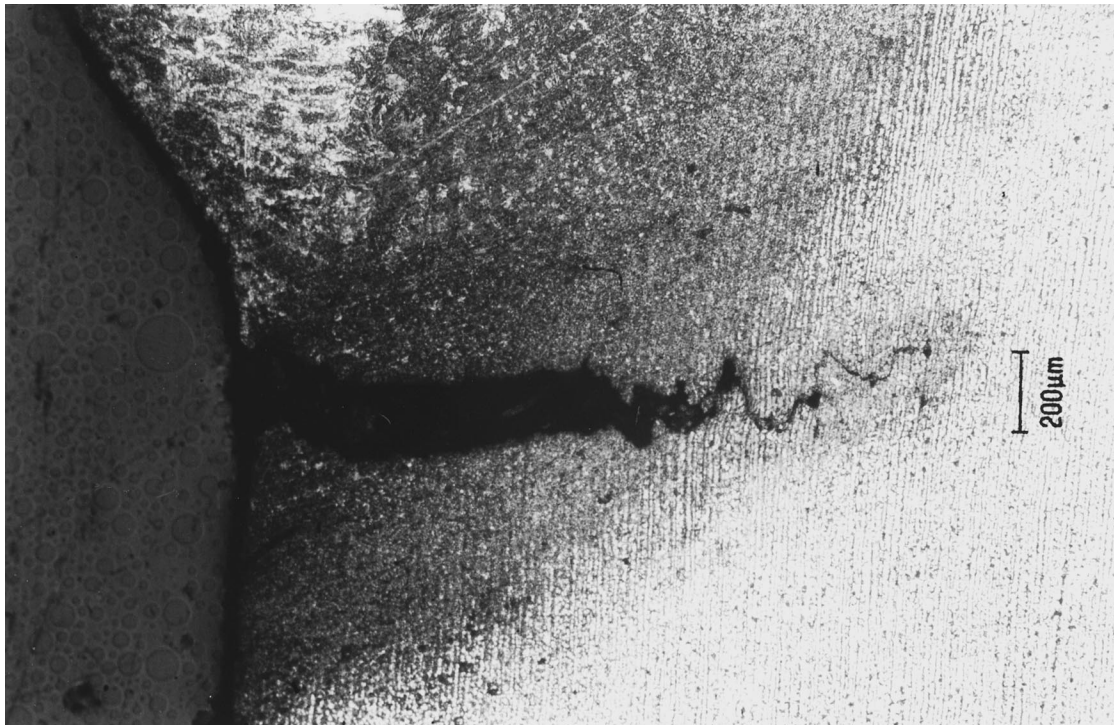
A careful examination of pipe material in Failure 3 shows a small surface brittle crack initiating at the toe of the girth weld in the coarse-grained heat-affected zone (HAZ), as shown in Fig. 14. The maximum crack depth is 1.64 mm. The effect of banding once the crack reaches the unaffected base metal is readily apparent. The characteristics found in this crack are typical of cold cracking at the weld toe, due to the presence of a hard, susceptible HAZ (see Table 4). This hard microstructure was probably produced by high cooling rates in a moderately hardenable steel, along with high hydrogen content in weld metal derived from the cellulosic electrode and poor cleaning. High residual stresses are very likely, due to the intrinsically high restraint of the parts during the repair weld, probably increased by a poor fit of the sleeves.

When the crack initiates in the girth weld (as in Failure 3), it could also be possible that a crack propagates into the pipe. Failure 3 showed the presence of cracks in sleeve material of a depth similar to the sleeve thickness. This defect finishes in the area of the root of the weld, on the surface of the pipe. There is a probability that this circumferential crack proceeds into the pipe material, probably favored by lamellar tearing if the pipe is an old material (which is often the case). In this case, the crack would probably not be normal to the surface of the pipe. On the other hand, circumferential cracks in the pipe material HAZ, as that shown in Fig. 14, can directly propagate through the thickness.

Fig. 14. Toe crack in pipe material HAZ of girth weld in Failure 3 ($\times 50$).

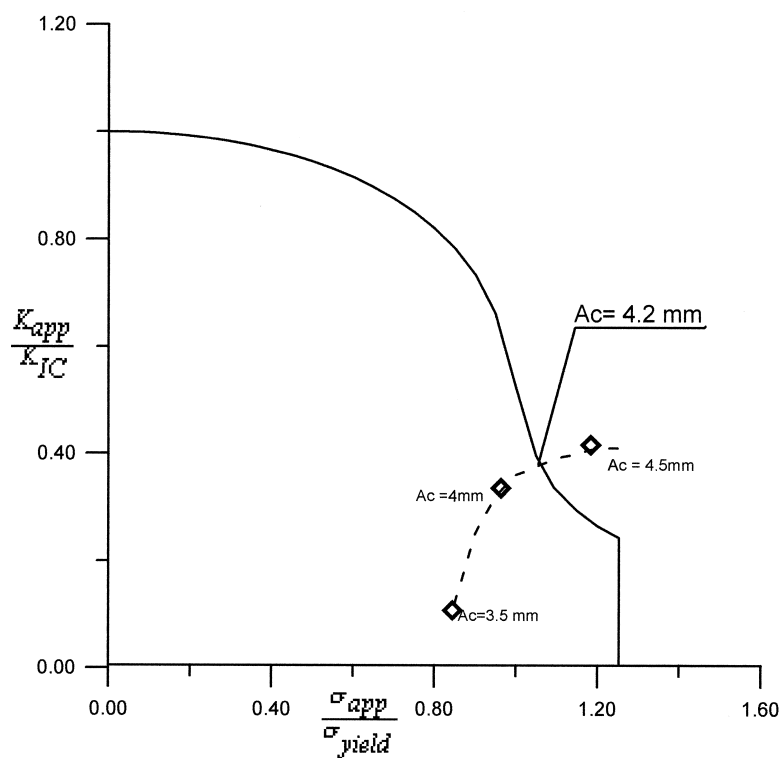
stress and the yield stress of the material. The FAD of Fig. 15 shows the range of critical crack values, assuming a conservative HAZ toughness value of $100 \text{ MPa m}^{1/2}$. The critical depth of a circumferential crack in the pipe material is 4.2 mm, that is, about 2/3 of pipe thickness. Failure is predicted as plastic collapse rather than fracture. The leak-before-break condition for this circumferential crack is amply satisfied. This, however, is of little use, since a burn through during the repair operations would lead to a very serious accident. On the other hand, the leak-before-break analysis for a hypothetical longitudinal crack that could run into the pipe material depends critically on the crack surface length [15,16].

Fig. 15. Failure assessment diagram of circumferential cracks in pipe HAZ of girth weld.
