Engineering Failure Analysis

Challenges to the integrity of old pipelines buried in stable ground

Jose Luis Otegui¹

Y-TEC (YPF – CONICET), Argentina

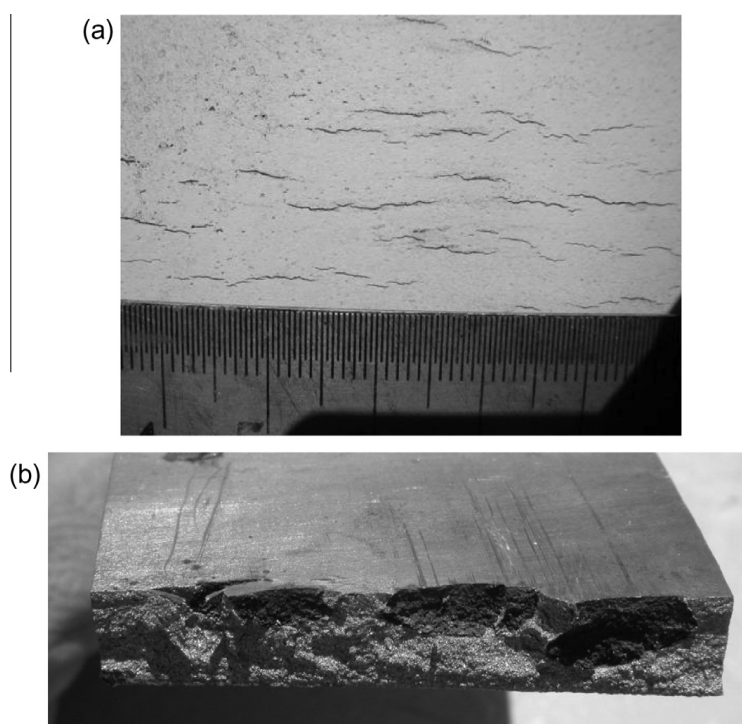
Characteristics of the failures are: colonies of intergranular and branched cracks, a considerable concentration of carbonates and bicarbonates in the soil, a black film of magnetite covering the fracture surface in the initiation sites, high pipe wall temperature and stresses, low hardness in base material, and electrochemical potential in the range of corrosion protection. Fig. 1 is an example of an SCC colony (a), cryogenic fracture (b) of the specimen gives a clear evidence of typical preexisting penny shaped cracks at the outer surface of the pipe wall.

Fig. 1. SCC cracks (a) colony in outer surface and (b) after cryogenic fracture [4].

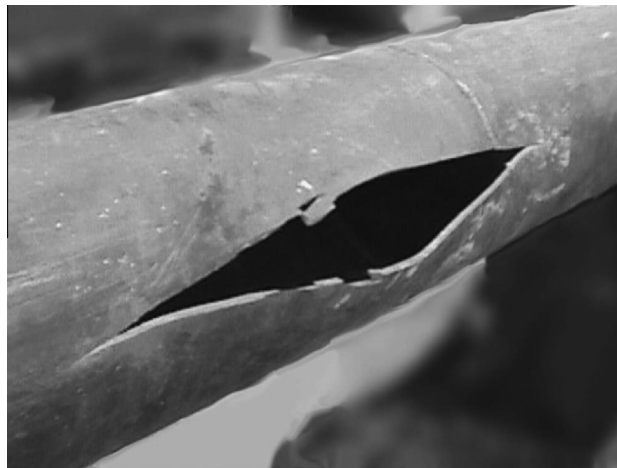
Fig. 2a. SCC failure in a 14 in. ERW oil pipeline [4].

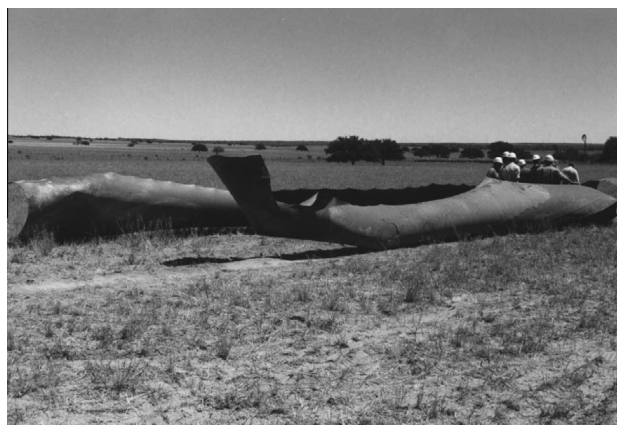
Fig. 2b. Failure in a natural gas pipeline [4].

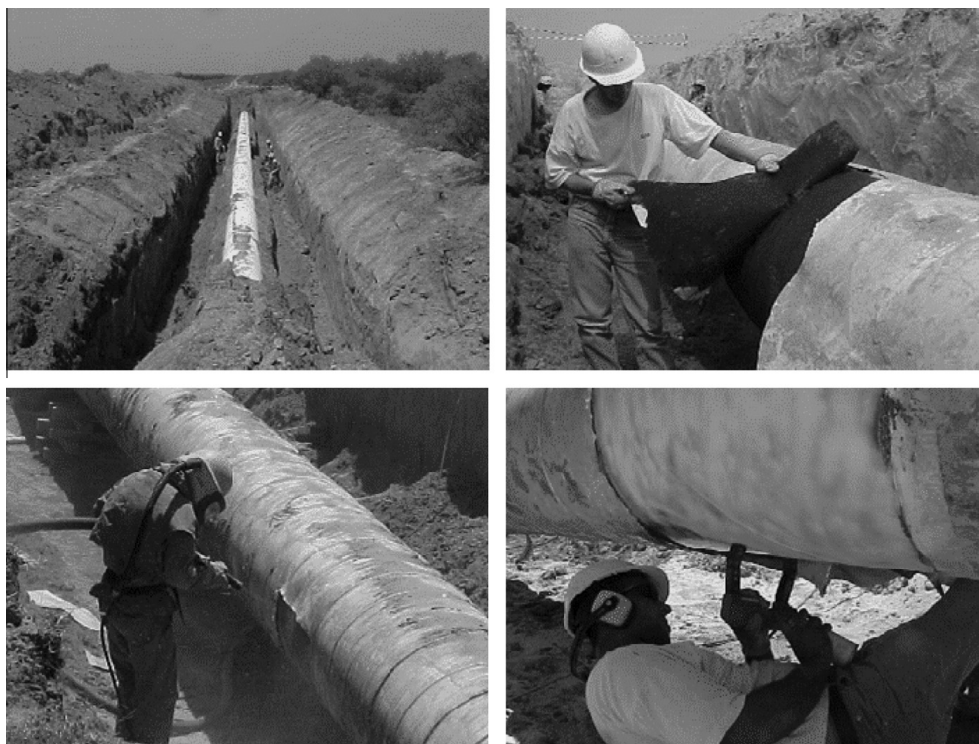
Fig. 3. Direct assessment of SCC in a buried gas pipeline [1].

Recoating is relatively expensive but has been the solution of choice in the last years in single – pipeline systems, because it does not require flow interruption. Some problems with this solution have been recently found in old pipelines, due to low strength of girth welds that made some of them fail when the pipeline was unearthed and hanged for the recoating [10].

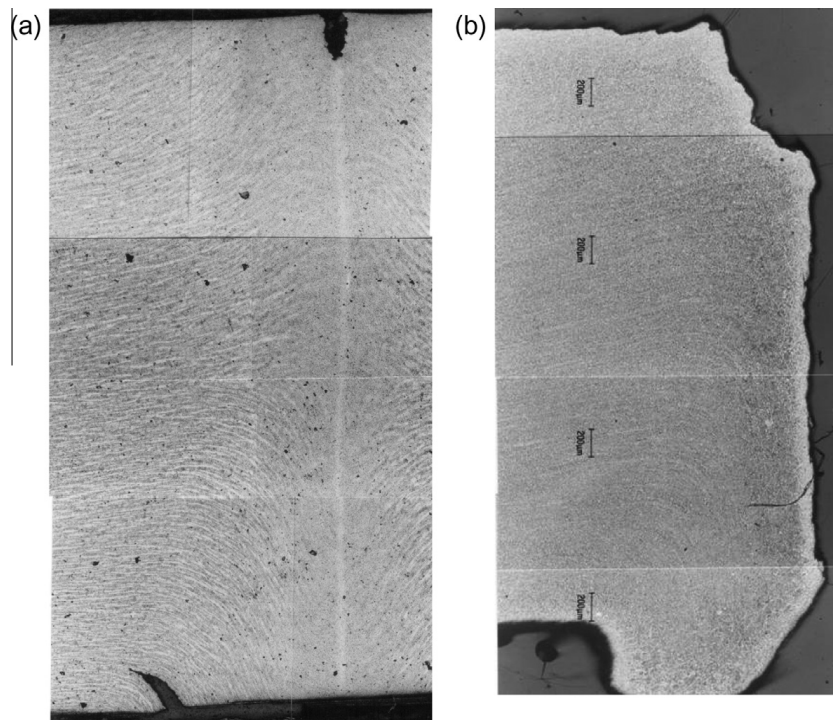
Defects typically associated with ERW, especially to those welds carried out with earlier low frequency electric heating, are due to incomplete joining and internal defects (inclusions, lack of fusion, etc.) in the middle area of the weld. These are known to have led at least to one fatigue – related failure in an oil pipeline [12]. One typical form of defect is the so-called hook crack, in which an inclined crack is formed a couple of millimeters away from the weld center line, following the lamination planes of the base plate.

Fig. 4. (a, b, X25) two cross sections of ERW welds [12].

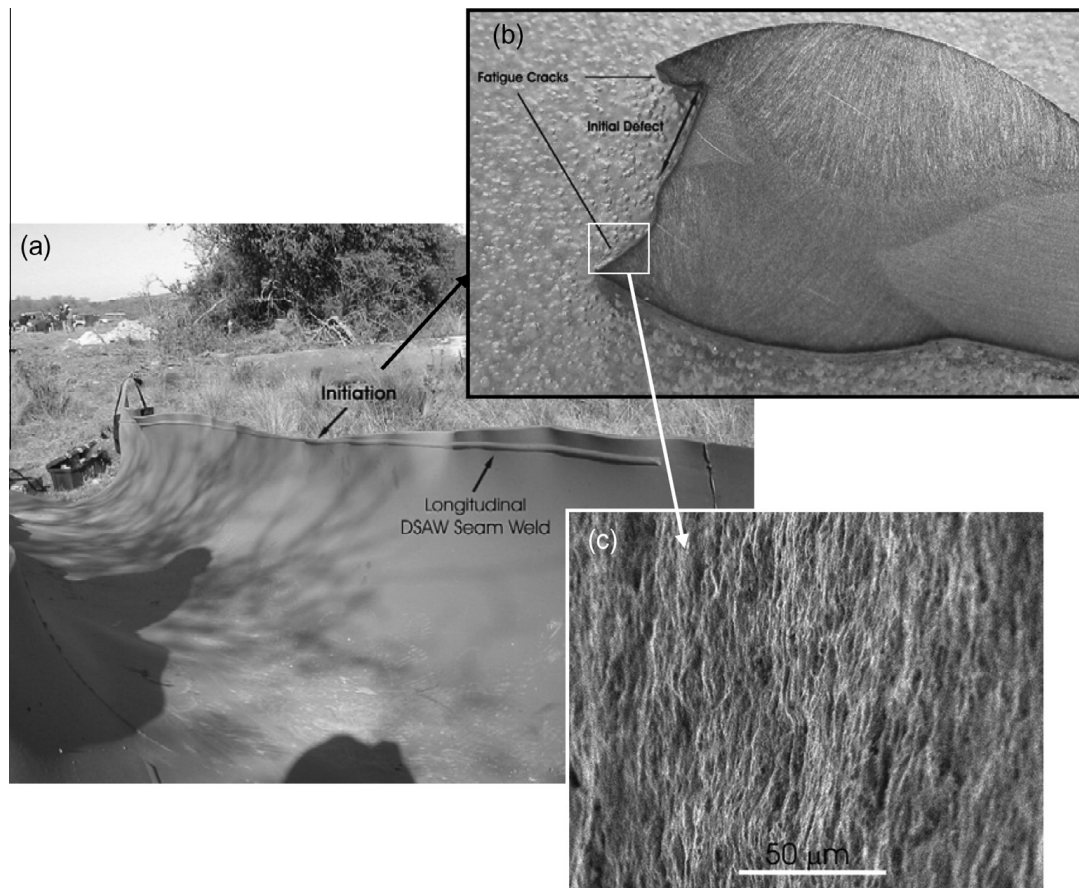
One interesting case is that of the (probably) only documented case of a fatigue failure of a natural gas pipeline [16]. The sudden propagation of a fracture at the DSAW seam weld provoked a blowout in a 45 year old 24" gas pipeline. Oddly enough for gas pipelines, it was found that fatigue cracks had propagated from a large embedded lack of fusion defect, Fig. 5. This fabrication defect was due to a gross lack of alignment during seam welding.

Fig. 5. (a) Blow out of gas pipeline, (b) fatigue cracks propagated from embedded weld defect and (c) striation marks at fracture surface [16].

in the early life of the line many more large pressure cycles than expected had occurred. Most reasonable hypothesis for large pressure cycles in this gas transmission pipeline are related to using the line as storage capacity (line pack) to deal with large variations in gas consumption during the day.

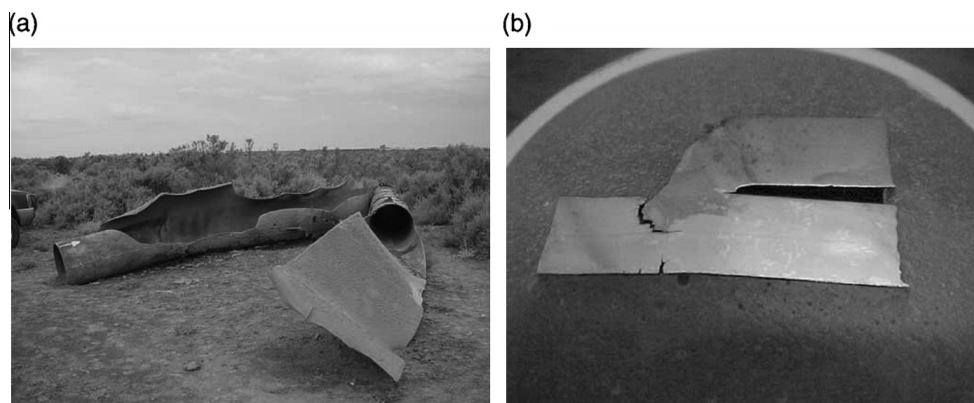
Fig. 7. (a) Burst of a 24" gas pipeline. (b) Fracture initiation at a rectangular repair patch [19].

A couple of failures during late 90s were related to inadequate design and installation of repair patches and fillet welds of poor quality, see for example Fig. 7 [19]. After an extensive review of ILI data, direct assessment found that fillet welded patches had been widely used in gas and oil pipelines for many years [20,21]. The most common problems associated with these failures are:

- Very poor through the thickness strength of the old pipe materials, due to severe microstructural banding.
- High impurity levels and sometimes also lamination defects from aligned non-metallic inclusions.
- High through-thickness stresses at the toes of the longitudinal patch-to-pipe fillet welds.
- Welding defects, mostly undercuts and lack of fusion.

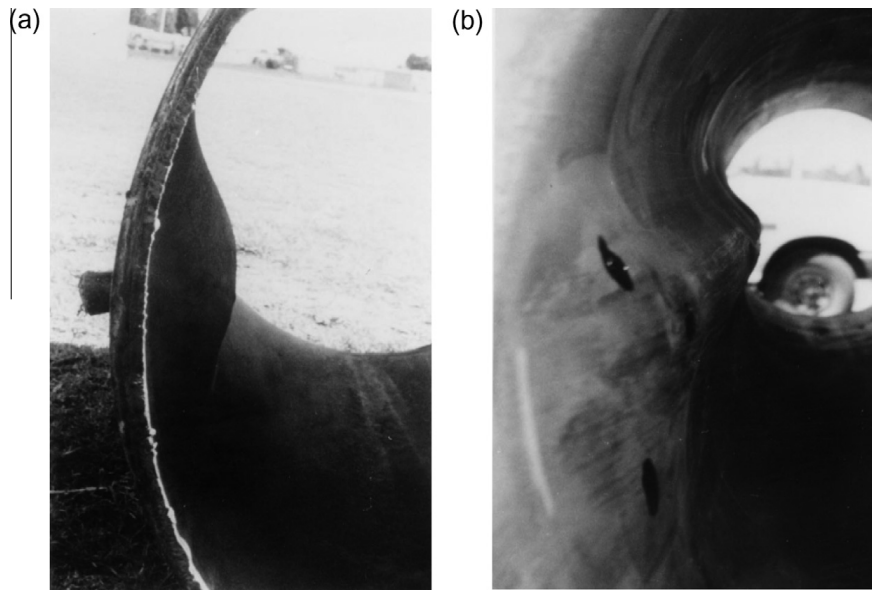
Other risks related to sleeve repairs are weld burn-through during repair, and, on the other end of the timeline, the eventual collapse of the pipe wall under the sleeve. Local collapse of the pipe wall under full encirclement sleeve reinforcements is associated with breaks and blow outs in nearby sections of a gas pipeline, that cause large gas losses and abrupt depressurization in the repaired tract. Two examples are shown in Fig. 8.

Although these defects do not represent an imminent risk of failure, they should be eliminated because they impede the normal running of an ILI tool. Four failed repairs were experimentally evaluated, and the effects of different geometric factors were numerically assessed. All possible causes of the appearance of these defects and measures to minimize their occurrence were evaluated. The position of the repaired portion with respect to the blow out, the local geometry of the repair and previous defects, and the amount of gas caught in the interstice between the pipe and the reinforcement, all affect the likelihood of a pipe collapse under a sleeve repair [25].

Fig. 8. Two examples of local collapse of gas pipelines under sleeve repairs [23].

In order to minimize the recurrence of these types of failure, a series of changes were introduced in the repair method, including improvements in the fabrication of the sleeves and their in-field installation into the pipeline, and NDE specifications. Determinations of minimum weldable wall thickness were improved, in order to ensure avoidance of tube perforation during welding [26]. Epoxy hardenable interstitial fillers were tested and included in the repair procedures, in order to reduce the pipe to sleeve gap and thus minimize the risk of sleeve failures and plastic collapse of the pipe [27].

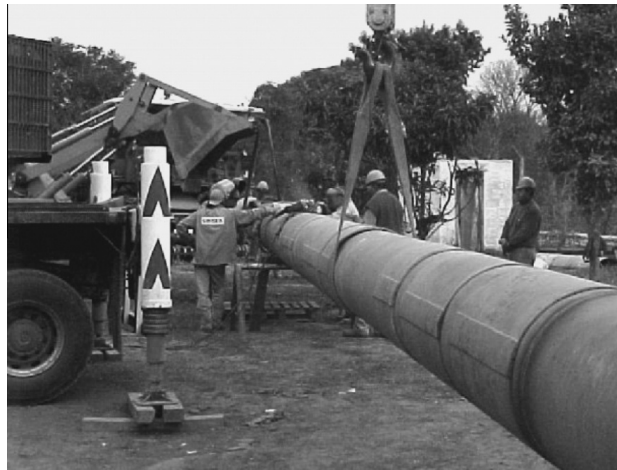
Fig. 9. A tract of pipe with multiple sleeve repairs being prepared for hydrostatic burst testing [28].

Argentine oil and gas operators are still coping with tracts of densely repaired pipelines, some of which are jokingly called patch-lines. Although the integrity of each repair is well documented, a final concern came about the structural integrity of gas pipelines with multiple full-encirclement weld repairs. Work was done to identify and quantify the effects of the number and type of repairs, the distance between them, and the pressurization of the pipe-to-sleeve gap on the mechanical behavior of the pipeline. The studies included full-scale experimental burst testing and finite element modeling, Fig. 9. It was concluded that the reliability of the repairs is strongly influenced by the construction procedures, but that interaction between neighboring repairs is not appreciable if the repairs are more than a half pipe diameter apart [28,29].

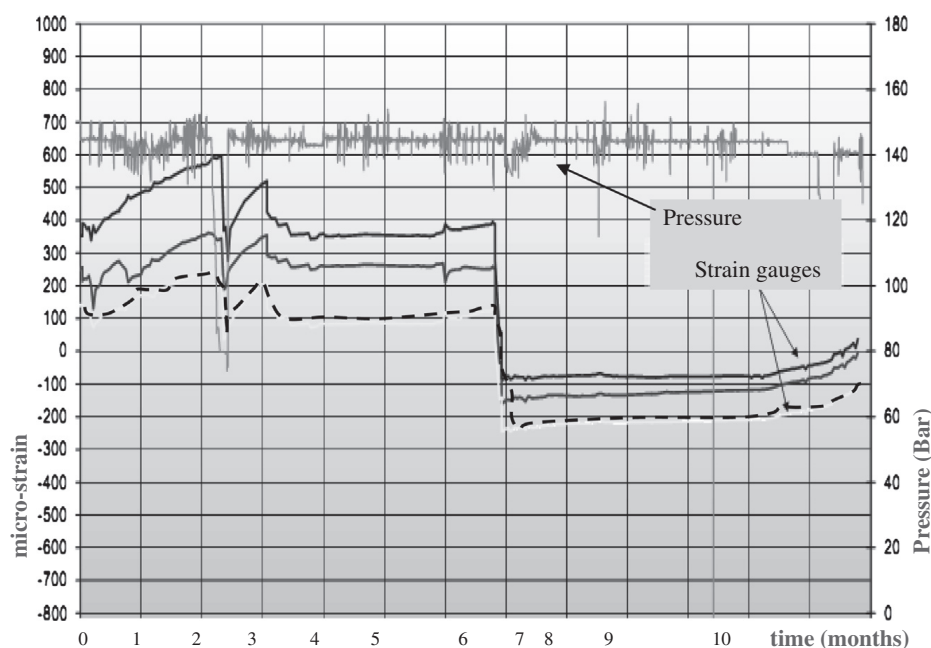
It is well known that water saturation changes dramatically the mechanical properties of the soil: dry soil is orders of magnitude stronger than moist soil. This became a problem when coupled to the third condition: when local population started using gas from these interconnection and distribution lines, for cooking but mostly for heating, gas flow started to fluctuate with usage in an annual cycle. NG flow cycles induced marked temperature cycles in the pipeline and surrounding soil, thereby generating relatively large thermal strain gradients. These cyclic axial strains in the pipeline, coupled with the aforementioned cycles in shear strength of the soil, were probably creating small axial pull–push cycles. The cumulative effect of these cycles eventually led to high axial stresses in certain zones of the pipelines.

Fig. 10. Record of strain gauge readings in a buried pipeline.

Ensuring integrity of these suburban pipelines depends, in part, upon correct quantification of soil-induced pipe loads [31]. In zones of known soil instabilities, vibrating wire strain gauges placed on the pipe wall are now being used to assess the axial and bending loads transmitted to the pipe. Limit values are set as alarm levels to indicate when to carry out remedial work and/or stress relief. Fig. 10 shows a typical record of measured strains. Although a thorough interpretation is beyond the scope of this work, in this example it is seen that strains measured by the three gauges increase or decrease simultaneously, indicating tension rather than bending. Strain variations are not related to pressure variations, the abrupt decrease corresponds to work done in the right of way to relieve stresses in the pipe. Note that after this operation the pipe seems compressed, in fact this indicates that the gauges were not zeroed when placed. The slow increase at the right part of the graph indicates that after the mitigation effort the soil movement is again tensioning the pipeline.
