Engineering Failure Analysis 9 (2002) 109–122

**ENGINEERING
FAILURE
ANALYSIS**

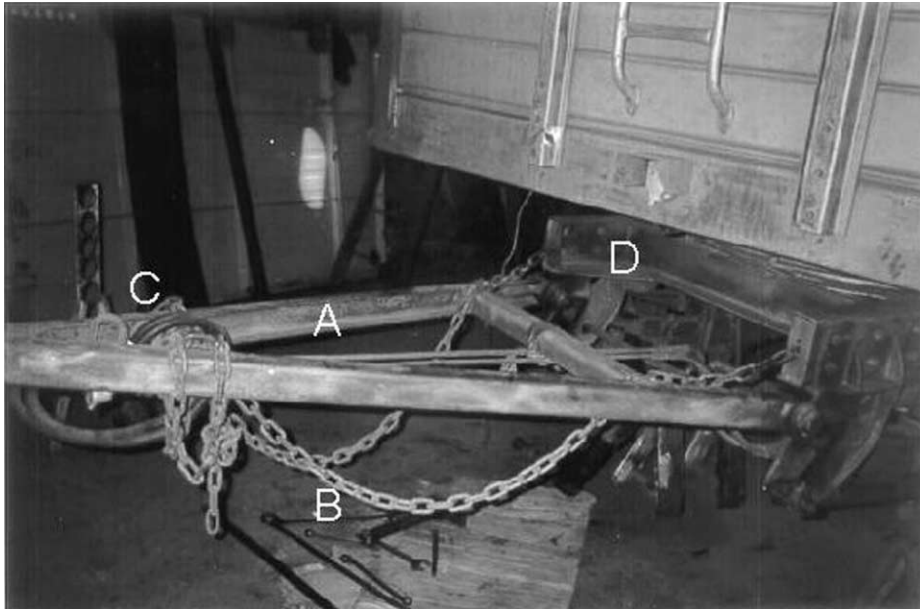
Fig. 1. Front view of trailer: A-frame (A), safety chains (B), brake hoses (C), and rotating platform (D) of the front (steering) axle.

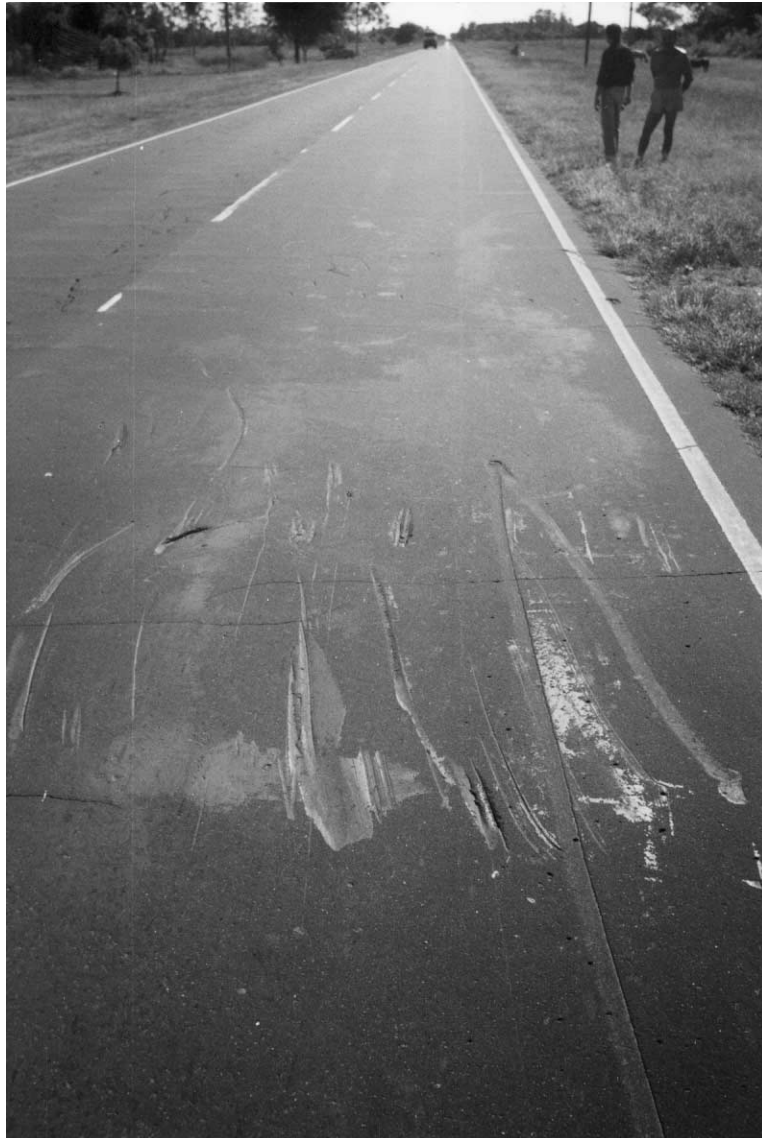
Fig. 3. Overview of the two-lane road at the crash site The marks in the pavement indicate the place where bus and trailer impacted.

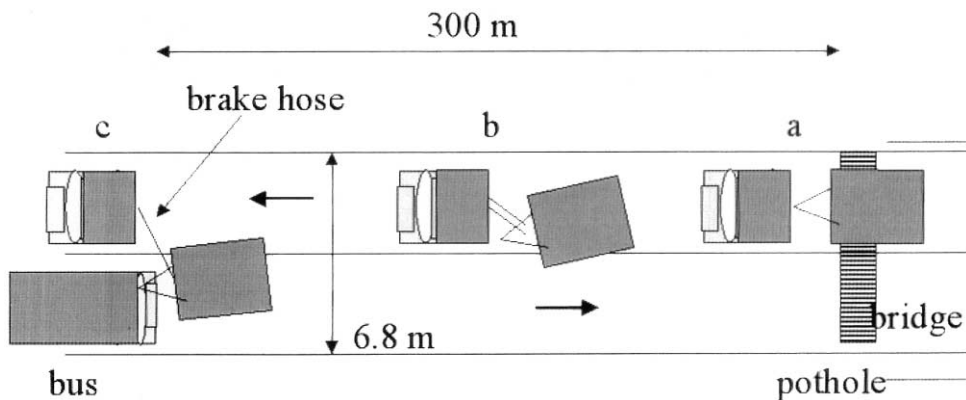
Fig. 4. Sketch of the area of the accident. (a) eyebolt breaks after crossing the bridge, (b) safety chains break, (c) bus and trailer crash.

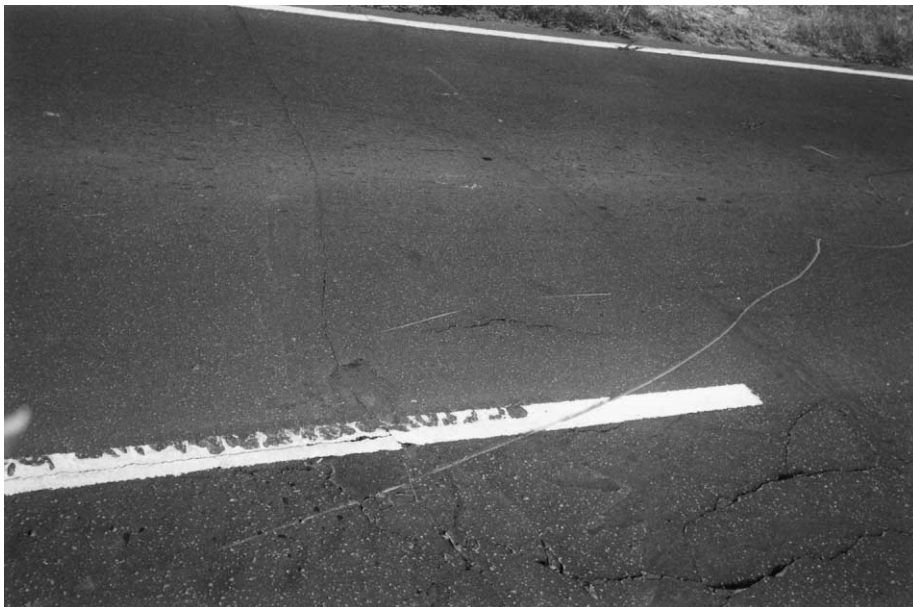
Fig. 5. Semicircular scratches on the pavement produced by the A-frame across the central line of the route.

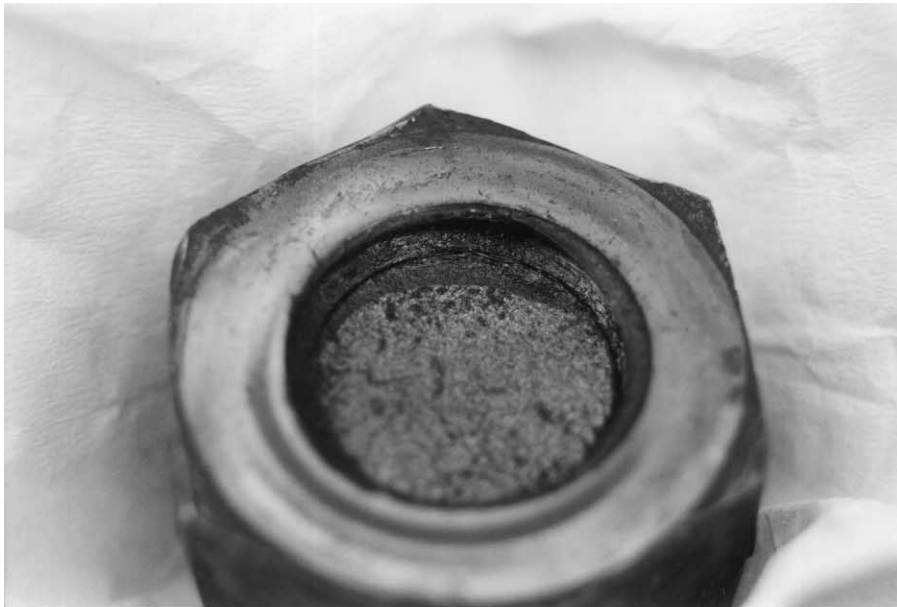
the bank 10 m downroad from the bridge (see Fig. 6), while its washer was found about 50 m from the bridge. A link of the safety chain was found near the place of the crash, on the opposite bank. The retention spring was found broken, still attached to the trailer. A good correspondence between the marks in the pavement and the positions of the remains on the banks was obtained [2].

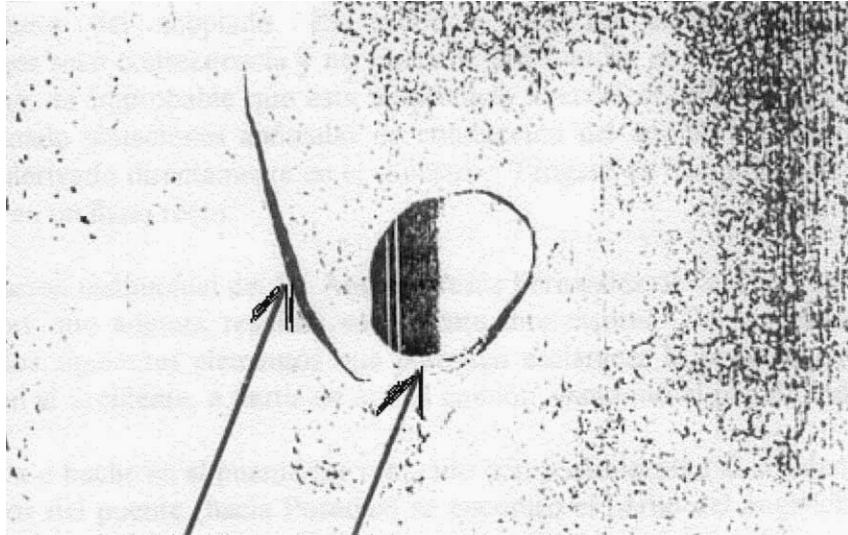
Fig. 7. Deformation and crack around one the bolt holes of the front axle rotating plate.

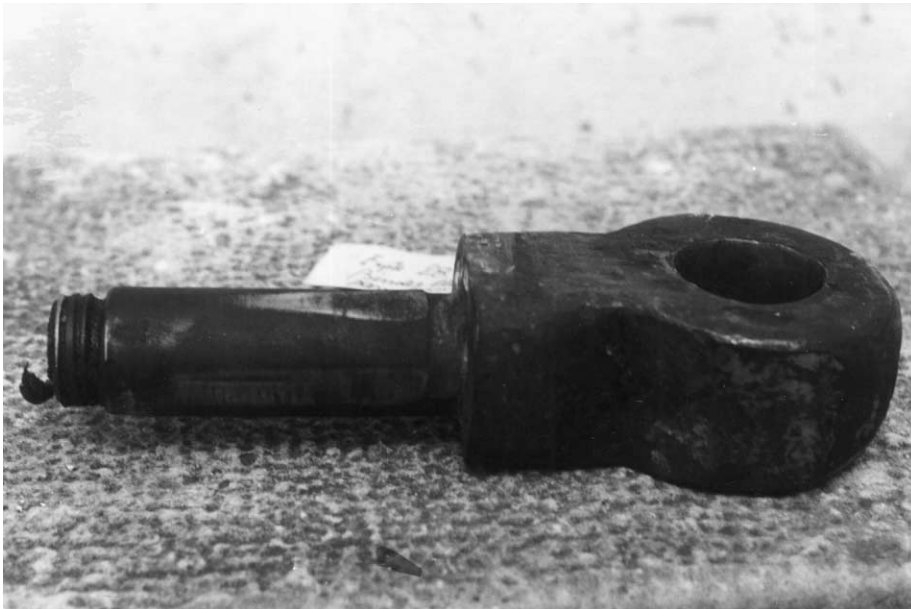
Fig. 8. Detail of the broken eye and bolt assembly.

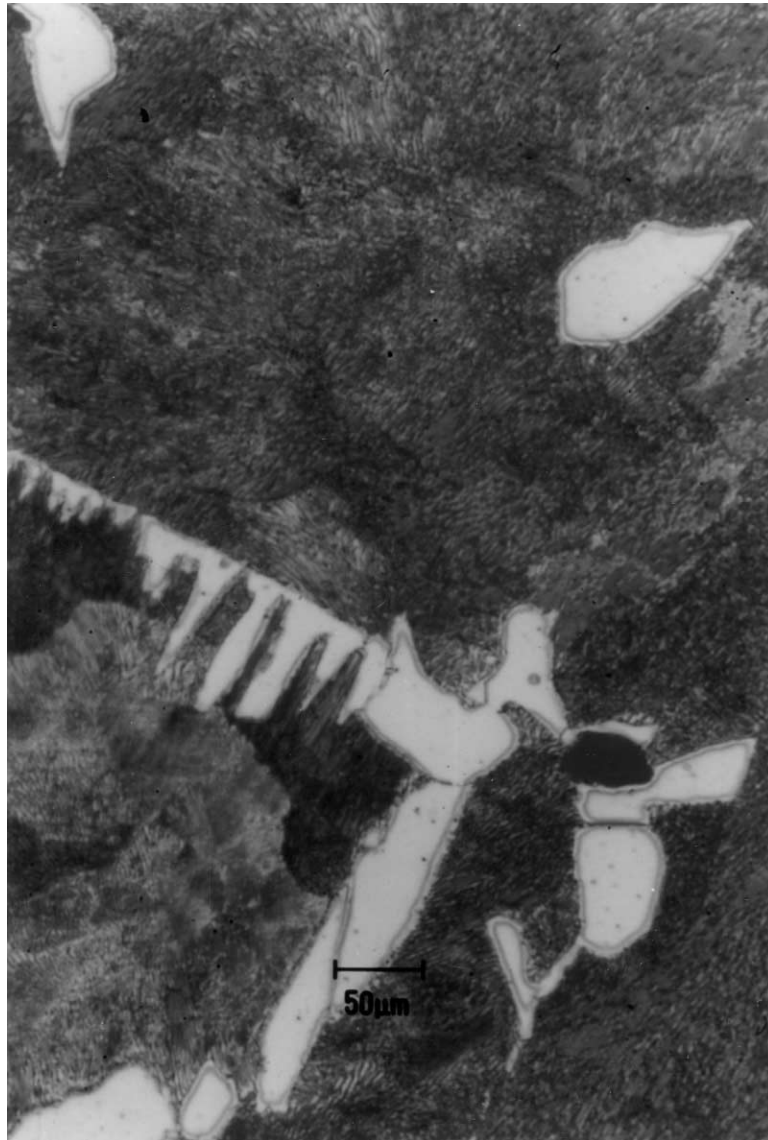
Fig. 9. ($\times 200$) Microstructure of the wrought SAE 1045 bolt material. Widmstätten pearlite–ferrite ratio is 85/15.

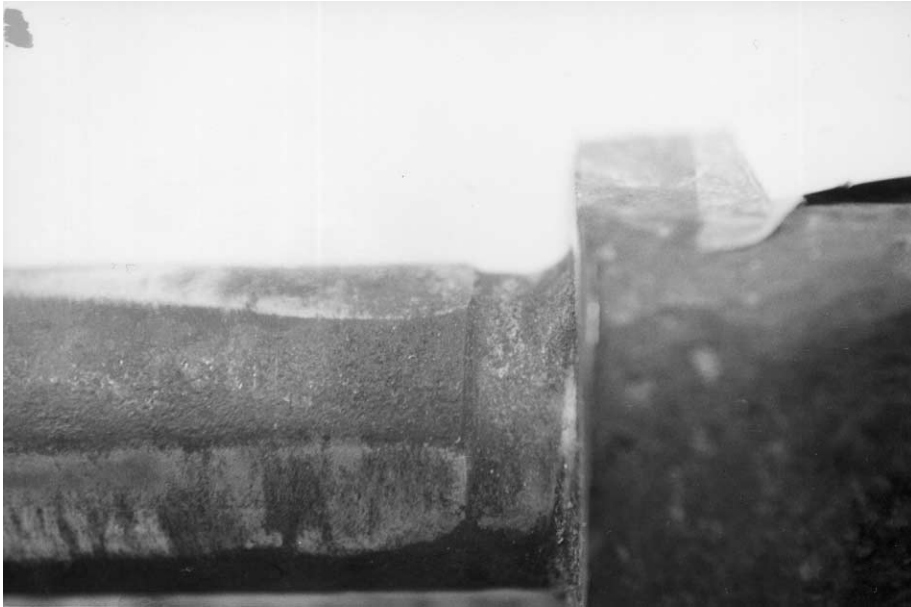
Fig. 10. Evidence of high premature wear in the eye to bolt weld, due to friction against the walls of its lodging in the A-frame.

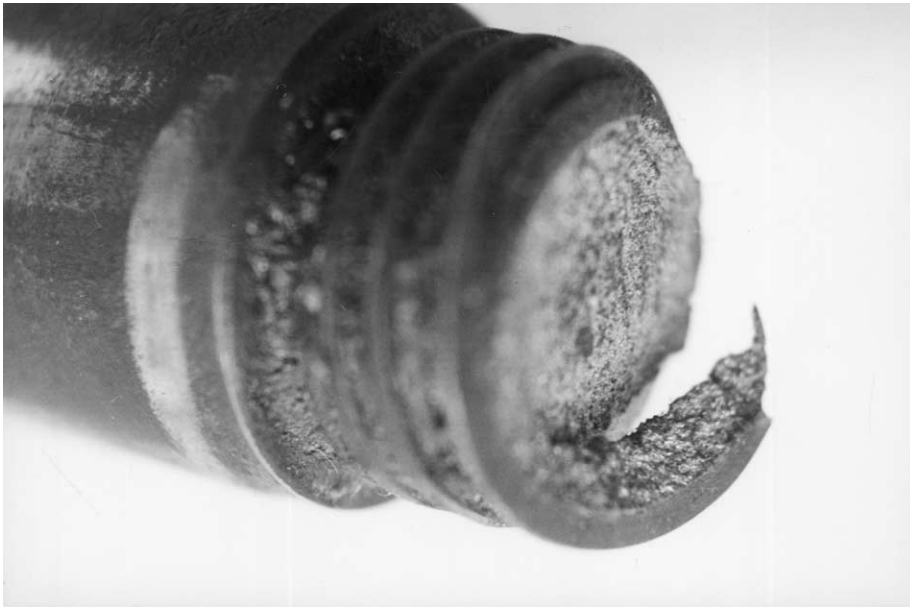
Fig. 11. Fracture surface in the bolt. Note initiating crack within the first thread inside the fastener, and ligament torn by final plastic collapse.

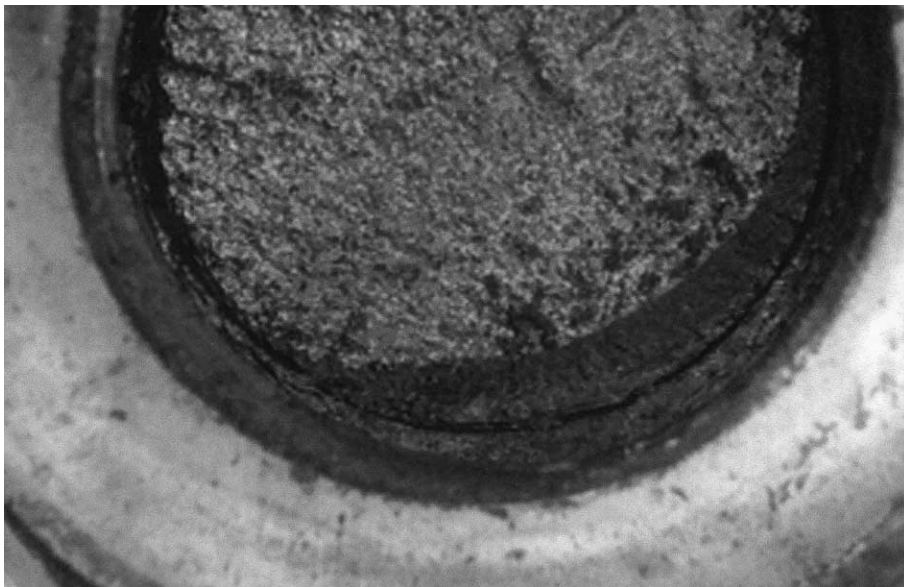
Fig. 12. Detail of fracture initiation from a crescent shaped 3.3 mm deep fatigue crack.
