Fatigue assessment of an electrical resistance welded oil pipeline

M.D. Chapetti ^a, J.L. Otegui ^{a,*}, J. Motylicki ^b

^b OLDELVAL S.A., Gral. Roca, Rio Negro, Argentina

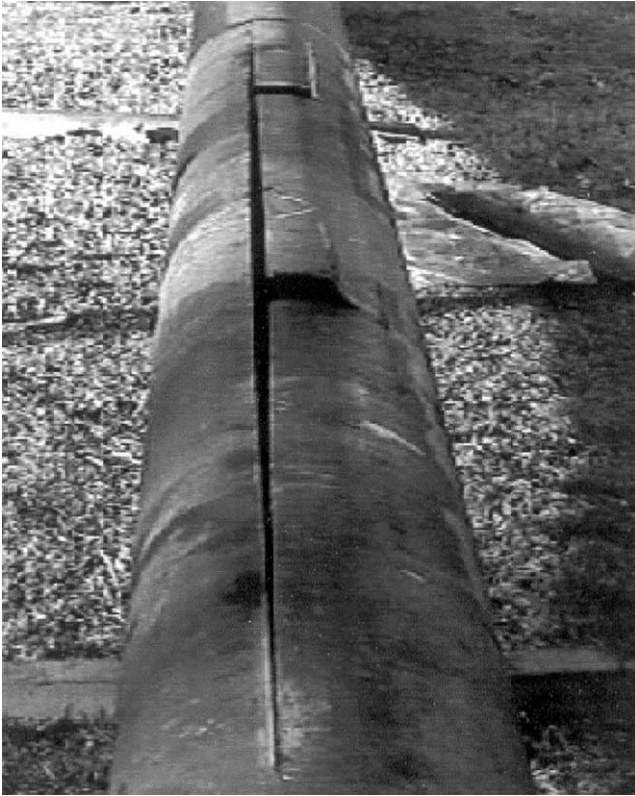
In 1998, an oil pipeline company faced a blowout in a 20 year old 14 in. diameter, 1/4 in. thick pipe, due to the sudden propagation of a preexisting longitudinal crack at the outer surface of the Electrical Resistance Welding (ERW) longitudinal weld, see Fig. 1 [1]. The total length of the fracture was 480 cm. The blowout occurred 40 min after the passage of the scraper through the section, 950 m downstream from a pumping station. Due to the resulting abrupt fall of pressure, the scraper returned back and stopped in the middle of the fractured area. The square windows observed in Fig. 1 were cut in order to take the remnant oil out of the line and to extract the scraper.

Visual inspection revealed the presence of a surface crack, with a depth of the order of 70% of the thickness, and a length of about 160 mm, whose sudden brittle propagation provoked the blowout. The inspected surfaces were corroded due to a long exposition to weather conditions before the examination. Surfaces had to be cleaned with diluted hydrochloric acid, but it was not

Fig. 1. Sudden propagation of a longitudinal crack at the outer surface of the ERW seam weld. Note windows made to recover oil.

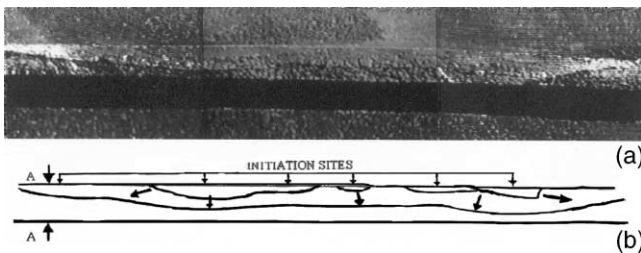
possible to recover many details of the propagation history in the surfaces. The crack shows signs of propagation and coalescence of individual defects starting from the external surface, with variable surface lengths between 10 and 40 mm. Fig. 2(a) shows the crack surface, while Fig. 3(b) shows a sketch of what is seen in Fig. 2(a). Arrows indicate initiation sites on the outer pipe surface, and sense of growth on the crack surface. Beach marks indicating the shape of successive crack fronts during propagation, coalescence stages and final crack size before the blowout can be noted.

Fig. 2. (a) Surface of initiating crack, showing signs of fatigue growth. (b) A sketch of what is seen. Arrows indicate initiation sites and sense of growth.

This study established that in-service propagation of the cracks, as shown in Fig. 2, took place at the mid section of the ERW seam weld of the pipe by a mechanism of fatigue. These cracks propagated from small surface cracks or defects, located at the bottom of the longitudinal machining marks on the outer surface of the tube, in the highly deformed and hardened central area of the ERW longitudinal weld (see Fig. 1). In order to identify a mechanism of crack initiation or the shape and size of preexisting defects, extensive fractographic analyses were done on samples taken from other positions of the pipeline. Where In Line Inspection (ILI) had revealed the probable existence of crack like defects, samples were cut out of the pipeline and inspected. As

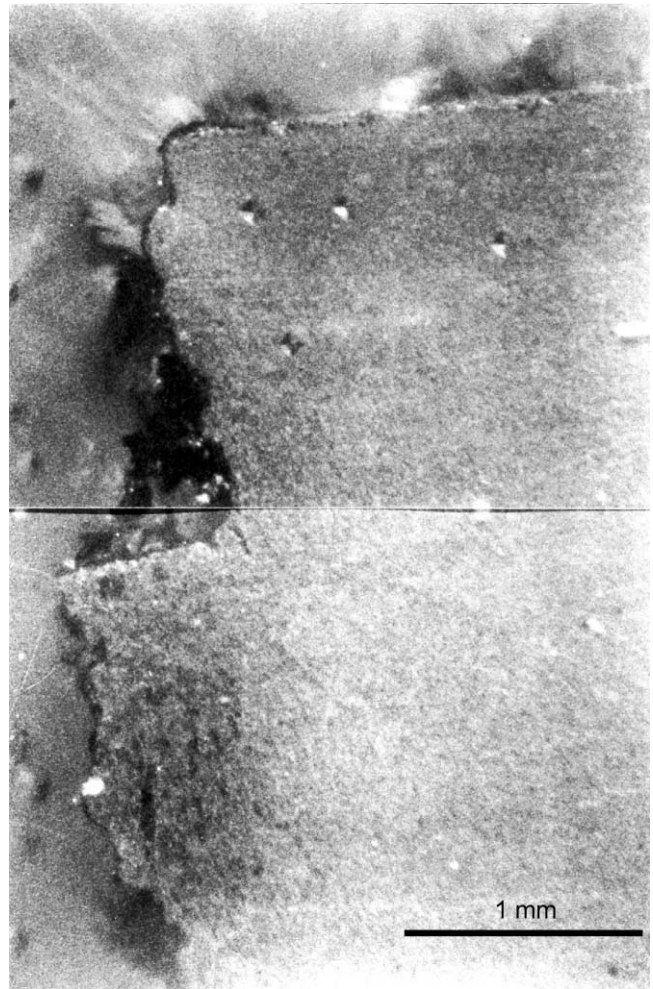
Fig. 3. Cross-section of the first 3 millimeter of the crack path ($\times 30$).

Extensive magnetic particle tests in tracts of pipe adjacent to the failed tubes failed to detect any cracks. Indications in weld material have been associated to shallow longitudinal marks produced by the machining of the weld reinforcement. It is apparent from the evolution of the cracks that there were at least three or four initiation sites. Cross-sections of the cracked weld were made, in order to find indications of these initial cracks. As an example, Fig. 3 ($\times 30$) shows the first three millimeters of the crack path along the cross-section indicated as AA in Fig. 2(b). The crack path is clearly influenced by the microstructure, which forces 90 degree changes as seen in the top left and middle of the figure. This second, larger kink corresponds to the onset of the final unstable fracture.

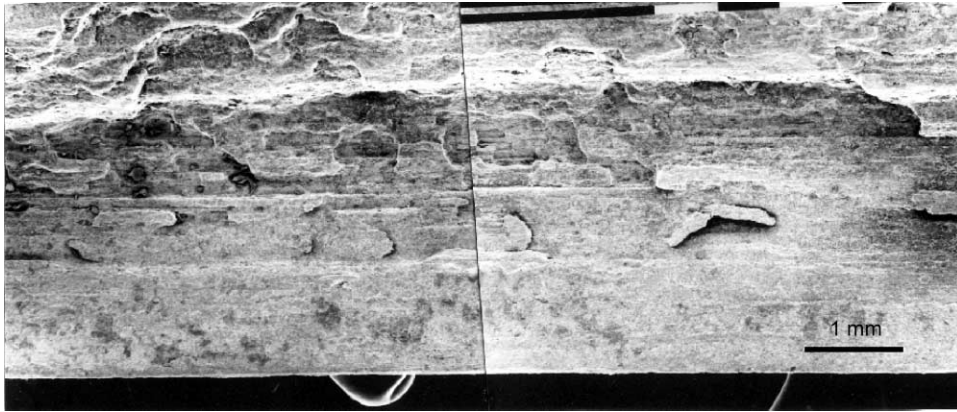
SEM fractographic evaluations show a clear differentiation between the smooth fatigue crack surfaces and the rough surface of the final fracture, see Fig. 4 ($\times 10$). The surface of the final fracture shows parallel bands which correlate with the microstructural banding produced during lamination of the pipe. Fig. 4 also shows that in the mid-section of the longitudinal welds there are two-dimensional or volumetric discontinuities, aligned longitudinally and in the sense of the thickness. They are due to small defects of lack of fusion, with caught non-metallic inclusions, located in the highly deformed weld area. They present plane or curved surfaces, with small protuberances in the ends. Maximum depths and lengths measured are less than 0.5 mm, while most defects are about 0.25 mm.

Fig. 4. SEM fractography ($\times 10$), showing surfaces of fatigue crack and final fracture.

Table 3 shows the experimentally determined fatigue constants C and m . Note that Paris m exponents are very high. This is probably because tests were carried out with ΔK values relatively low, near the propagation threshold. Fatigue growth of cracks from initial depths of 0.6 mm up to a final depth of 4.5 mm, was modeled by integrating the experimental results, considering a single crack. Large fatigue lives were obtained, as shown in Table 3. Real service life of the pipe was only 20 years. The largest inclusion found in the propagation pattern within the fatigue tests was 0.2 mm long. This is much smaller than the largest inclusion found in the fracture surfaces of the blowout, which were about 2 mm long (see Fig. 4). These defects can considerably increase the propagation rates of the cracks.

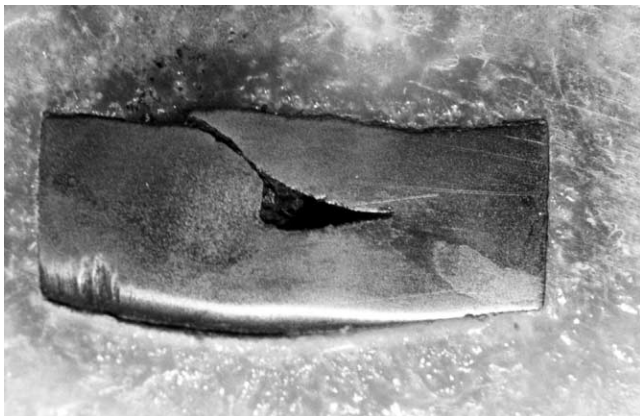
Fig. 5 ($\times 5$) shows a cross-section of the weld, in which a large hook crack is seen. This is a volumetric defect, with its innermost portion oriented parallel to the pipe

Fig. 5. A benign type of hook crack in the ERW ($\times 5$).

surface. The crack driving force in its tip is quite small, since hoop stresses are almost parallel to the crack surface. This is the most benign type of hook crack, the most frequently found in field, and the most widely discussed in the literature. Experimental tensile test results verified that its significance on the strength of the pipe is related to the reduced load carrying ligament.

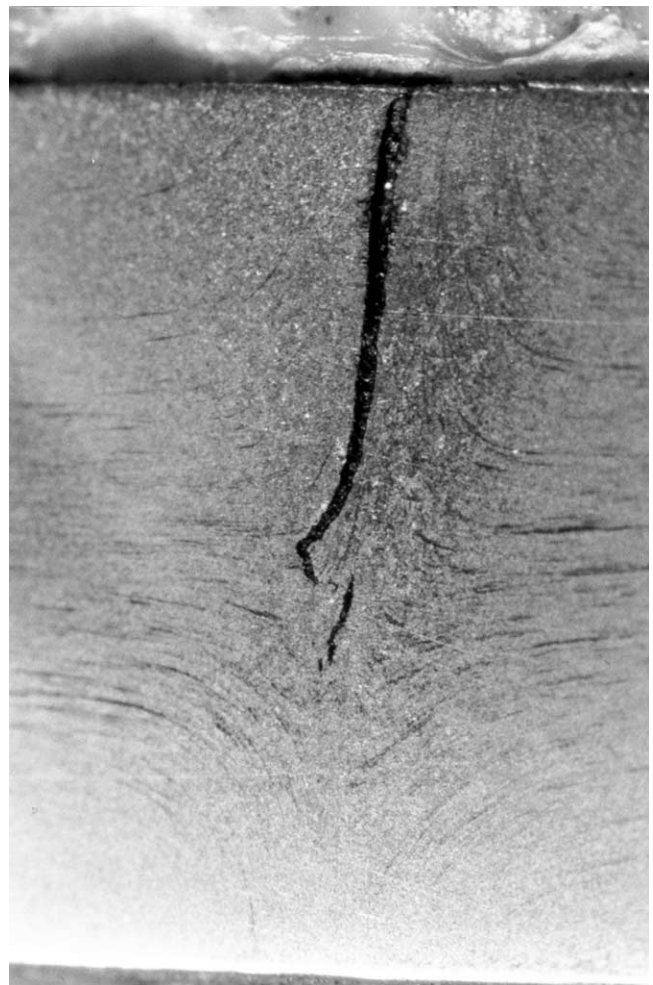
Fig. 6. A sharp, through the thickness hook crack in the ERW ($\times 20$).

The polished and etched cross-section of Fig. 6 ($\times 20$) shows a different type of hook crack. The main crack breaks the outer surface (upper part of the figure) and is very sharp. The crack path tends to follow the microstructural banding, right up to the mid thickness. Near the crack tip of this main crack, other small cracks are seen, related to the banding of the material flowing into the inner surface. The figure shows how interaction among all these cracks can give rise to a rather deep, sharp and through thickness crack. This defect is an indication of the probable source of the original defect that leads to the fatigue failure under study. Fatigue propagation from the initial defect was related to cyclic loads originated in changes of pressure in the tube. Such pressure changes existed indeed during most of the service life of the pipe. Pressure changes of large amplitude and low frequency are associated to the maneuvers for the passage of the scraper.

To eliminate the paraffin deposits and to improve the efficiency of the transport, the scraper is regularly passed through this section. Until the occurrence of this failure, the compressor plant did not possess a scraper trap. Therefore, in every passage of the scraper suction discharge pressures had to be balanced. Discharge pressure was decreased from 70 to 40 kg/cm², and suction pressure increased from 7 to 40 kg/cm². The pressures in other compressor plants along the line had also to be adjusted during these maneuvers, but in these cases the decrease in the discharge pressure was only from 70 to 63 kg/cm², while the increase in suction pressure was from 7 to 25 kg/cm². During the last 5 years, the scraper was passed once a week in winter and twice a week in summer, but data on the frequency during the previous 30 years of service is not reliable. Installation of scraper traps has already been finished in all plants.

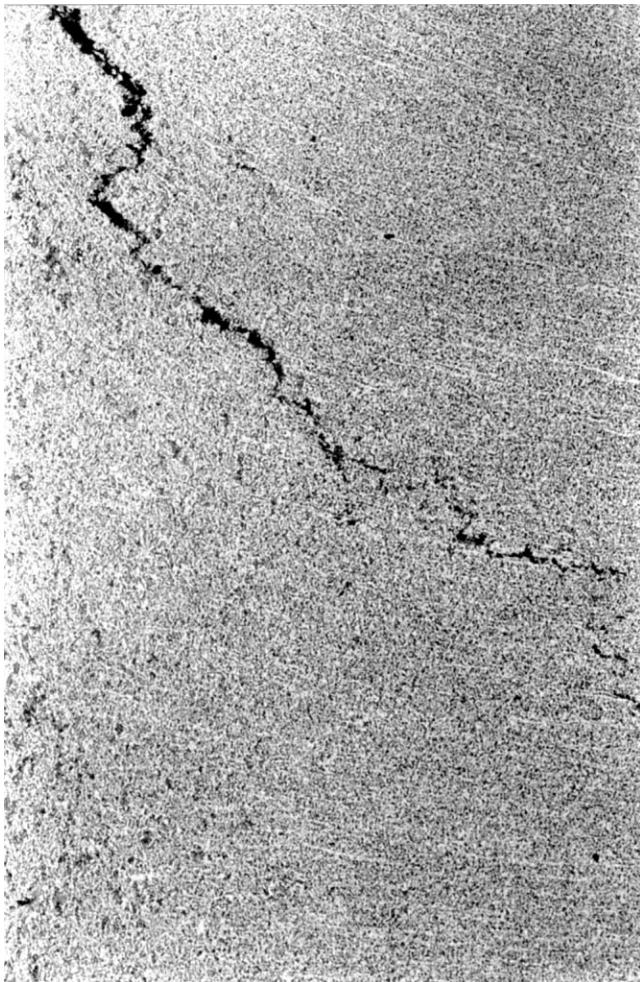
The propagated fatigue cracks followed a trajectory mostly perpendicular to the applied stress, but were sometimes forced to follow a curved and stepped path, as shown in the cross-section of Fig. 7 (Salitral, $\times 80$), and in greater detail again in Fig. 8 (same specimen, $\times 400$). It can be seen that this path is induced by the

Fig. 7. Trajectory of propagated fatigue cracks. Cross-section of Salitral sample ($\times 80$).

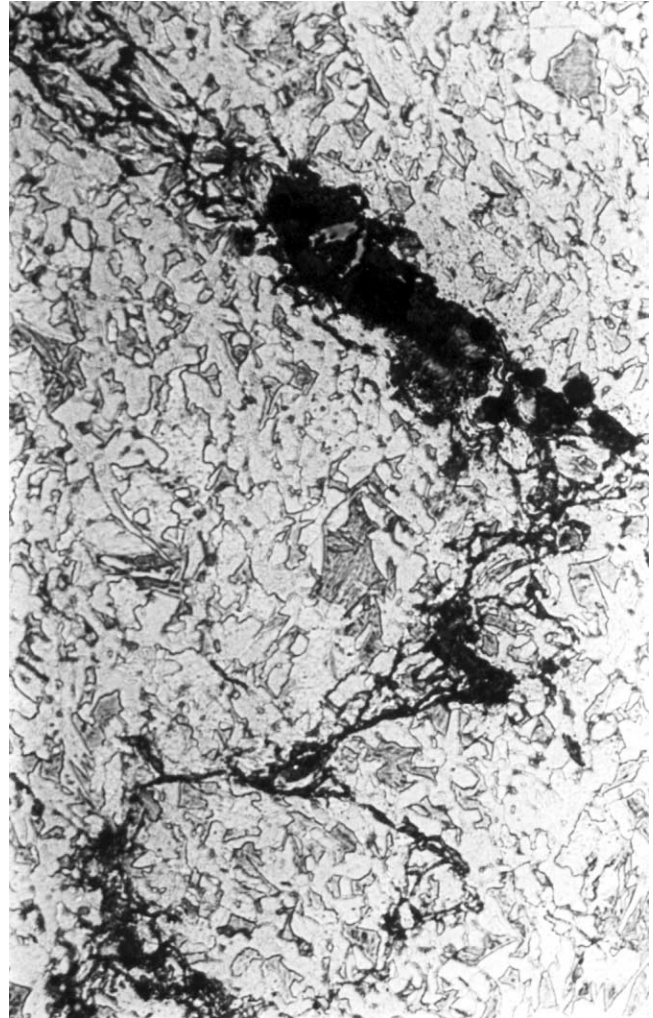
Fig. 8. Stepped path induced by microstructural banding in the ERW metal. Cross-section of Salitral sample ($\times 400$).

microstructural banding in this highly deformed region of the ERW seam weld, and possibly favored by the high through the thickness stress gradient generated by the three point bending load in the small thickness specimens (6.35 mm). In a membrane stress distribution this stepped crack behavior could be not so marked.

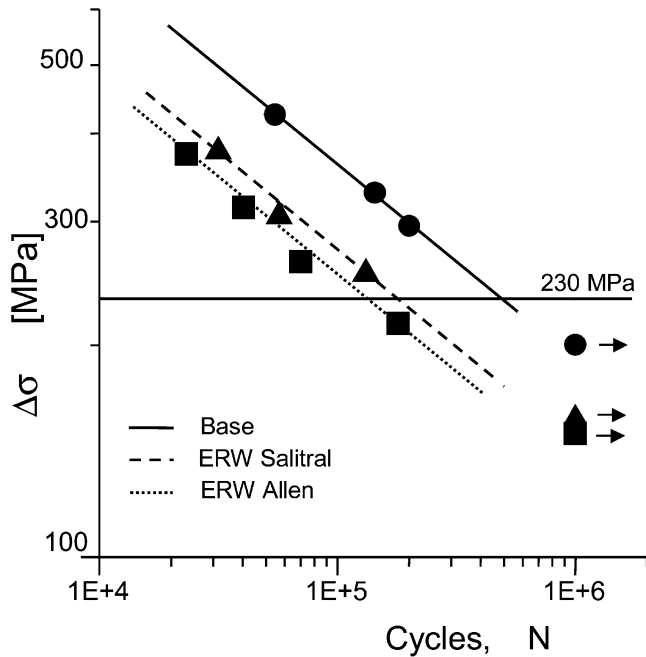
Fig. 9 shows the S – N curves for fatigue initiation from the outer surface of pipe base metal and seam welds. It can be seen that the number of cycles to initiation of fatigue cracks is relatively high in all cases, and especially in the base material. For 230 MPa stress cycles, which represent those developed during pressure variations from zero to the maximum pressure of the pipeline, the number of cycles necessary to initiate a crack is between 100,000 and 200,000 for the weld material, and about 500,000 for base metal. In the Salitral weld tests, initiation is located in defects within a microstructure with low resistance, mostly non-metallic inclusions located in the surface, in the weld center line. Cracks grow straight, following the direction defined by

Fig. 9. S - N curves for fatigue initiation from the outer surface of the pipe base metal and seam welds.

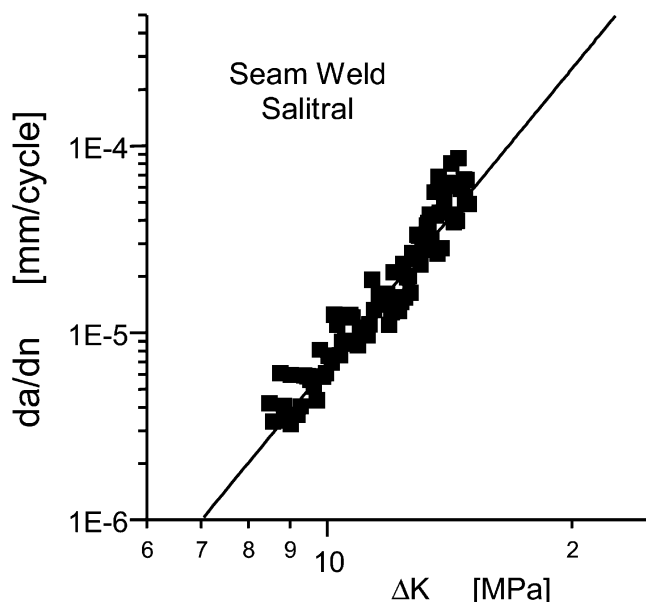
Fig. 10. Experimental fatigue crack growth data for the EMW metal at Salitral.

an example, Fig. 10 shows the experimental da/dN vs. ΔK values for the ERW metal at Salitral, from which the fatigue constants C and m were derived.
