On-site determination of an uncommon cracking mechanism due to composition gradients in a nickel steel weld

This article analyzes a 3.5% Ni steel cryogenic cylindrical vessel, after the detection by non-destructive inspection of cracks in a circumferential weld. Possible in-service damage mechanisms are discussed, in particular, vibration, low cycle thermal fatigue and hydrogen embrittlement. On-site experimental analysis allowed defining that cracks were due to a manufacturing problem. A final weld bead with much greater concentration of Ni generated an uncommon mechanism of thermal fatigue. In Ni alloyed steels, small variations of Ni around 36% involve variations of almost an order of magnitude in the coefficient of thermal expansion. Proposed actions for integrity assurance of the vessel and lessons learned for fabrication of future vessels are briefly discussed.

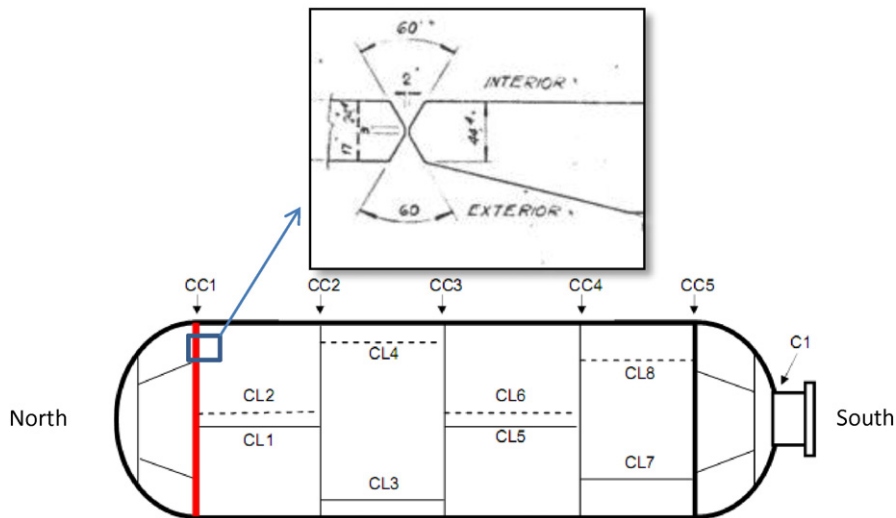
This article originates in a failure analysis of cracks found in the shell-to-cap circumferential weld of a 2440 mm diameter, 82 mm thick cryogenic vessel at a petrochemical complex, Fig. 1. All studies were performed on site, during a programmed plant stop. Two vessels with the same characteristics and operational history were operated at the facility, but only one presented discontinuities.

Fig. 1. Cracked vessel. Inset: detail of the Cap – surround welded joint.

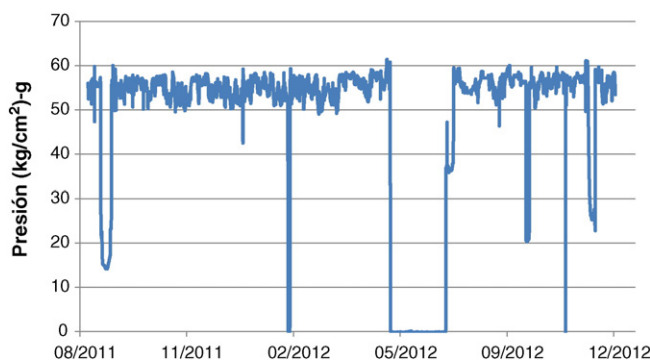
Fig. 2 shows the record of pressures during 2011 and 2012. This vessel was taken out of service, on average, 6 times per year. At scheduled stops the temperature rise up to room temperature was very slow, at a rate of 0.4 °C/min, but could be up to 2 °C/min during unscheduled stops. Cooling rates during commissioning again were always controlled below a maximum of 0.3 °C/min.

Fig. 2. Pressure cycles during last year and a half of service.

The likelihood of mechanical fatigue can be assessed on the basis of service pressure cycles (Fig. 2). There are two main cycle amplitudes. The larger pressure range is in the order of 60 bar (peak to peak), indicative of operation outages. Operating pressure cycles are in the order of 10 bar.

- Operation stop and start cycles of 90 MPa (hoop) and 45 MPa (axial), that is, less than the third part of the yield strength of the vessel material.
- In-service cycles of 45 MPa (hoop) and 22 MPa (axial).

Both conditions lead to very low cyclic stress conditions, below the fatigue limit of the base material. This allowed discarding the mechanism of mechanical fatigue due to pressure cycles [10]. On the other hand, the circumferential component of the cyclic

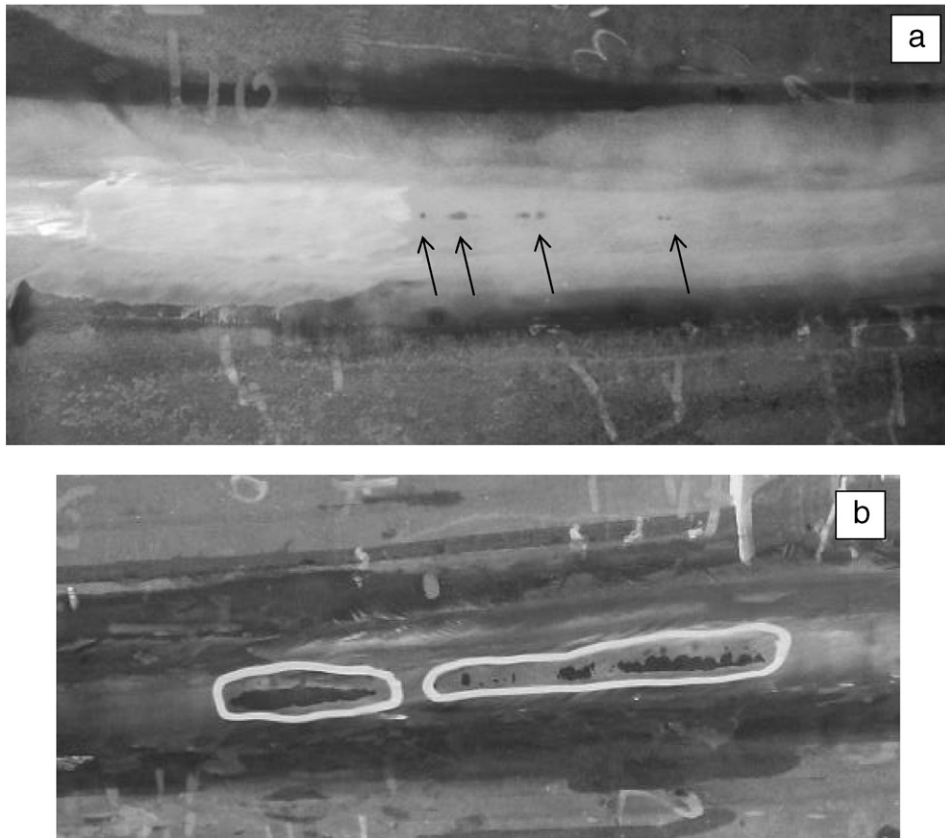
As mentioned, circumferential cracks in the weld of the North cap detected during the NDT inspection carried out in 2010 were eliminated by grinding. Evidence of the indications was not kept. During the NDT inspection in 2012 in. penetrant testing, chemical analysis, hardness and field metallography were used to identify the new cracks detected. All these techniques were used “in situ”, directly on the component during the plant stop. This time, cracks were in different directions. Fig. 3(a) shows the detected mid-weld cracks, as detected by penetrant ink.

Hardness of most of weld material is 150 to 170 HB, similar to the hardness of shell base metal. But very high hardness was detected at specific sites, with values between 330 and 415 HB. These sites were subsequently identified by chemical etching with Nital 10% and the presence of two dissimilar materials was identified: one, susceptible to etching, and the other, non-susceptible. Immune areas to Nital etching are delimited in Fig. 3(b) [3].

Composition of region 3 corresponds to electrodes E8018-C2 or E8016-C2, as recommended for this steel type [6]. Detected cracks were all located in weld metal, on the edge of zones 2 and 3, on the side of the harder material. In these hard areas contents of Ni of up to 7.5% and of Cr up to 12.5% were found. Zn was also detected in both weld metals.

Fig. 3. a) Mid-weld cracks, as detected by penetrant ink, b) after Nital etching, immune areas are delimited.

From Fig. 3 it is seen that the difference in thermal expansion of INVAR is larger with respect to materials with lower Ni content (zone 3), than with a material with a higher Ni content. Zone 3 depicts where the cracks were actually detected, Fig. 3.

Cracks are located in austenitic weld metal, Fig. 3. Although hydrogen cracking is usually not as important in austenitic steels as is in ferritic steels, some nickel alloys are susceptible to this mechanism [15]. On the other hand, the dissolution of hydrogen in austenite is much greater than in ferrite, so most of the available hydrogen would diffuse into the austenite, enhancing embrittlement in austenite [16]. Fig. 8 [17] shows that this mechanism is active throughout the operating temperature range, and during outages (room temp.).

The results of this study allowed predicting the recurrence of this cracking problem, since repairing the weld by grinding, as was done, does not necessarily remove the mechanism of nucleation and propagation of cracks. Future service cycles would re-nucleate and propagate cracks. Therefore, a strategy was agreed on actions to be taken during the next scheduled stop:

- Repeat mapping of chemical composition and high quality metallographic replica, using reagents that allow revealing austenitic microstructures, and delimit the areas of dissimilar microstructure.
- Grind out dissimilar weld material and measure remaining thickness.
- Where the resulting thicknesses are insufficient, repair the weld with a MMA procedure using low-hydrogen, low-nickel electrodes.
- Perform a post repair heat treatment to allow the diffusion of the hydrogen trapped in the weld metal.

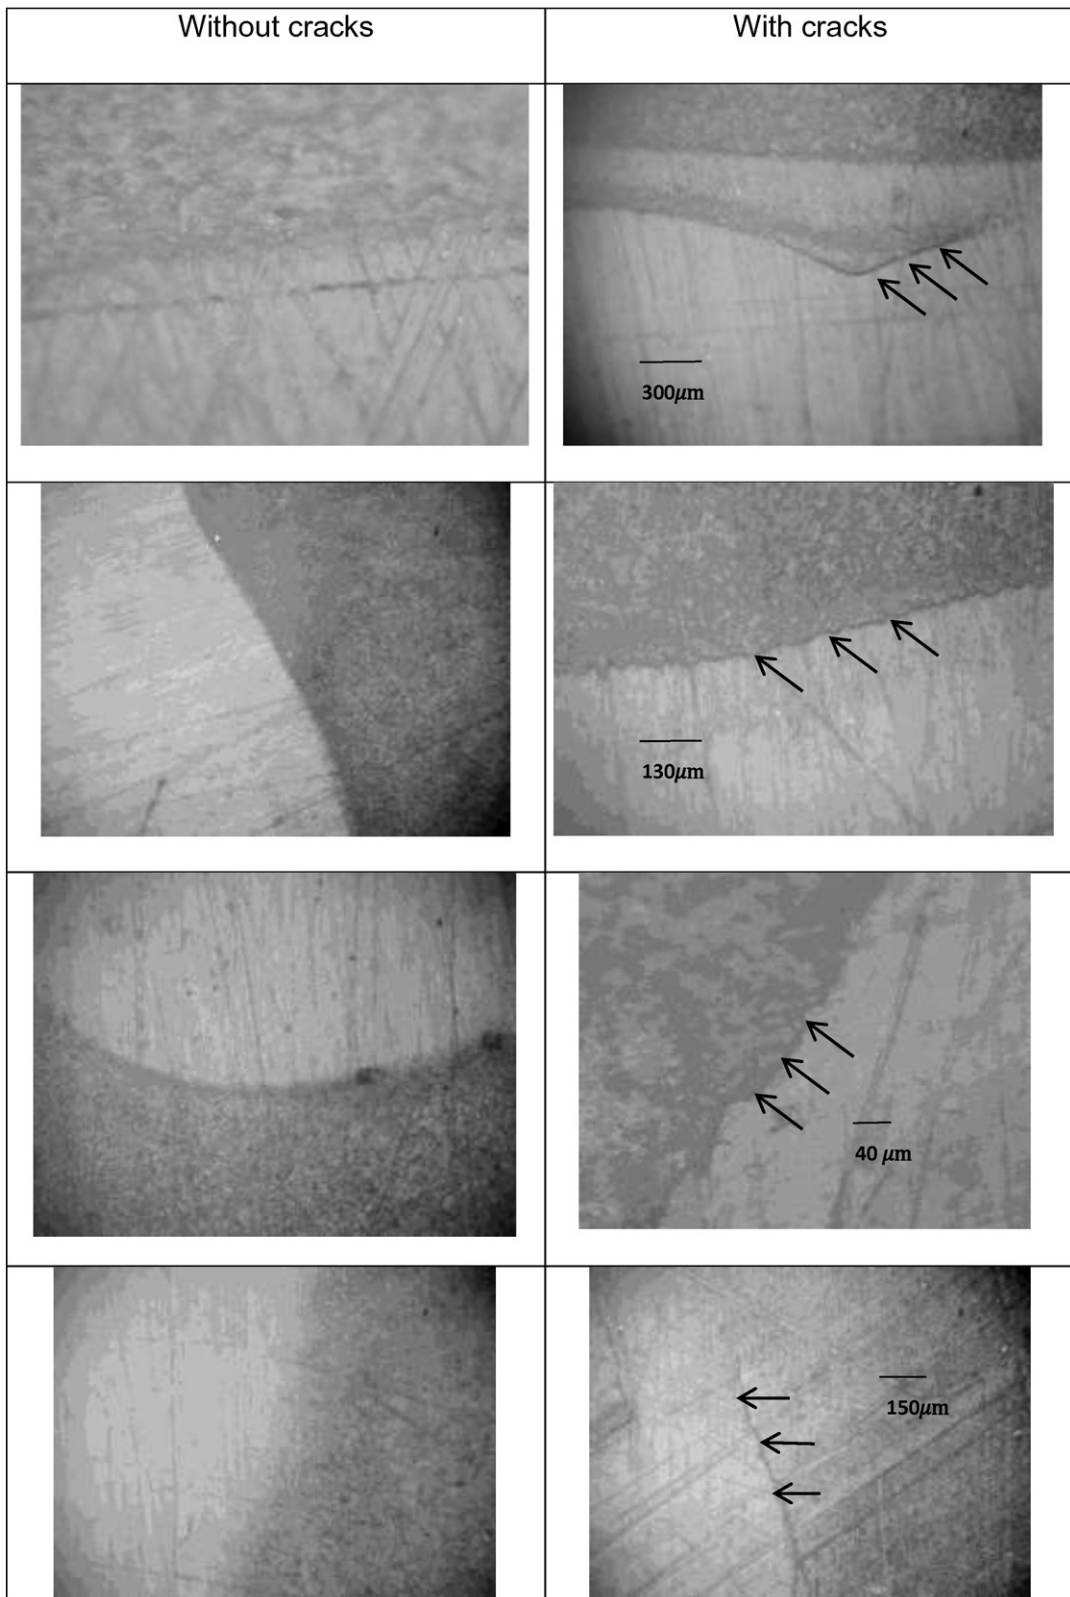
Metallographic replicaes at several intersections between the etched and un-etched regions are shown in Fig. 4. In all cases cracks occur at the interface of both materials, mostly on the side of un-etched weld material. Pictures at the left show areas without cracks, while cracked areas are shown at the right. The quality of the replicaes does not allow clear identification of the microstructure of the weld materials. However, the etched material is compatible with a typical ferritic–bainitic weld metal, while the un-etched material is most probably an austenitic stainless. [8].

One notable shortcoming of these replicaes is that the differentiation between transgranular and intergranular crack paths is not quite clear. The component was repaired and returned to service immediately after these in-situ analyses, so no further experimental evidence was available afterwards.

Fig. 4. Metallographic replicas at the intersection of both weld filler materials.

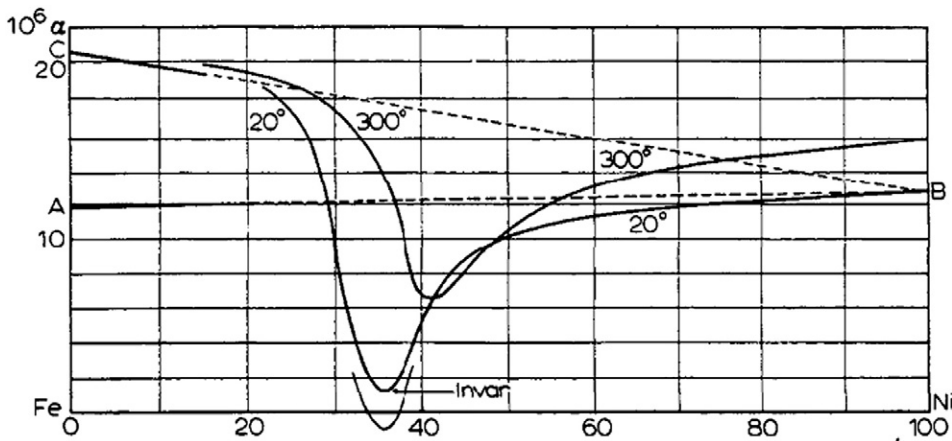
Fig. 5 [11] shows the variation of the coefficient of thermal expansion of nickel containing steels/alloys. There is a sharp decline for a certain Ni% range, reaching a minimum of 10^{-6} for an alloy with 36% Ni. This alloy is known as INVAR (that comes from “invariant”) and has great technological importance for applications requiring alloys that do not become deformed with temperature. This discovery earned Charles Guillaume a Nobel prize in 1920.

Consider an extreme case in which the 3.5% Ni weld metal (Table 2) is surrounded by Invar. Fig. 5 defines a difference of thermally induced strain of the order of $20 \times 10^{-6} K^{-1}$. Considering a thermal cycle in each service outage of the order of 120 K, a maximum differential deformation “ ϵ ” of the order of 2400×10^{-6} is obtained. Some part of this strain would be accommodated as elastic displacements, since the INVAR portion of the weld is not fully restrained by its surrounding low Ni environment.

Fig. 5. Variation of coefficient of thermal expansion upon nickel content.

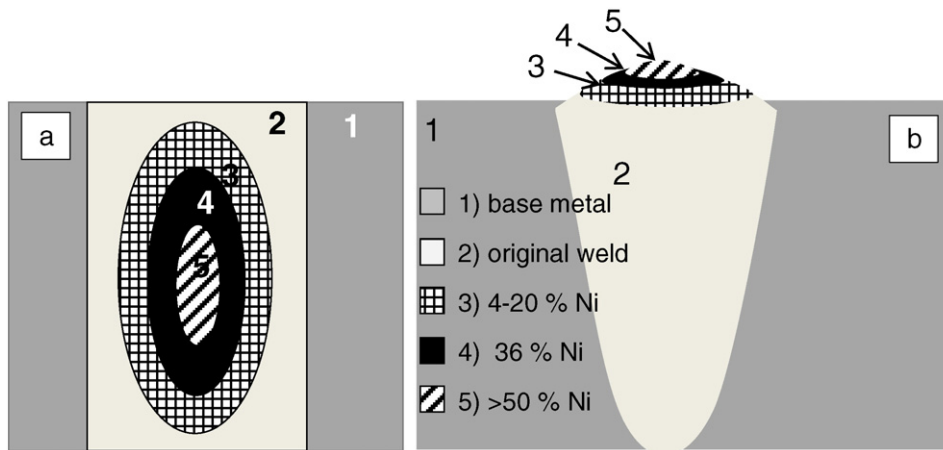
Consider an E NiCrFe-2 weld metal, which provides 70% of Ni (Table 2). If this electrode is used for the recap or repair of a weld previously welded with a low Ni electrode, and neither further weld passes nor heat treatment are carried out afterwards, it is reasonable that a large composition gradient between adjacent weld beads would remain. According to the dilution of the high-nickel weld metal into the low Ni previous passes, areas in the weld metal with nickel values close to the invar composition (36% Ni) can be expected. This is sketched in Fig. 6(a, b).

In this case, as the temperature lows down for operation, zones 1, 2, 3 and 5 in Fig. 6a contract. Since the high Ni material is forced to deform along with the surrounding low Ni weld and base metals, compression stresses will be generated in area 4 and tensile stresses in areas 3 and 5.

In areas subjected to traction (zones 3 and 5), high tensile thermal stresses would be added to the operating stresses (due mainly to internal pressure). Under these conditions, it is likely that added stresses would be sufficient to produce plastic strains during each heat cycle, and even cracking after few cycles.

If the volume of the “repaired” area is small, especially through the thickness dimension (Fig. 6b), this high Ni area would be forced to deform accompanying the material surrounding it, so the interface between zones 4 and 5 of Fig. 4 would see high stresses of thermal origin. Assuming a condition of plane strain, the apparent rigidity of the material is 1.1 E and hence the maximum possible thermal stress is:

Fig. 6. Schematic of gradients of chemical composition in the cap weld: (a) on the outer surface, (b) through-thickness.

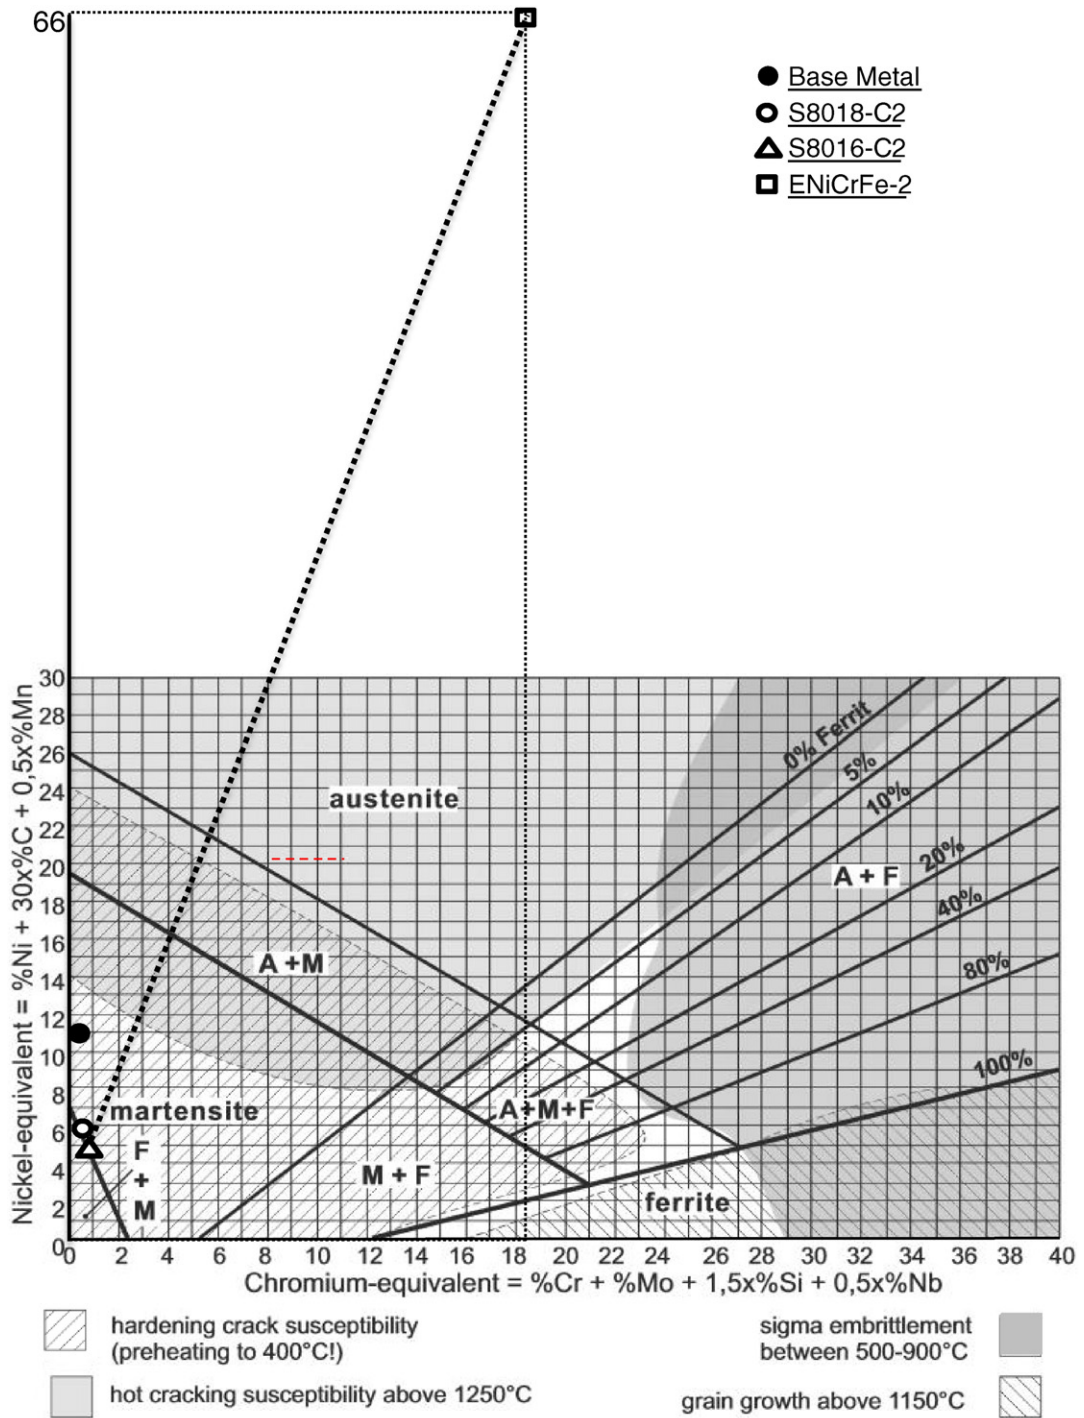
Fig. 7 shows the Schaeffler diagram [14], which defines likelihood of damage mechanisms depending on the composition of Ni and Cr alloyed steels. The compositions of alternative filler materials are identified. The dotted line indicates all possible compositions of ECrNiFe 2 filler metal diluted with former passes (S8018 C2 and C2 S8016). The line passes through two risk areas: hot cracking and cold cracking, but does not extend through the zone of Sigma phase embrittlement, so that this mechanism can be discarded. Hot cracking can also be discarded, since it would have been detected during fabrication and, on the other hand, it cannot explain the reappearance of the cracks in 2012.

Fig. 7. Schaeffler diagram of possible weld metal compositions.

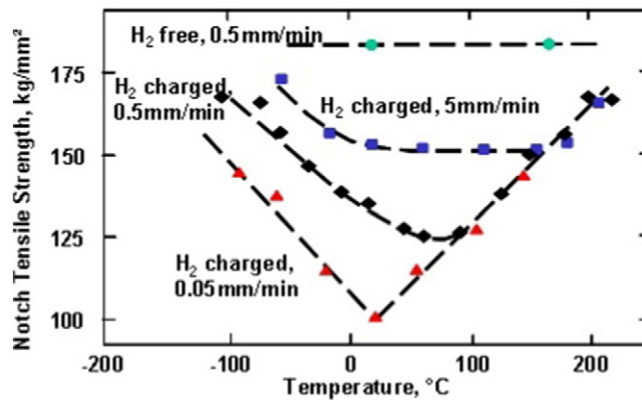
Fig. 8. Effects of temperature and hydrogen content on the impact strength of Ni steel.

embrittlement was probably due to poorly handled electrodes used in the repair pass, which were contaminated with moisture, and lack of post weld heat treatment that would have facilitated subsequent diffusion of absorbed hydrogen.
