International Journal of Pressure Vessels and Piping 79 (2002) 767–775

Integrity and service life of LPG carafes

P. Fazzini*, O. Santi, J. Belmonte, J.L. Otegui

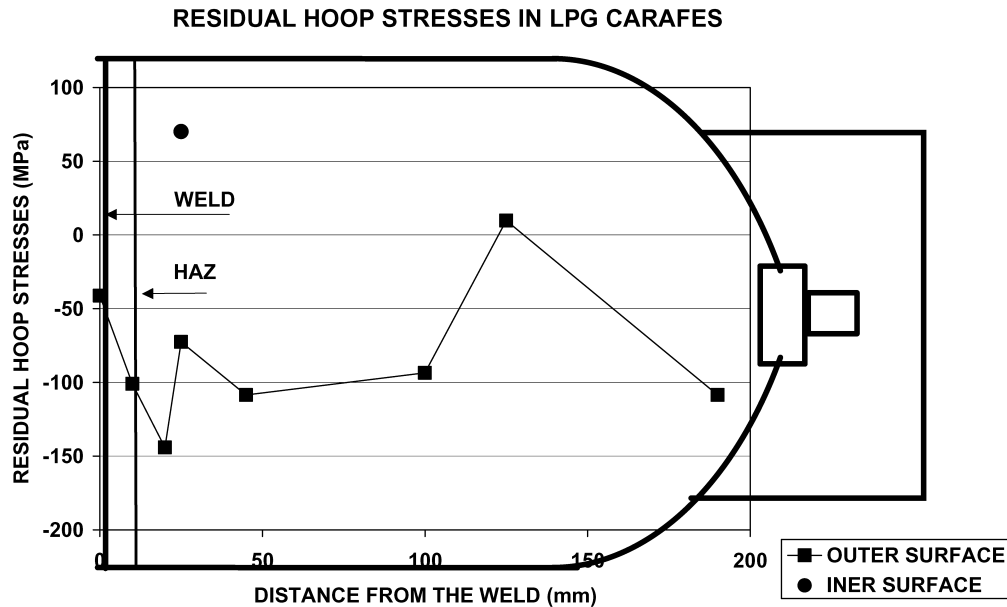
Residual stresses were measured in both inner and outer surfaces of the carafes. Particular attention was paid to those vessels showing the most critical defects as defined in Section 3. Typical results, corresponding to the SMAR carafe built in the 60s, are presented in Fig. 2. In the figure, circumferential stresses are shown as a function of the distance from the circumferential weld, for both the outer and inner surfaces.

Fig. 2. Residual hoop stresses in carafes.

experimental evaluation of circumferential residual stresses in the carafes, see Fig. 2, shows that in the region of the weld these are mostly compressive in the outer surface, with maximum values of about 100 MPa. Tensile residual stresses are found in the inner surface of the base metal close to the weld (square symbol), with a maximum value of 70 MPa. Residual stresses in the outer surface become tensile only close to the caps. This distribution leads to the conclusion that the original high-pressure hydrostatic test yields the weld and surrounding material of the body, while the caps only deform elastically. Therefore, the original high-pressure hydrostatic test could be considered a reliable way to reduce residual stresses. However, a relatively large bending component is found in the vicinity of the weld, probably due to the stiffening effect of the backing strip. Consequently, the largest tensile stresses act on the inside of the carafe wall, where defects undetected during visual inspection are most probably located.

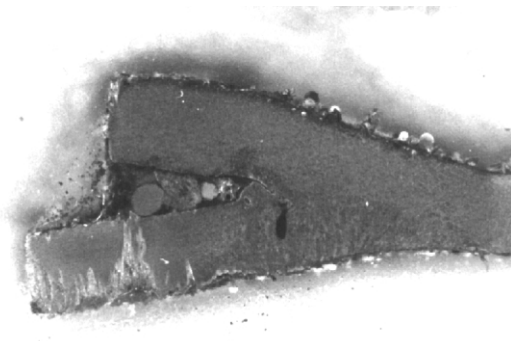
Fig. 3. Cross-section of weld, after etching with Nital 5%. Two weld passes are seen. Note the planar defect ($\times 5$). Plate thickness: 2.8 mm.

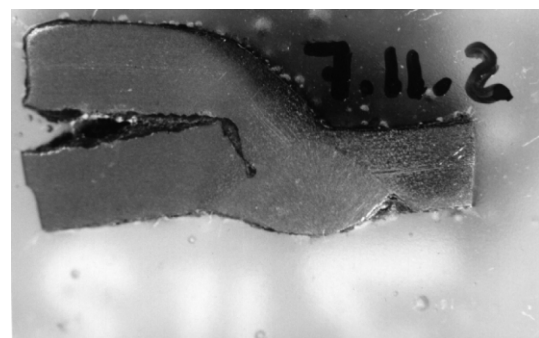
Fig. 4. Reduction of 50% is observed in the resistant section to the longitudinal stresses. Plate thickness: 2.8 mm.

and the backing strip. In Fig. 4 a reduction of 50% is observed in the resistant section subject to longitudinal stresses, and generates a sharp 1.5 mm deep notch susceptible to propagation in service [11,12]. Fig. 4 also shows poor geometry of the backing strip and discontinuous defects due to lack of fusion. Fig. 5 ($\times 100$) shows that the tips of these defects can be very sharp, and can then continue in the form of inclusions, lack of fusion and other defects within the fusion line between weld (left) and coarse grained HAZ (right). This sample also has a deep undercut at the weld toe in the outer surface. Consequently, during its use this carafe presented a high risk of failure.

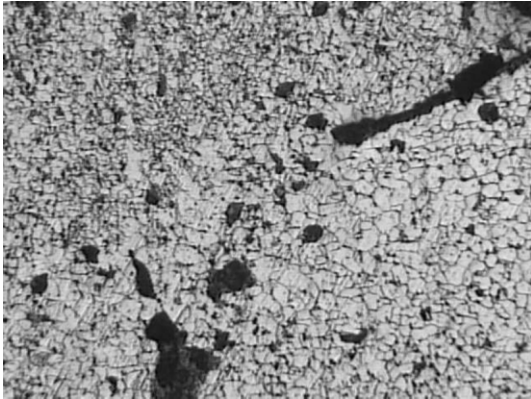
Fig. 5. Very sharp tips of defects ($\times 100$).

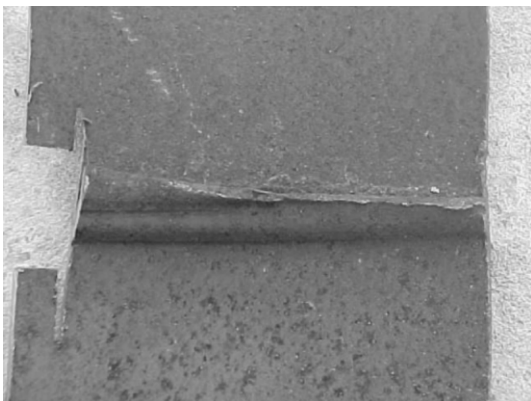
In the example shown in Fig. 6 (series 7) the inner surface of the circumferential weld is shown. The width of the backing strip is variable, and the surplus metal present after forming had not been machined out. This defect is common in the carafes of series 70 and 80, and can be attributed to cost reduction during fabrication. This variable width generates weld root geometries which in turn are also very variable. Fig. 7 ($\times 5$) shows a cross-section in one of the extreme cases. The backing strip does not operate as such, in that it is completely open, and the weld root shows severe lack of fusion, which, as it is perpendicular to the thickness, generating a potentially dangerous stress raiser.

Fig. 6. Inner surface of the circumferential weld.

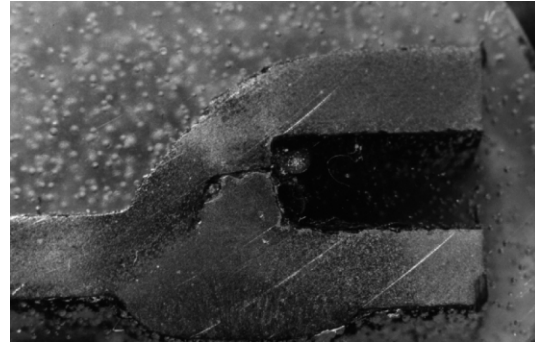
Fig. 7. A cross-section of one of the extreme cases ($\times 5$). Plate thickness: 2.8 mm.

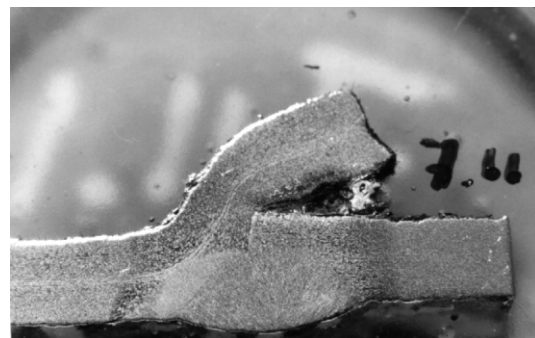
Fig. 8 ($\times 5$) shows a circumferential weld with potentially very dangerous defects. The backing strip is

again poorly formed, and fails to work as such. The crack-like through-thickness lack of fusion defect is seen in greater detail in Fig. 9 ($\times 100$). In Fig. 10, an extreme case of lack of fusion is observed. In this case the backing strip is well formed, but the first weld pass was laid outside the groove, and therefore the joint is fulfilled only by the second pass. Due to this, the weld shows incomplete penetration, with the resistant section only half the nominal plate thickness. Fortunately, the tip of this defect is not very sharp. An approximate calculation indicates that the strength of this section is only a quarter of the nominal strength of the carafe.

Fig. 8. A circumferential weld with really dangerous defects. Not well formed backing strip. Plate thickness: 2.8 mm.

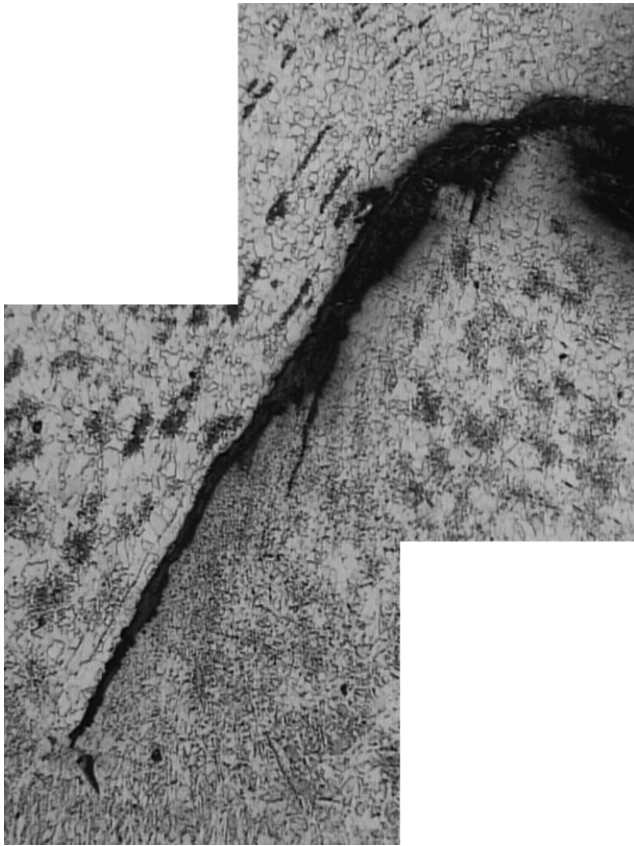
Fig. 9. Crack like through the thickness lack of fusion defect in more detail ($\times 100$).

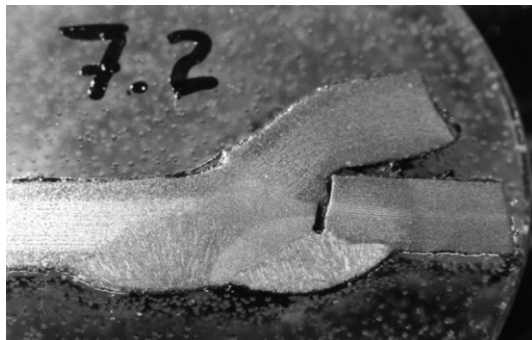
Fig. 10. First weld pass laid outside the groove. The joint is fulfilled only by the second pass. Plate thickness: 2.8 mm.

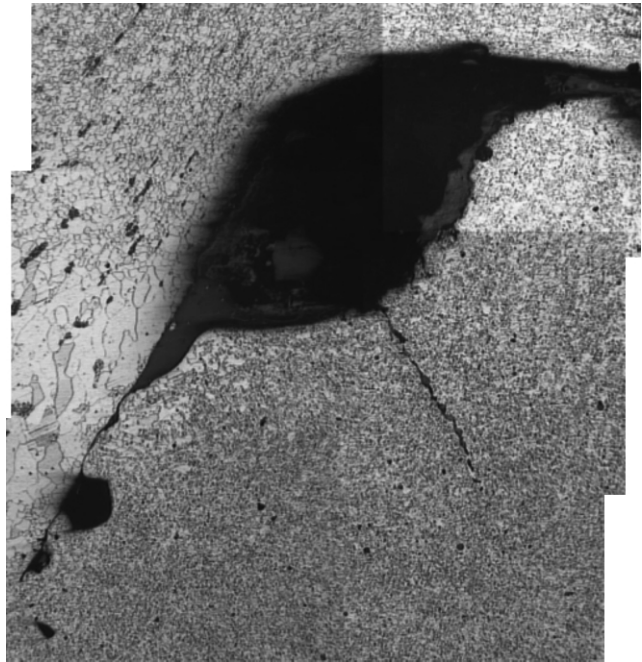
strongly banded, as observed in Figs. 9–11. It was mentioned previously that this type of materials exhibits strong mechanical anisotropy. This anisotropy is sometimes accompanied by laminations, but in all cases these were located in the backing strip, which is not subject to high stresses in the through-thickness direction. The base plate of sample 8-16 showed some type of surface treatment, possibly due to it being originally destined for another use. In an extreme case, the reduced transverse toughness gave rise to a crack in the backing strip, see Fig. 12. Cracks parallel to the surface of the base plate are indicative of a

Fig. 11. Lack of penetration in the weld root (upper right) associated with the thickness, lateral lack of fusion (lower left) and inclusions ($\times 100$, sample 7-6).

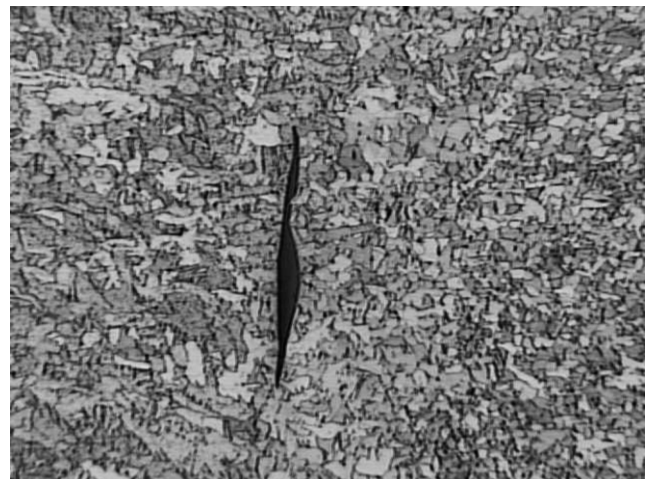
material with insufficient transverse ductility to withstand the large plastic deformations associated with the forming of the caps.

Fig. 12. A crack in the backing strip ($\times 100$).
