# Engineering Failure Analysis

## Failures in cabin type hydrocarbon heaters due to inadequate fuel control

J. Booman<sup>a,b,\*</sup>, M.O. González<sup>b</sup>, J.L. Otegui<sup>c</sup><sup>a</sup> Universidad Nacional de Rosario, Av. Pellegrini 250, S2000BTP Rosario, Argentina<sup>b</sup> GIE S.A., Integrity of Oil & Gas Facilities, Galicia 52, B7608AUB Mar del Plata, Argentina<sup>c</sup> INTEMA (Universidad Nacional Mar del Plata – CONICET), J.B. Justo 4302, B7608FDQ Mar del Plata, Argentina

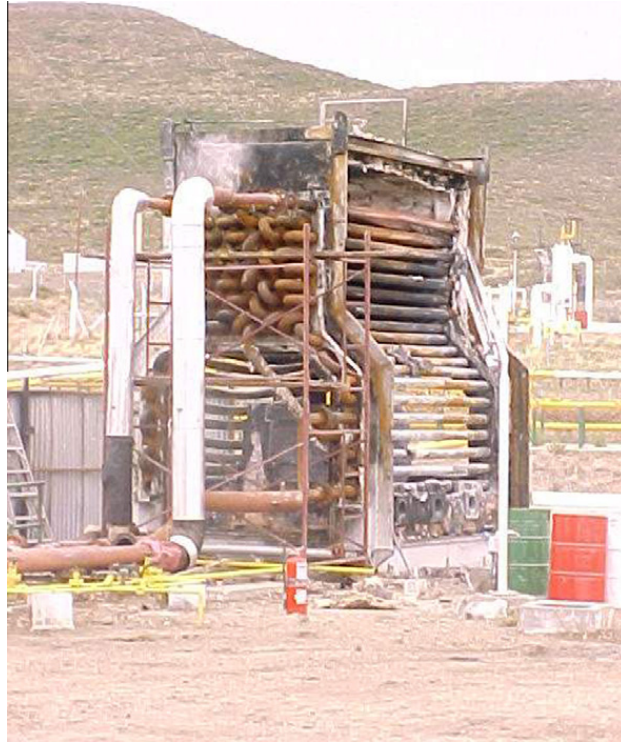
Metallurgical degradation of the carbon–manganese structural steels typically used for these applications is the most common cause for leaks and bursts within burners. Cracking of tubes, bulging and stress rupture lead to escape of hot hydrocarbons into the fired heater, resulting in an external fire. Material properties of tubes, operating conditions and time all contribute to high-temperature degradation of the tubes [4]. Let us see for example a couple of examples. A propane, butane and gasoline recuperation and dehydration heater that worked at 287 °C and 28 Bar developed a leak in a tube and a subsequent fire, Fig. 2.

Fig. 2. Fire in a propane, butane and gasoline recuperation and dehydration heater.

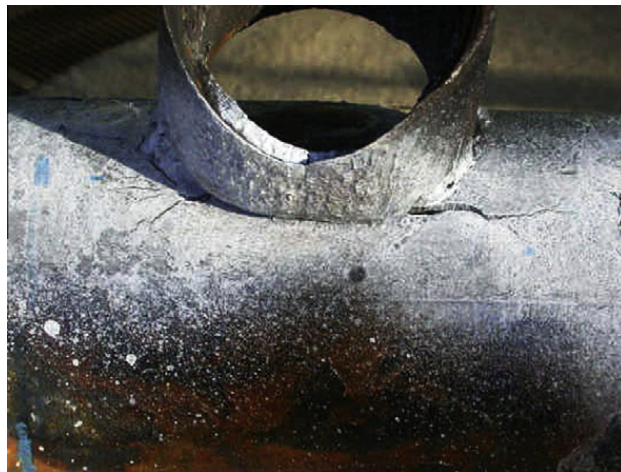
In this case, the initial leak originated at the welds of a nipple placed as mechanical protection for thermocouples used to measure tube skin temperature, Fig. 3. This accessory was of poor geometry, had an intermittent fillet weld, and had lost part of its mass due to thermal microstructural degradation and erosion from heater fumes. This is clearly a problem related to design or maintenance. Prior to the appearance of cracks, the material suffered high in-service temperatures for long periods; the nipple was not refrigerated by the process gas.

Fig. 3. Origin of failure Nipple placed as mechanical protection for thermocouples.

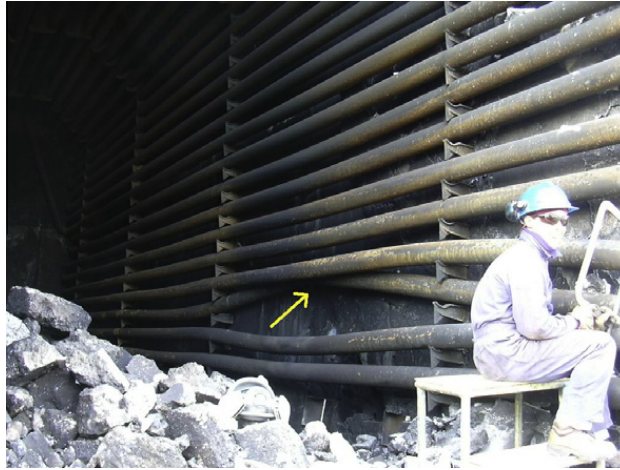
In another example, a fire resulted in the destruction of a JP1 heater in a natural gas processing plant. The failure occurred when a tube leaked, near the bottom of the heater, see Fig. 4. The leak was due to the in-service propagation of cracks initiated at small stress concentrations and pits in the inner surface of the tube.

Fig. 4. Leak in a tube near the bottom of a JP1 heater that resulted in a fire.

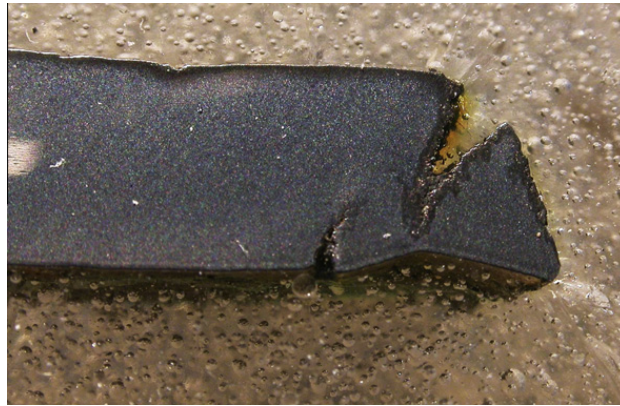
Fig. 5 shows a polished and etched cross section of the tube thickness. Note cracking from both, inner and outer surfaces. Leaking occurred when two of these cracks coalesced near mid thickness. Crack initiation was due to hydrogen damage

avored by carburization of the steel in a layer close to the inner surface of the tube. Microstructural damage by creep also helped crack initiation from the outer surface. Metallurgical analysis of cross sections revealed however that creep damage had only an important influence in the final stages of crack propagation up to the leak. Carburization and microcracking is detailed in Fig. 6. Hydrogen damage is localized to some aligned manufacturing defects. This damage was favored by a high concentration of sulphur in the JP1.

Fig. 5. Polished and etched cross section of the tube thickness.

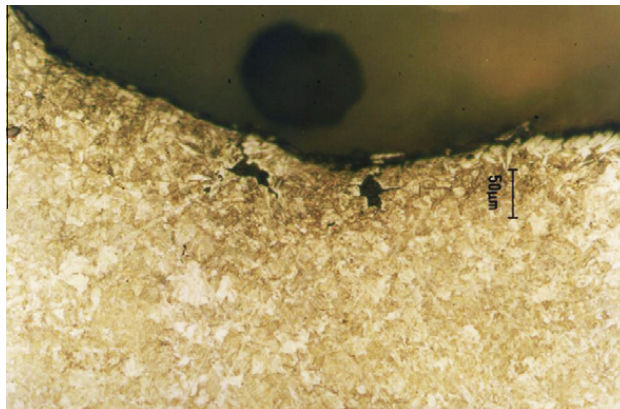
Fig. 6. Metallography of a cross section of the failed tube. Carburization and microcracking can be observed.

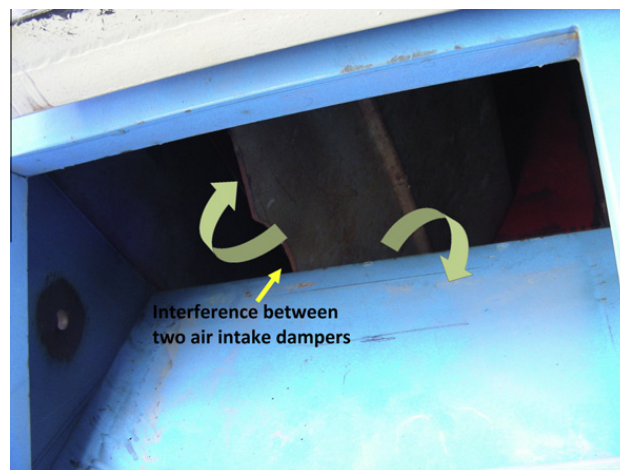
3. Air intake dampers have a design flaw and interfere. After cuts done by maintenance staff, both gates could get stuck both open and closed, see Fig. 7. The mechanical design does not accept the simultaneous and complete aperture of both dampers because their trajectories interfere. However, heater operation states that both dampers should be simultaneously open in more than one situation.

Fig. 7. Intake dampers after cuts done by maintenance staff both gates could get stuck both opened and closed.

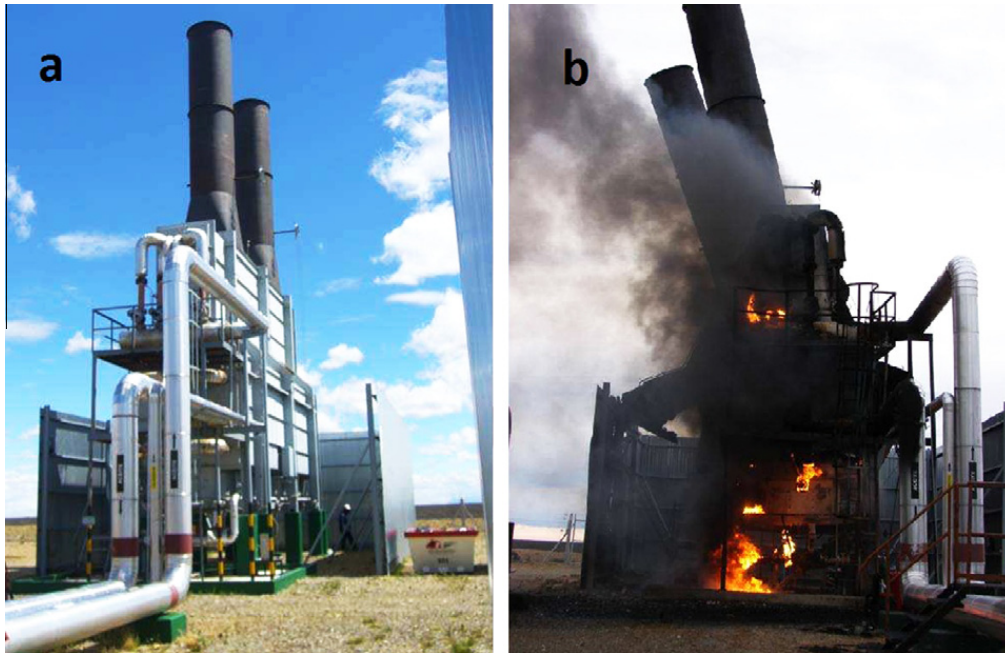
In this case, the heater that originated the fire had been running for more than ten years, after retrofitting. Fig. 8a and b shows the heater shortly before and shortly after the explosion. Paraffin Chemtherm 550 Oil (hot oil) circulated inside the furnace tubes. This hot oil furnace was installed in amine sweetening plant for natural gas. Heat is extracted from the hot oil and used in the regeneration of the amine, stabilization of gasoline and in the gas dryer for venting. The heater increases oil temperature by 70 °F, for a flow of 3000 gallons/min or 680 m<sup>3</sup>/h. The necessary heat is 60 million calories an hour, efficiency is 73%. Heat is provided by 8 treated natural gas burners, located in the cabin floor.

**Fig. 8.** Oil heater shortly before (a) and shortly after (b) the explosion.

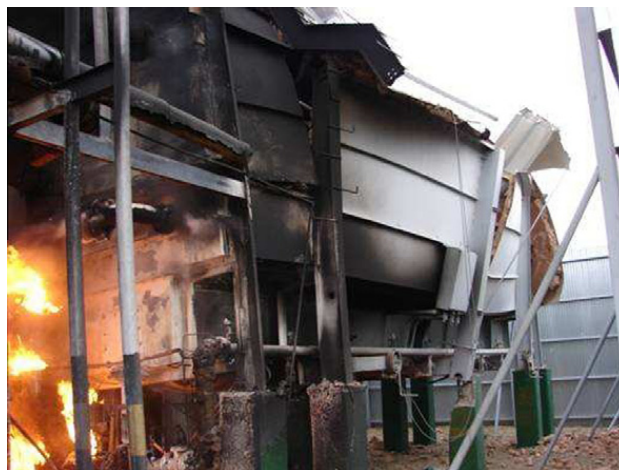
Fig. 9 shows the location of the fire subsequent to the initial explosion. Breaks produced by the blast were found in steel beams that hold the heater shell and in concrete housings, showing a large released energy. The power of the explosion caused ruptures of the thinner metal envelope, but only in a part of the wall of the heater. The force of the explosion caused displacement and deformation in oil tubes, both inside and around the heater, which provoked leaks in some bolted flanges. Oil leaks ignited immediately, causing a second explosion and subsequent fire. This fire was circumscribed to the front of the heater. Burners placed closest to the burnt front show the effects of fire.

**Fig. 9.** Location of the fire subsequent to the initial explosion

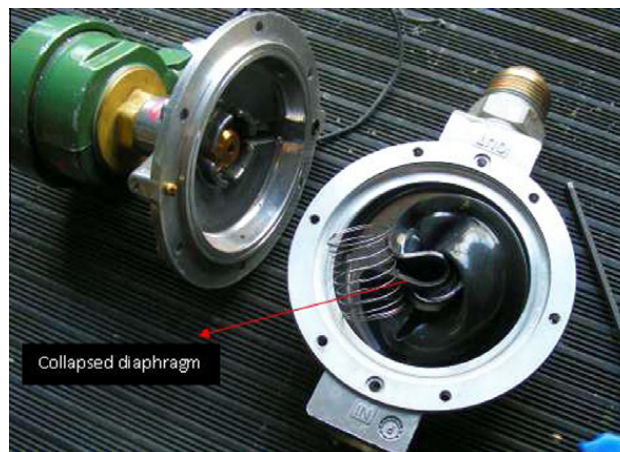
Fig. 10. Collapsed rubber diaphragm of solenoid valve.

Inspection of the solenoid valves revealed that some were broken. Failures are related to collapse of the rubber diaphragm, see Fig. 10. Burst testing of a new valve verified that the failure was due to a wrong pressure range selection. Valves were operating at pressures more than 10 times larger than the design pressure for the installed valves.

The nominal pressure of valve solenoids was much lower than the maximum possible pressure in inlet gas. The valves were working since 2009 without failures detected, but failure would be likely in the event of an increase in fuel gas pressure. This is the case of the shutdown caused by the PLC when closing these valves without previously closing the safety main valve. This sequence of events involves an unfortunate combination of failed valves and errors in the control system. Uncontrolled gas intake through some burners created an explosive mixture inside the heater. Underlying causes are limitations of the heater safety systems as compared with the requirements of modern safety standards, and problems of traceability of the information and communication with suppliers.
