Intergranular susceptibility in failures of high pressure tubes

This work addresses the influence of metallurgical susceptibility to intergranular cracking on the repeated cracking and failure of thick wall curved steel tubes from a petrochemical reactor. These tubes are made of HP-4 steel, bent and heat treated, and then subjected to autofrettage. Internal pressure is around 250 MPa. All failures are characterized by strongly branched, mostly circumferential multiple intergranular cracks. Most cracks initiated in the outer surface, in contact with steam; these were related to stress corrosion cracking (SCC). Some cracks initiated in pre defects in the inner surface, in contact with a polymer, and in the mid thickness of the tube wall. This study includes the assessment of deformation and temperature induced embrittlement mechanisms, measurement of longitudinal residual stresses, and mechanical testing included tensile, Charpy and SCC tests. Susceptibility to intergranular cracking was experimentally assessed by recreating conditions of embrittlement by thermal treatments and tensile testing. Samples with 0, 3 and 5% plastic deformations were subjected to 24 h thermal treatments b

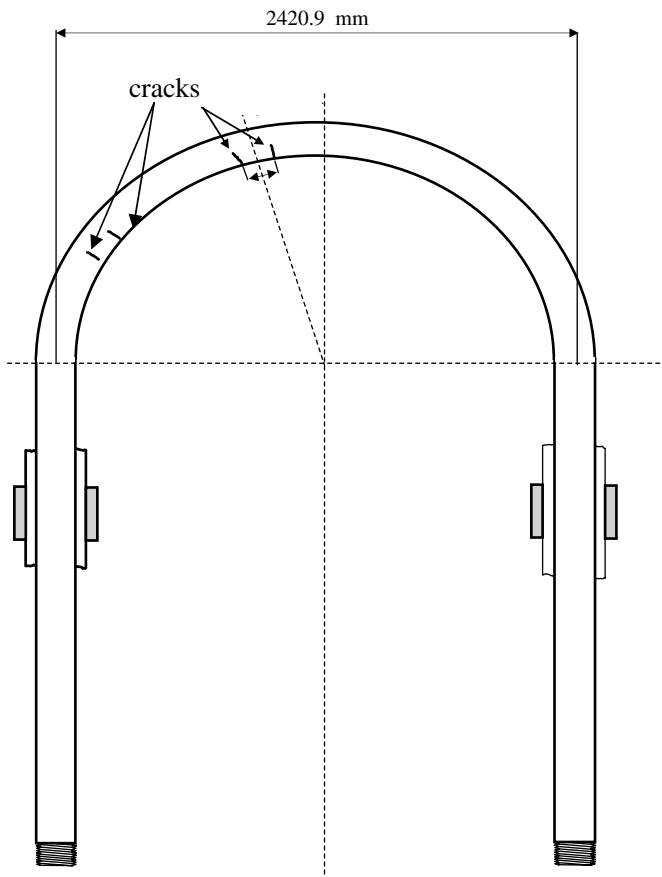
Fig. 1. Typical location of cracks in a curved tract of a reactor.

All failures are characterized by intergranular and branched cracks propagation, initiated in the curved sections (Fig. 1); no crack was detected on the straight parts [2]. Before 2004, cracks initiated at the outer surface (water side). Fig. 2a shows the results of black on white magnetic particles testing of the outer surface of the thick walled tube. Typical H-shaped branched crack can be seen. Subsequent ultrasonic mapping allowed recognizing typical crack branching and propagation in the pipe wall, see for example Fig. 2b. Smaller secondary cracks are not displayed in this sketch.

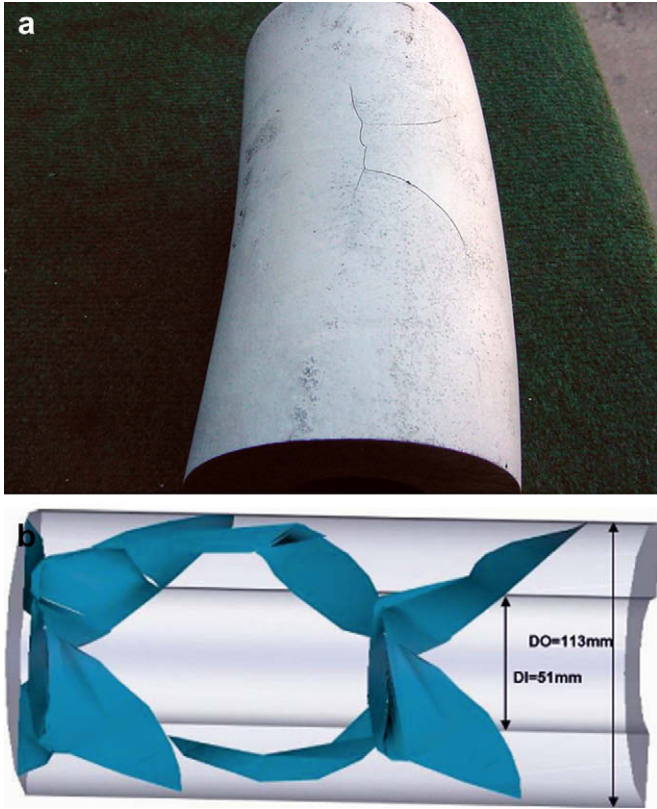
As already mentioned (Fig. 2), all tubes failed due to the propagation of branched cracks in the curved section of the tubes. Many secondary cracks were detected in almost all the failed tubes, most of them initiated at the outer surface, which did not break the other surface of the pipe.

Fig. 2. (a) Typical H-shaped, branched crack, as seen in the outer surface of the thick walled tube. (b) Mapping of typical crack branching and propagation in the pipe wall.

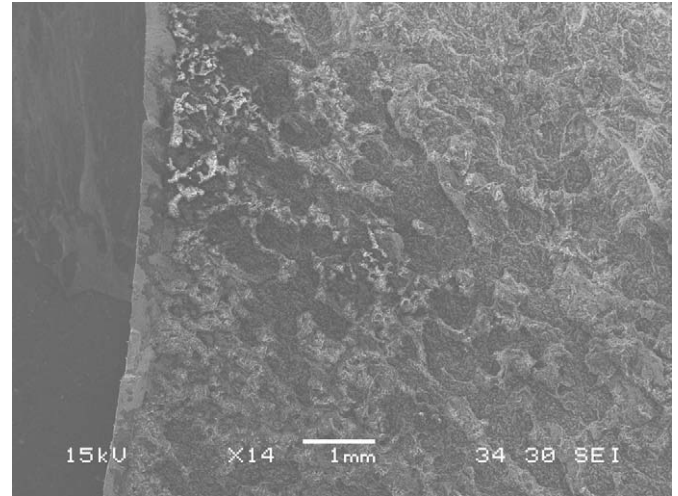
No matter what the initiation site was, subsequent propagation of the cracks was in all cases intergranular. Fig. 4 ($\times 25$) shows a scanning electron microscope (SEM) fractography of a typical intergranular crack propagation from a transgranular initiation site, shown vertical, to the left (curve 57, 2004). A black magnetite film is covering most of the crack surface. The optical metallography of Fig. 5 ($\times 200$) shows as an example a polished and 2% Nital etched cross section of curve 57, with a typical intergranular crack propagation in the martensitic material of the tube. Its initiation site had a typical fatigue aspect, although its surface was also covered by a black magnetite film. The micrograph also shows the acicular characteristic of a tempered martensitic microstructure. Two step colour etching for multiphase steels was used; first etching with 4% picral, and then etched using a 10% aqueous solution of sodium metabisulfite.

Fig. 4. SEM fractography of a typical intergranular crack propagation from a transgranular initiation site, shown vertical, to the left (curve 57, 2004) ($\times 14$).

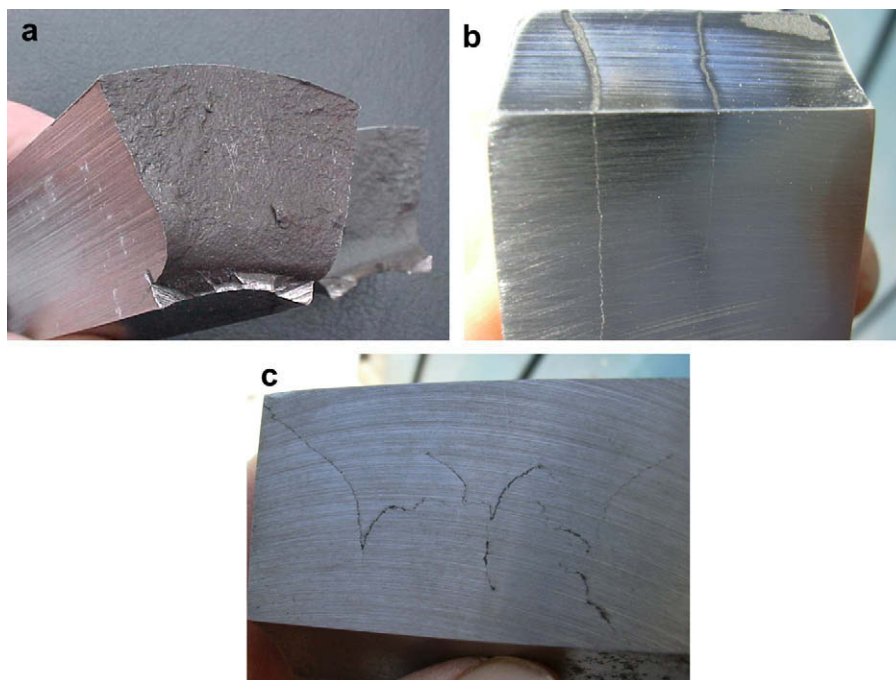
Two of the last failures showed similar growth characteristics, but apparently initiated in the inner surface and in the mid thickness of the tube. These proved that previous assumptions did not fully explain the failure mechanism. Examples of Fig. 3a, b, c

correspond to these three different failure types: (a) a typical failure before 2004, initiated at the outer surface; (b) curve 57 old (2004), initiated at the inner surface; and (c) curve 57 new (2004), initiated at mid thickness and failed after less than a month in a replacement tube. These last failures prompted a study to determine the weaknesses of the material that eventually favored the occurrence of failures, in order to define and implement effective mitigation measures.

Fig. 3. Three cracks corresponding to different failures, initiated (a) at the outer surface, (b) at the inner surface, and (c) at mid thickness.

The last two failed tubes changed this pattern. After many years of service, cracks in curve 57 initiated in pre existing cracks in the inner (polymer) surface of the tube (ID). Oddly enough, the replacing tube failed only after one month in service. Cracks in this new curved tube began in the middle of the thickness of the tube wall.

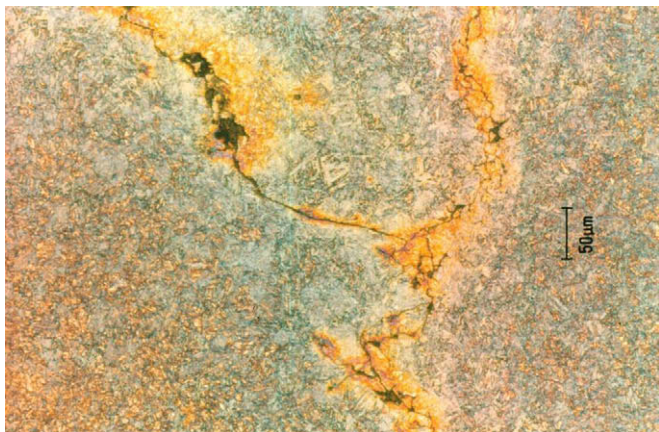
Fig. 5. Typical intergranular crack propagation in the martensitic material (curve 57, 2004) ($\times 200$).

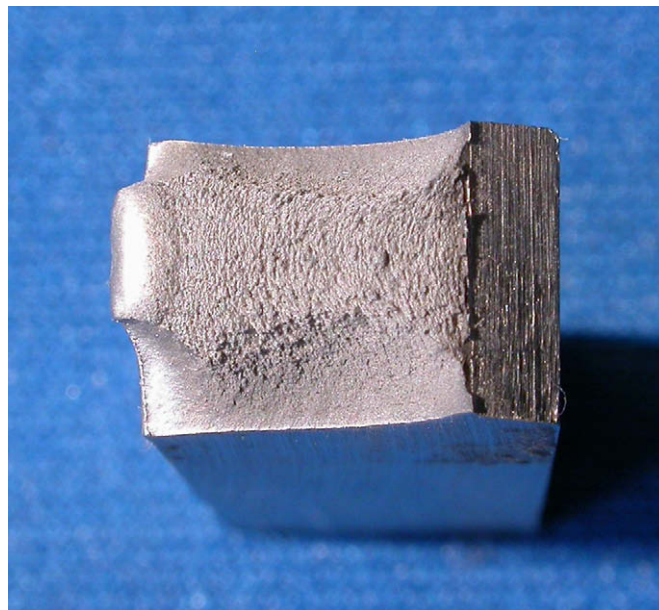
These freshly broken fracture surfaces were then inspected in the SEM. Fig. 6 shows a typical fracture surface of a specimen from a cracked curve. All specimens show well developed shear lips close to three free surfaces, which justify the high values of impact energy, and which are apparently unaffected by any embrittlement. Even a small crack in a shear lip in one specimen did not result in a significant decrease of impact energy. In the 30% inner area, however, some differences were appreciated. Note in Fig. 8 how the fracture in this inner area propagated in a wavy pattern, that reveals a specific crack path related to the weakest microstructural features. As expected, the specimens with the smallest shear lips showed the lowest impact energies.

Fig. 6. Fracture surface of a specimen from a cracked curve.

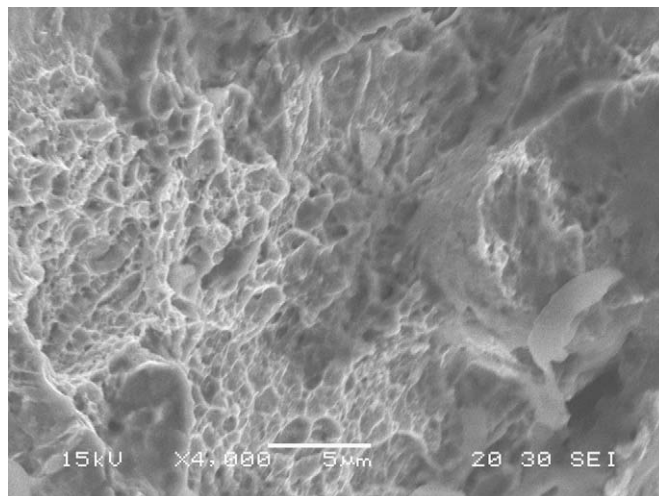
Fig. 7 ($\times 4000$) shows the fracture surface in the inner area of the Charpy specimens from the straight tube. Note the micro void ductile fracture mechanism. Fig. 8 (a $\times 500$, b $\times 4000$) shows the fracture surface in the inner area of a specimen from a cracked curve (Fig. 6). Note that now the fracture surface is not flat. Although a micro void ductile fracture is also seen, secondary cracks are quite numerous. These secondary cracks were produced by the impact itself; no black films are seen in their surfaces.

Fig. 7. Fracture surface in the inner area of the Charpy specimens from the straight tube ($\times 4000$).

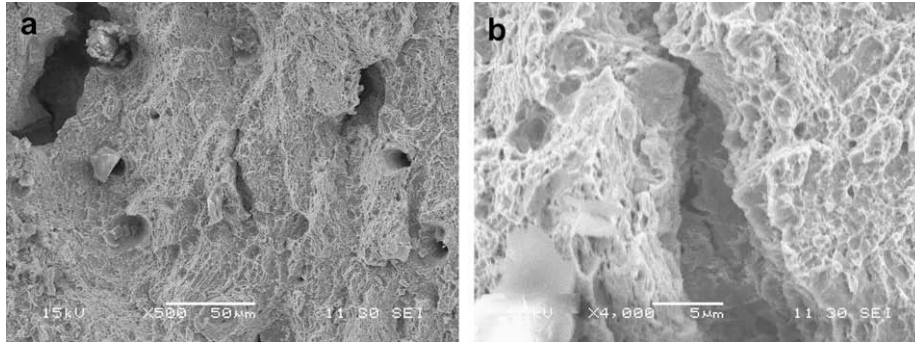
Fig. 8. Fracture surface in the inner area of a specimen from a cracked curve (a ×500, b ×4000).

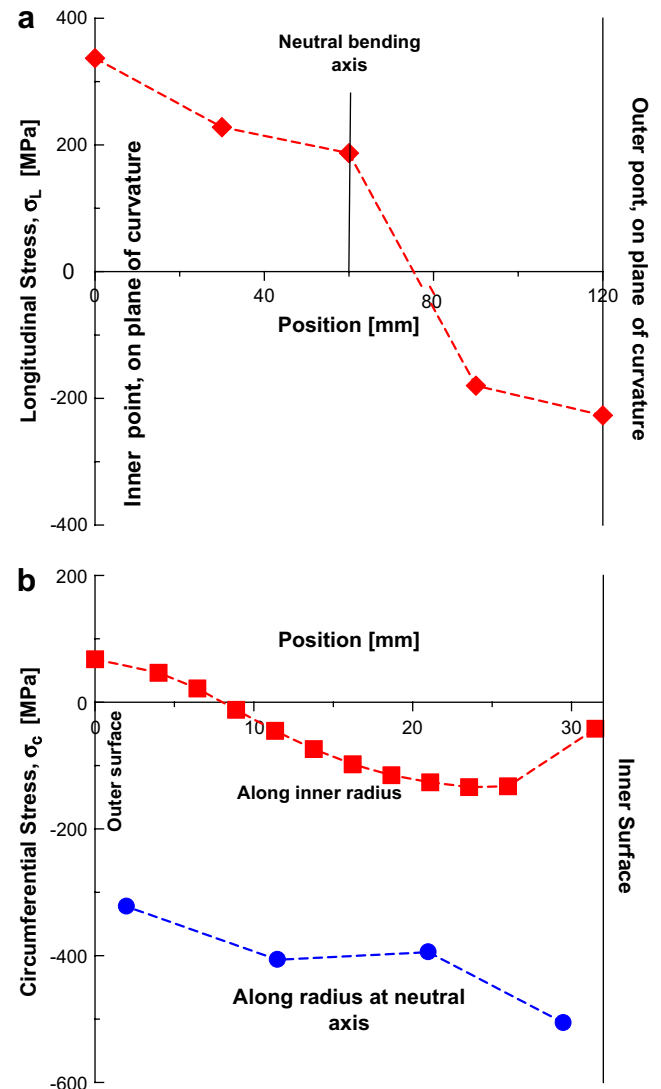
Fig. 10a, b shows the measured (a) longitudinal and (b) circumferential residual stresses, respectively. The measured radial residual stresses are compressive, with a relative maximum value of around 80 MPa, near the mid thickness. Maximum circumferential residual stresses are 400 MPa, in compression; tensile maximum is only 70 MPa. The observed distributions according to

The most relevant result is that relatively large longitudinal stresses were measured; the maximum tensile longitudinal stress is 340 MPa. The stress distribution obtained along half the perimeter can be directly associated with the plastic deformations generated during bending of the pipe to manufacture the curve. These stresses are comparable with the expected service stresses, so they could have contributed to the occurrence of the observed failures.

Fig. 10. (a) Longitudinal residual stresses. (b) Circumferential residual stresses.

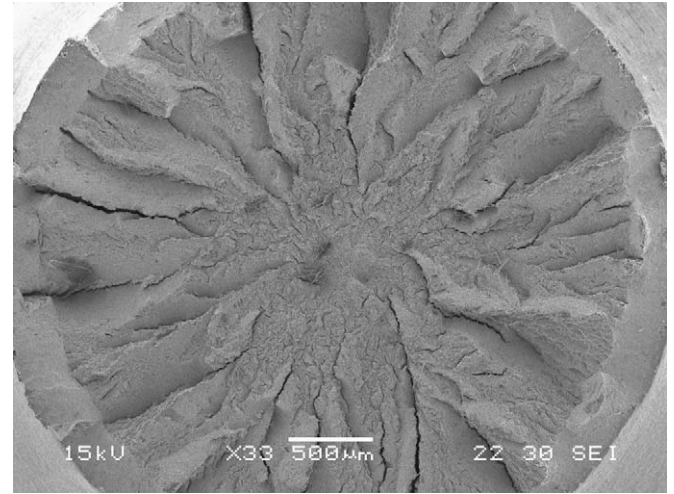
Fracture surfaces change in the case of notched tensile specimens. Fig. 15 corresponds to the original material, tested with a 0.65 mm deep, 55° Charpy-like notch. The fibrous central area remains, but the radial area and the outer ring disappear. These are replaced by an area with circumferential crests (ridges), concentric with the central and fibrous area normal to the propagation of the crack from mid thickness until the surface of the sample. As in the previous observations, the central area presents a great quantity of small cracks. Fig. 16 shows the fracture surface of specimen #9, tested with the same slot, but with a previous 5% plastic deformation and a temperature of 325 °C during 24 h. The central fibrous area disappears almost totally; only circumferential waves are observed in the propagation direction.

Fig. 15. Fracture surfaces in the case of notched tensile specimens.

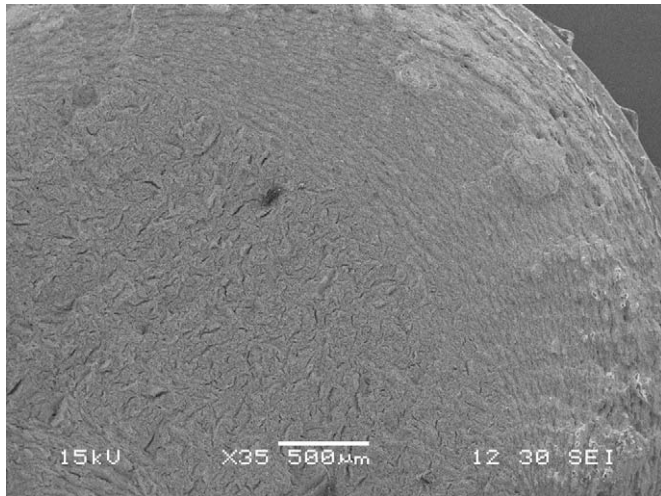
Fig. 16. Fracture surface of specimen #9.
