Root causes of fire in a solvent pipe at a petrochemical plant

J.L. Otegui^{a,*}, P.G. Fazzini^b^a INTEMA – University Mar del Plata – CONICET, J.B. Justo 4302, (B7608FDQ) Mar del Plata, Argentina^b GIE S.A. Galicia 52, (B7608AUB) Mar del Plata, Argentina

The root causes of a leak followed by a small fire in a 2 in. solvent pipe in a Petrochemical Plant are discussed. The fire occurred during blanket heating to 300 °C to dissolve polymer clogs. Fractographic and metallographic analyses showed that the failure is characterized by intergranular through the thickness propagation of longitudinal cracks initiated at the outer pipe surface. This cracking mode is called r-type cavitation. The leaking solvent self ignited, polymer deposits inside the pipe carbonized, microstructure changed. All these indicate that pipe temperature during blanket heating reached 550 °C, much above the specified 300 °C maximum. At this temperature yield strength of the pipe material got below nominal hoop stress due to normal internal pressure. The failure of the temperature control system in one of the heating blanket sets was the main event that caused the fire. However, other conditions and exceeded bar

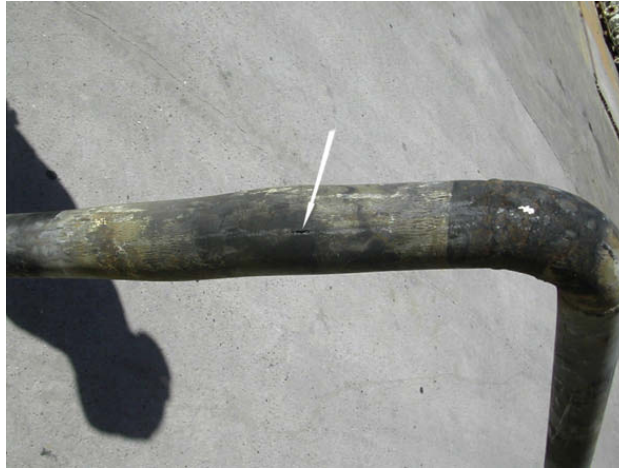
Fig. 1 shows the failed section of the pipe, the leak is indicated by a white arrow. The solvent inside the pipe leaked in the heated section and self ignited, creating a fire jet that ended quickly.

Fig. 1. Failed section of the pipe.

Visual evidence seemed to validate this initial hypothesis. Fig. 2 shows the failed section, after cleaning. A ½ in. long longitudinal crack is very open, this is the origin of the leak that produced the fire. The figure also shows a colony of many other although smaller longitudinal cracks. Noticeable in Fig. 1 is also the large increase in diameter in the affected region. Diam-

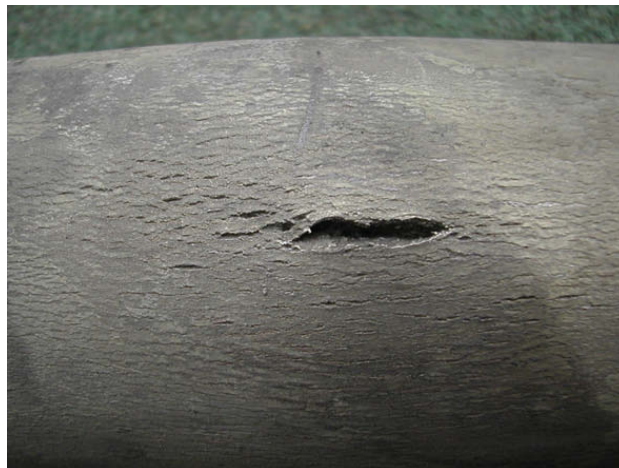
Fig. 2. Failed section of the pipe after cleaning.

eter mapping showed maximum increase in diameter of (around 20%) over a length of around 5 in., where all cracks are located. The rest of the pipe does not show apparent distortions.

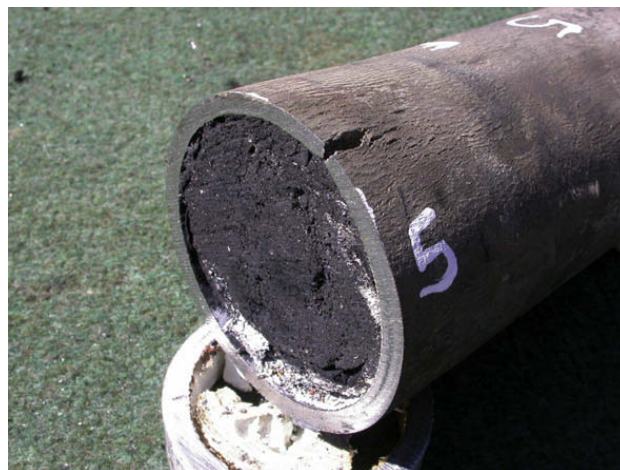
Cross-sections were cut at different locations, including the failure place, and samples identified. The inside of the pipe revealed diverse degrees of clogging, depending on the section. Fig. 3 shows that at the failed section the polymer clog is carbonized, while at other sections the clog remains white, see for example Fig. 4. The carbonized PE region spans a 500 mm length of pipe. The clog is layered, revealing different stages of deposition. The clog revealed soft and porous. Pneumatic tests revealed that most sections do allow the passage of low pressure air. There is also evidence of solvent flow during the heating process.

Fig. 3. Carbonized polymer clog in the failed section.

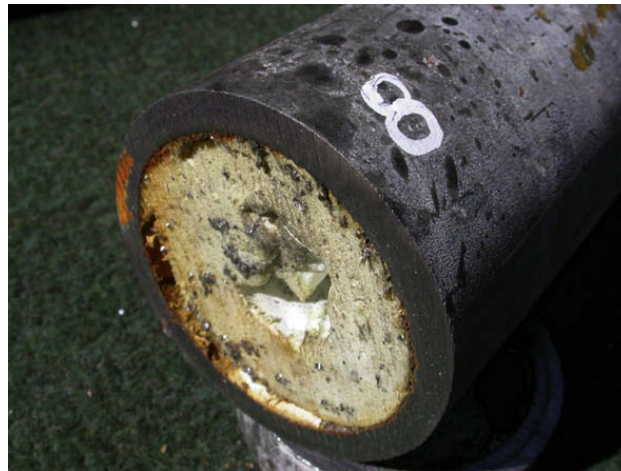
Fig. 4. Not carbonized polymer clog away from the failed section.

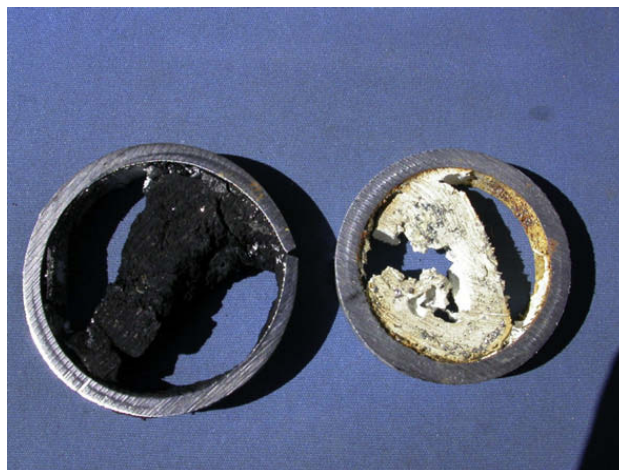
Table 2 shows the results of a diameter and thickness mapping around and far from the failed section. Maximum thickness reduction is more than 40%, and occurs in the failed section. Largest plastic deformations in the pipe material occur in the areas of the perimeter where polymer residue is thicker. This occurs in the failed region (Fig. 3) but also in other sections affected by the heating. Fig. 5 shows sections where polymer residue is thinner.

Fig. 5. Sections where polymer residue is thinner.

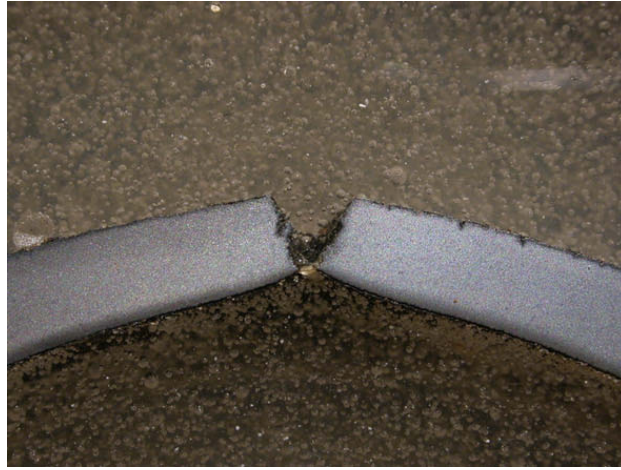
Possible microstructural variations in the failed section, and the size, morphology and orientation of cracks and defects in that region were assessed. Circumferential specimens from each section were polished and Nital etched, as shown in Fig. 6 ($\times 3$). In these and the following pictures, outer diameter is placed at the top.

Fig. 6. Polished and Nital etched circumferential specimen.

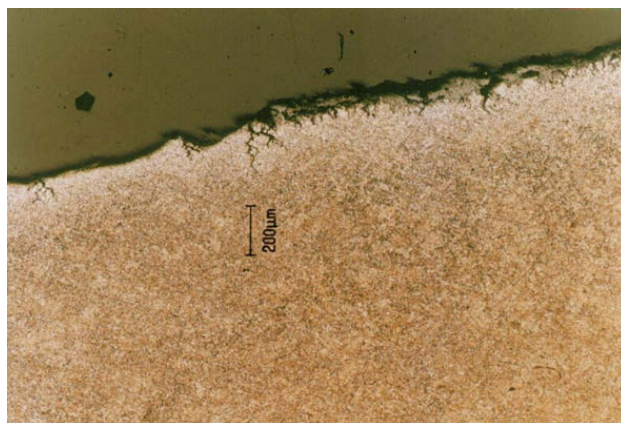
Fig. 7 ($\times 50$) shows the microstructure near the failed section, close to the outer pipe surface. The lighter colour of a 0.2 mm thick subsurface layer indicates severe decarburization; and many branched through the thickness cracks initiate from the outer surface. Fig. 8 ($\times 50$) shows the microstructure near the failed section, close to the inner pipe surface. The darker colour of a 0.35 mm thick subsurface layer indicates severe carburization.

Fig. 7. ($\times 50$) Microstructure near the failed section, outer pipe surface of pipe wall.

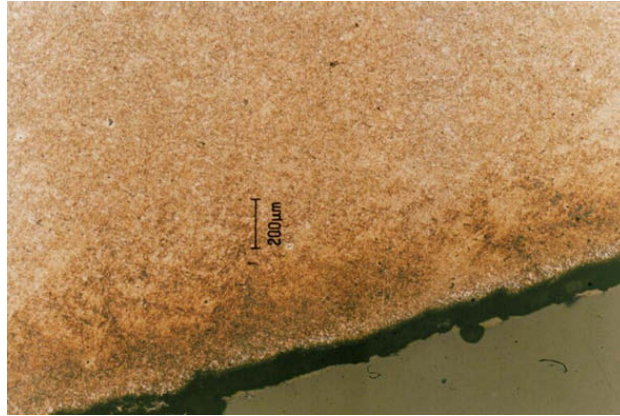
Fig. 8. ($\times 50$) Microstructure near the failed section, inner pipe surface of pipe wall.

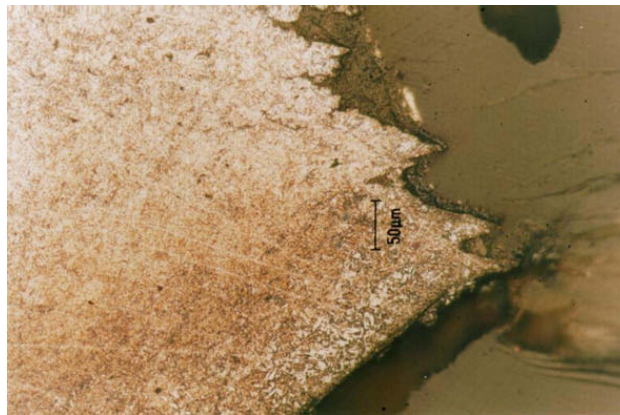
Fig. 9 ($\times 200$) shows the thickness crack that led to gas leakage and fire. Near the inner pipe surface, grains are elongated, indicative of large plastic deformations, while near the outer surface crack path is intergranular. Fig. 10 ($\times 200$) shows details of the other side of this crack, near the outer pipe surface. Note the intergranular path, many small secondary embedded intergranular cracks are seen at both sides of the main crack.

More detail of the intergranular nature of the main crack and the secondary cracks in the mid thickness of the pipe wall is seen in Fig. 11 ($\times 500$). Note the mostly ferritic microstructure, which is representative of most of the thickness. This contrasts with the acicular microstructure in the carburized layer close to the inner wall (Fig. 9).

Fig. 9. ($\times 200$) Crack that led to gas leakage and fire.

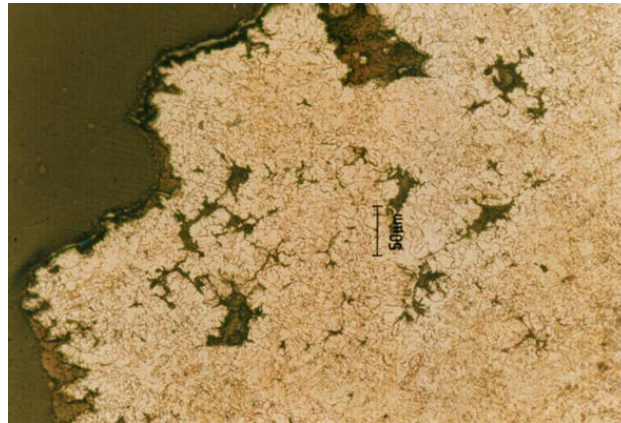
Fig. 10. ($\times 200$) Secondary cracks, wide open, near outer pipe surface.

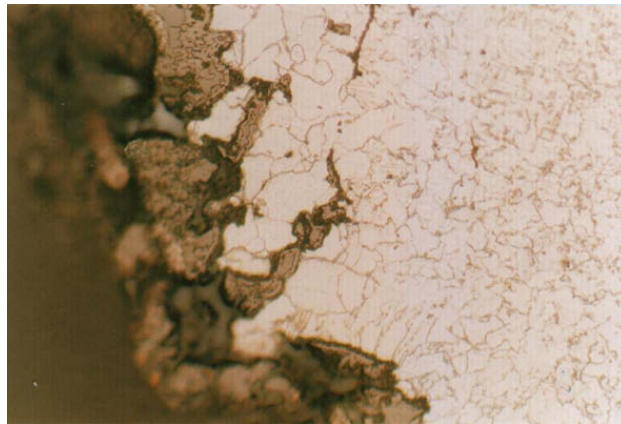
It is concluded that the leak was produced by the intergranular propagation of a crack initiated at the outer, decarburized surface of the pipe. This was only one of the many intergranular cracks initiated in that surface, other similar cracks in different stages of development are seen for instance in Figs. 3 and 7. These secondary cracks have depths ranging from 0.1 to 0.5 mm, but most of them span the decarburized surface layer.

Fig. 11. ($\times 500$) Detail of intergranular nature of the main crack.

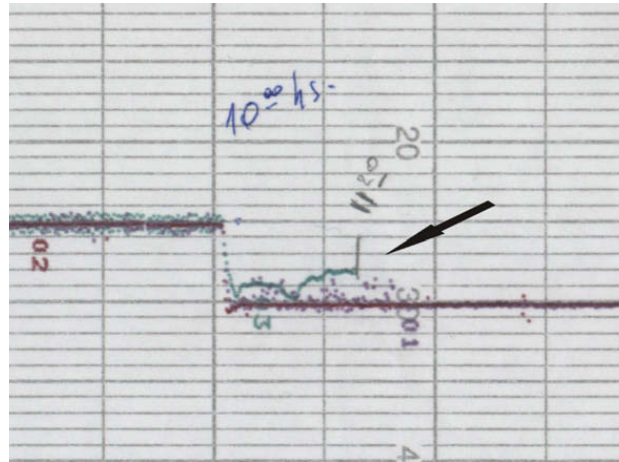
Heating of the pipe was achieved by means of blankets placed in tandems of three, each tandem is controlled individually. Temperature is controlled by one thermocouple in one of the blankets of each tandem, outputs of every three thermocouples are plotted together. Fig. 12 shows the temperature evolution indicated by three thermocouples, the readings of the thermocouple involved in the failed section is indicated by an arrow. Note that scatter is very low in the one channels, while dots are somehow more scattered in the other two channels. After a stepped temperature increment, at 10:00 AM the specified maximum temperature of 300 $^{\circ}\text{C}$ was reached. Fig. 12 shows that the thermocouple at the failed tract starts an erratic behaviour shortly after 10:00, and at around 11:20 dots disappeared. Heating, however, continued.

At the moment of the break the section withstood 14 h of heating, but maximum temperature at the failed section is uncertain. Plant information is that these blankets are designed for standard heat treatments, and can reach temperatures near 1000 $^{\circ}\text{C}$.

It is clear that it cannot be ensured that the failed section was kept at the specified maximum temperature of 300 $^{\circ}\text{C}$.

Fig. 12. ($\times 200$) Temperature evolution during blanket heating.

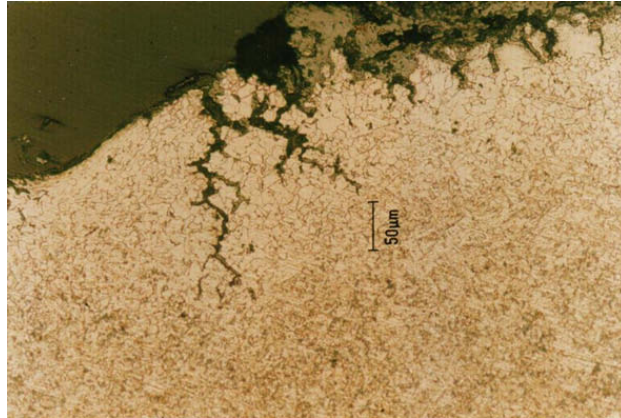
The failure under study occurred due to an excessively high temperature, which put the material into a very brittle condition at a temperature below recrystallization. The material strength dropped dramatically, and the failure mode became intergranular crack propagation, in a mode called r-type cavitation. The excessive temperature is most probably the result of the failure of the temperature control system of the blanket sets.

Fig. 13. Case under study, r-type cracks aligned normal to the tensile stress.
