## Engineering Failure Analysis

## Failure analysis of flexible metal hose at compressor discharge

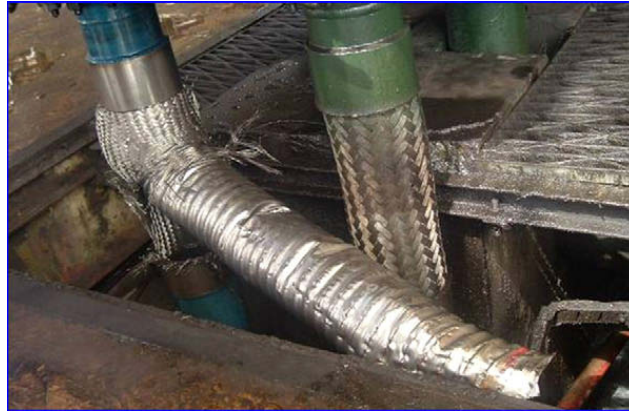
The failed flexible hose is made of AISI 304, has an inner 0.6 mm thick, longitudinally welded, annular corrugated hose of diameter 6 in., covered by a single braid of same material (Fig. 1). The wire of the braid is 0.6 mm diameter. Both ends have sleeves and flange fittings. The failed flexible, identified as “short elbow”, was at the discharge of the propane compressor, working under a maximal pressure of 13 bar (Fig. 2). Two different kinds of braids can be identified in the installed flexible hoses, the difference does not obey to the unlike operational conditions where they are working, discharge an intermediate pressure, but to modifications in braid design introduced by the manufacturer. Both kinds of braids are supposed to be

Fig. 1. Failed flexible hose at the discharge of a propane compressor.

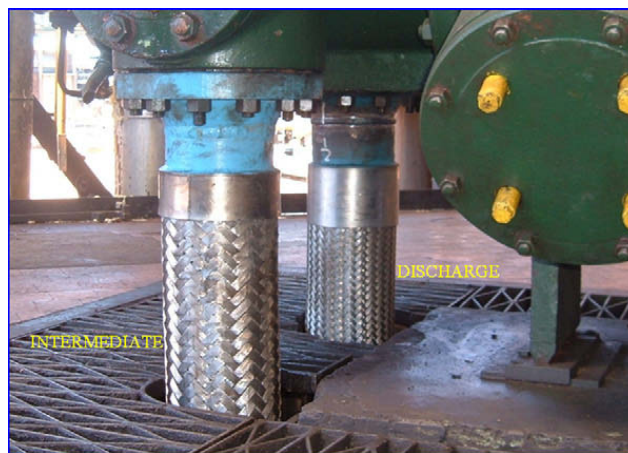
Fig. 2. Replaced flexible at discharge and intermediate pressure.

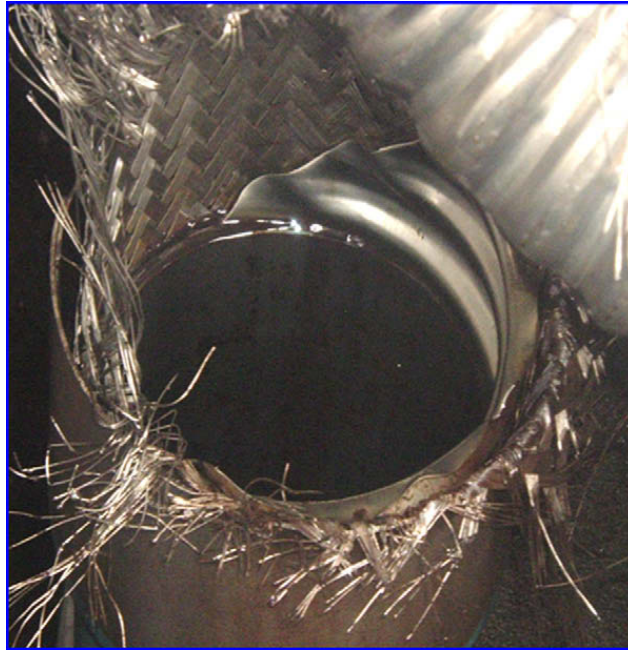
During the failure a mainly circumferential fracture took place, near the lower sleeve. (Detail in Fig. 3). The fracture was branched along partially longitudinal cracks, forming a section that separated from the rest of the tube and is not available for its analysis. This section was probably expelled by the force of the gas during the breakage. At the end of the failure the corrugated hose was straightened, acquiring a length several times the original.

**Fig. 3.** Inner side of intermediate pressure hose, at the final failure place, near the lower sleeve.

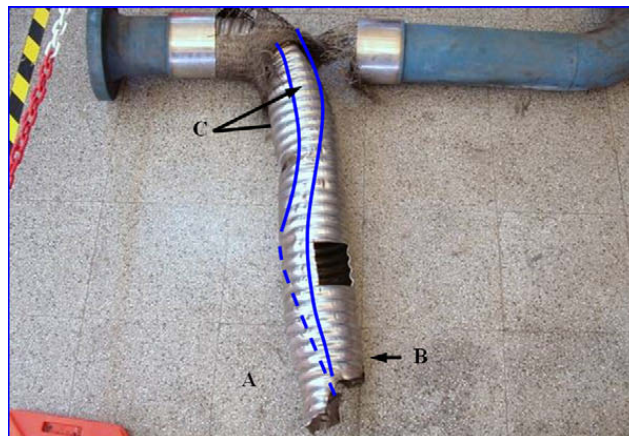
The corrugated hose presents two bands of wear on the outer lobes of the wave, due to contact with the metallic braid, this loss of material generated a local reduction of the thickness, larger than 50%. Therefore, of the initial thickness of 0.6 mm, in some sectors there was only 0.3 mm. The wear pattern is not uniform in all the surface of the corrugated, it is aligned in two longitudinal strips, these strips begin in opposite sides (approximately 180° in the perimeter in the upper end), and join

**Fig. 4.** Wear pattern on the corrugated, scheme of the distribution.

on the outer side of the curve in the lower end (Fig. 4). On the other hand, no contact marks can be seen on the other side of the tube at the same height (Fig. 5, see position B). At the other end, opposite to the burst site, wear is located along two opposite sidebands.

as it is indicated in Fig. 4. The wire braid narrows its diameter as traction is exerted, so it is inferred that the flexible joint worked under slightly compressed condition, hold in that condition by the end fittings. Under those conditions a gap between corrugated and the braid was generated, allowing the formation of a squirm by lateral instability. It had to be stabilized by the wire by means of traction stresses of a sector of the strands, fact that matches with the distribution of the wear in the corrugated and the braid.

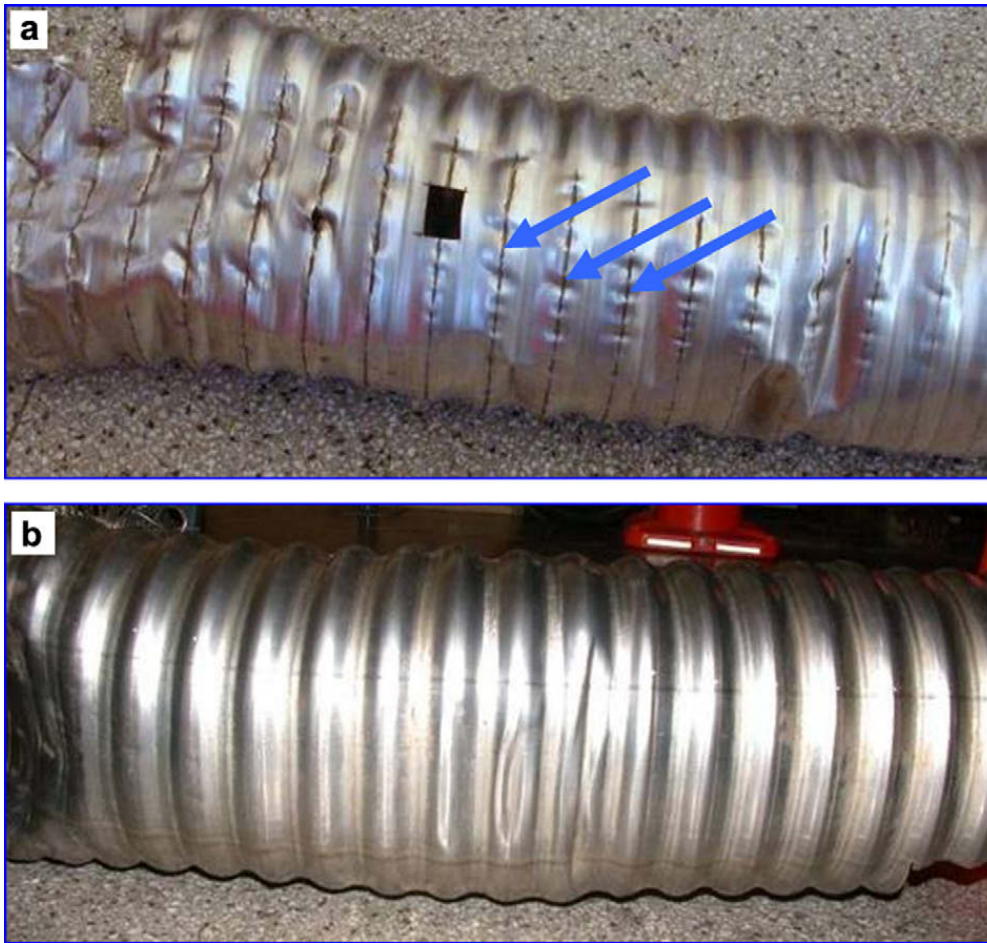
Fig. 5. Severe wear of the corrugate on the outer side of the elbow (a) and no wear marks can be seen at the opposite side (b).

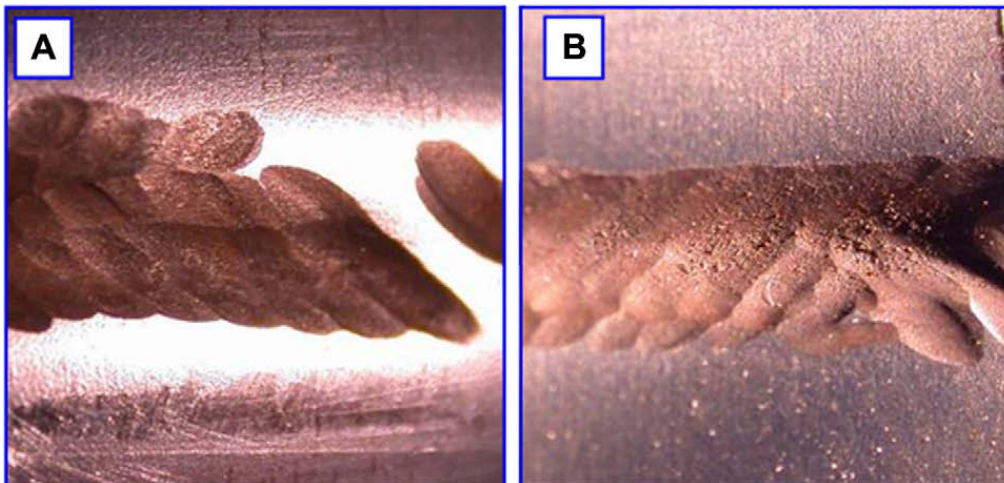
Details of each one of the two samples obtained with rubbing marks are observed in Fig. 6. The marks follow in all cases the pattern of the metal braid. The concavity that is observed in the zone with wear was produced when stretching the lobes of the corrugated.

Fig. 6. Wear pattern on corrugated at the outer side of lobes (approximately  $\times 20$ ).

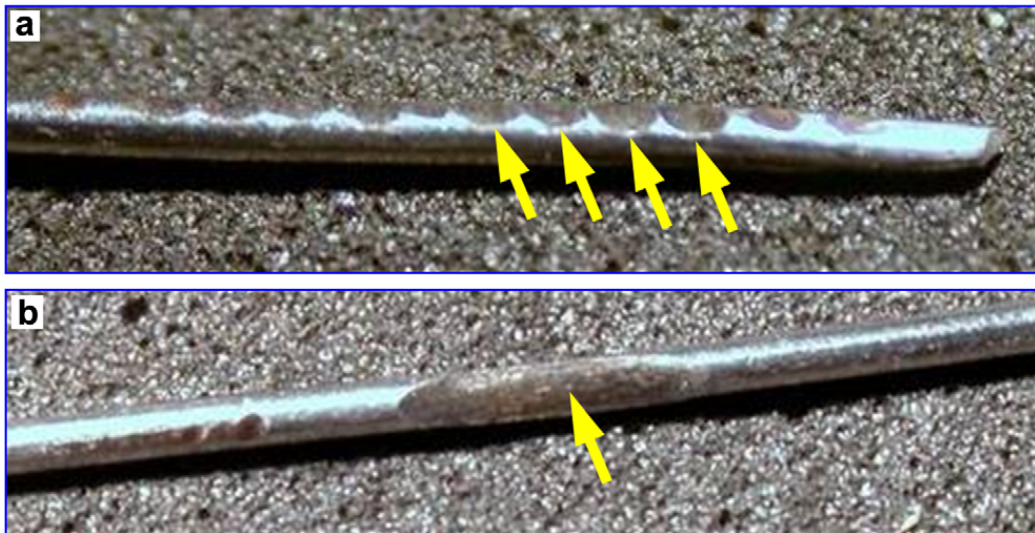
All the samples obtained from wires of the mesh form the zone near the lower ferrule have characteristic wear marks, made against other wires of the mesh (Fig. 7a) and against the lobes of the corrugated (Fig. 7b). All the wires in the zone of the failure of the braid have signs of wear, with a metal loss of more than 50% of their original section [2].

**Fig. 7.** Wear marks on wires produced by other wires (a) and against lobes of the corrugated (b).

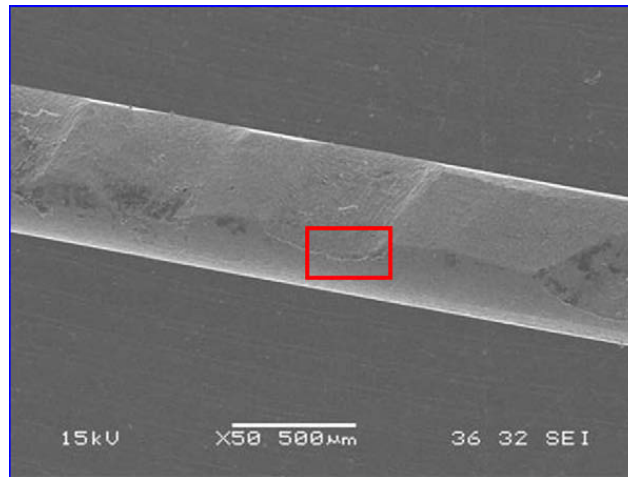
Electronic scanning microscope (SEM) inspection allows defining the nature of wear. The distance between wear marks agrees with the diameter of the wires (Fig. 8 –  $\times 50$ ). When the edges of rubbing marks were analyzed, signs of plastic deformation and striations in the direction of the wire were found (Fig. 9 –  $\times 300$ ). The inspection with larger magnification does not show any evidence of erosion by particles.

**Fig. 8.** Transversal striations on wires of the braid, produced by other wires ( $\times 50$ ).

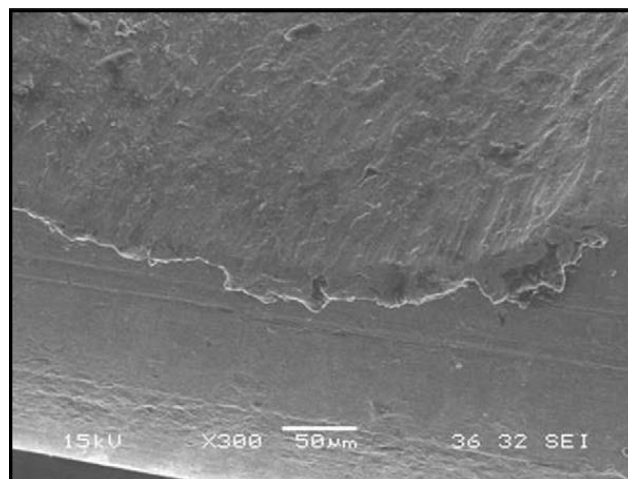
**Fig. 9.** Detail of Fig. 8. Plastic deformation and striation produced by other wires ( $\times 300$ ).

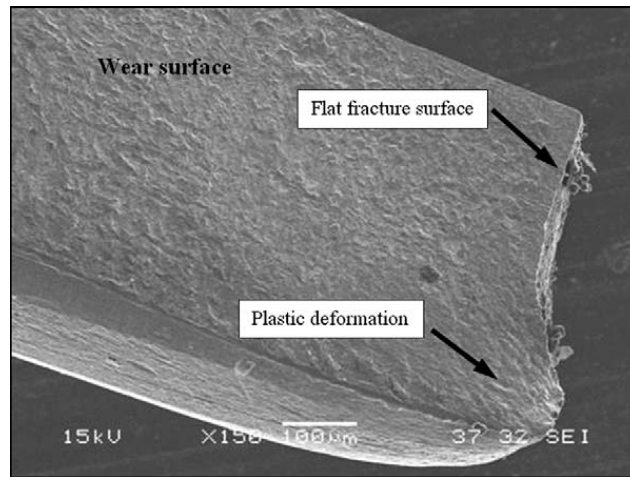
Inspection of the ends of the fractured wires allows determining the failure mechanisms. The analyzed samples all have the same characteristics. All they are cut in a severely worn zone, the fracture front has an area of plastic deformation and a

flat fracture zone (Fig. 10). Fig. 11 shows a front sight of the fracture zone on another sample. The areas present are the same in all samples.

Fig. 10. Wire of the failed zone ( $\times 150$ ).

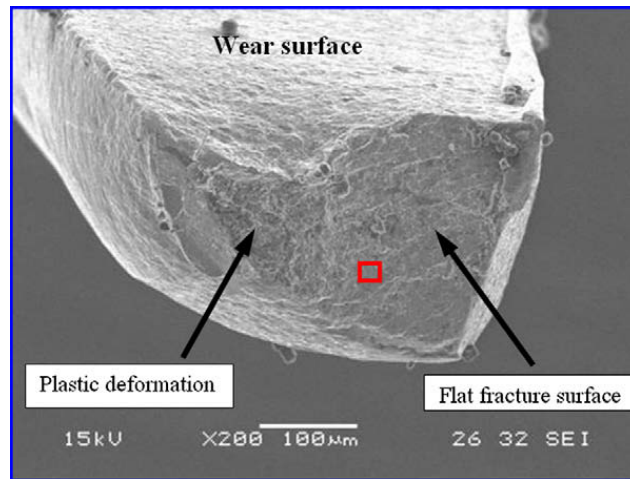
Fig. 11. Micrograph of a wire tip, with the same characteristic parts as in previous samples.

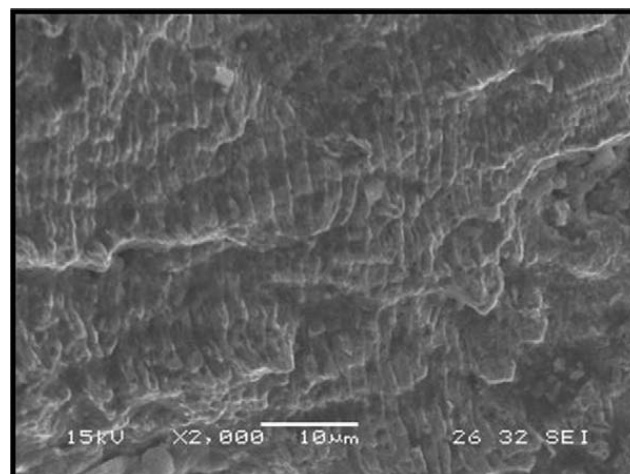
A larger magnification of the squared zone in Fig. 11, in the front of flat fracture, shows striations characteristic of fatigue crack propagation (Fig. 12) [3]. Striation spacing is 1–2  $\mu\text{m}$ , the crack advances from right to left in the figure. Near the initiation zones this spacing is reduced approximately to one fifth, so it is more difficult to appreciate. In austenitic steel, the

Fig. 12. Detail in Fig. 11. Fatigue propagation striations on the flat fracture surface.

fatigue propagation mechanism generates typical striation marks, indicative of the advance of the crack due to the action of in service cyclical stress [1].

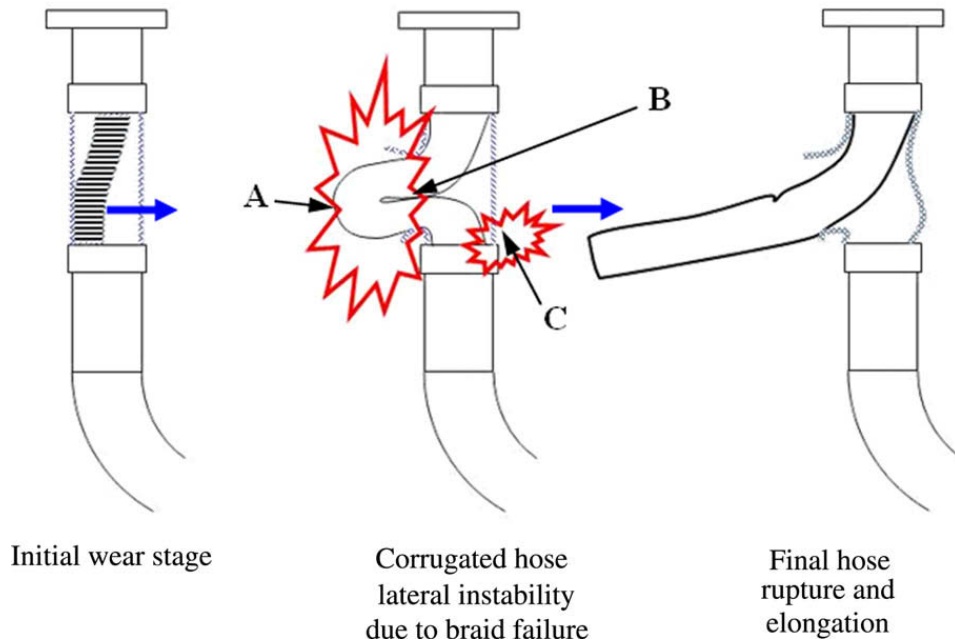
Fig. 13. Failure stages and corrugated hose deformed areas in correspondence with them.

The failure mode can be defined as wear of the braid and the corrugated hose. Wear lead to a section reduction over 60% in some parts of the braid, so it failed by overload of the remaining ligament. The wear was produced by rubbing between the braid and the corrugated tube. This abrasion can be seen in well defined areas and unequally distributed in the perimeter of the tube, being particularly severe in zone A of Fig. 13, as detailed in the description of the wear areas. In the final instances of the failure the corrugated tube produced a squirm towards the outer side of the curve, outside the mesh that could not contain it, producing the elongation of the corrugated.

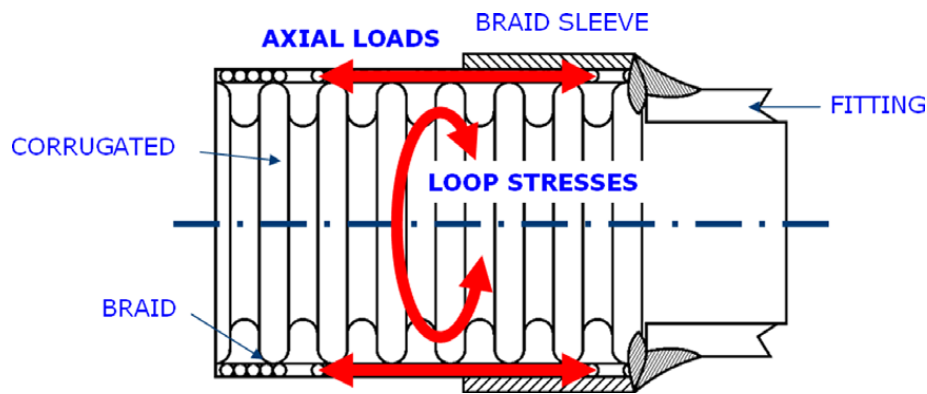
In flexible connections with metallic braids, the corrugated must have enough section to resist the hoop stress generated by internal pressure, but it does not oppose any rigidity to the axial loads, reason why these loads are mainly supported by the covering braid (Fig. 14).

Fig. 14. Main stresses on braid and hose.
