Engineering Failure Analysis

Common root causes of recent failures of flanges in pressure vessels subjected to dynamic loads

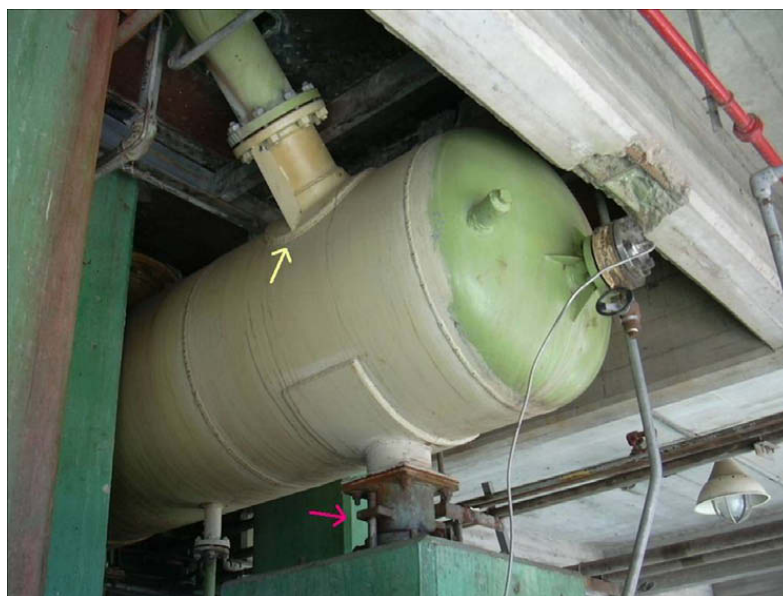
Leaks developed where indicated by white arrow in Fig. 1, at the end of a longitudinal reinforcement of the pipe inlet. Pipe and reinforcement are 6.7 mm thick, saddle and vessel are 12.8 mm (design thickness of the vessel shell was 9.5 mm). Excess heat input caused undercuts in HAZ of the thinner plate. Brittle HAZ developed from too high cooling rates in saddle material. Discontinuous fillet welds were specified for the vertical reinforcement of the pipe inlet, these welds created high stress raisers at the ends of weld, and especially at the end of the reinforcement plate.

Fig. 1. Case 1: Elastics supports of discharge vessels.

The spring-loaded supports located at the bottom of the vessel (grey arrow in Fig. 1) include frictional dampeners, which showed indications of excessive wear. All signs of malfunction are consistent with the excessive weight of the vessel, due to being much thicker than designed.

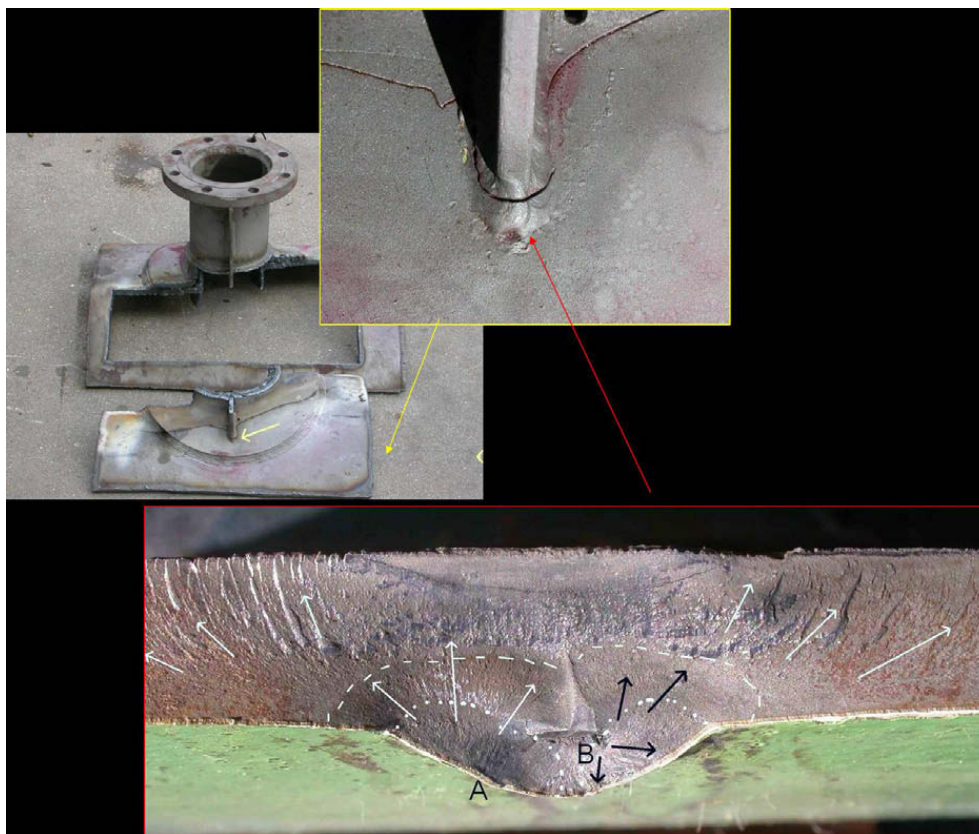
The crack initiated at the root of the fillet weld, and grew parallel to the surface of the vessel wall, on the outer surface of the saddle, see Fig. 2a–c. The crack path followed the weakest section in the fillet weld, near the end of the reinforcement of

Fig. 2. The cracked area.

the pipe inlet, in the coarse grained HAZ of the saddle plate. The white arrows in Fig. 2c schematically indicate the direction of crack advance. The fracture surface shows the typical flat morphology indicative of propagation by mechanical fatigue. Very delicate and spaced beach marks are observed, indicating that the amplitude of the cyclic stresses were mostly constant during the whole crack propagation process.

Crack propagation was due to small amplitude stress cycles, during a very large number of cycles. A change in the roughness of the fracture surface is apparent in the upper part of the crack in Fig. 2c, with a river pattern marks parallel to the crack growth direction, indicative of faster crack growth. The fracture surface grows inclined with respect to the thickness, along the perimeter of the vessel, with a butterfly wing shape that completely penetrates the thickness of the saddle and partially penetrates the vessel wall. The deepest point of the crack is 92.3% of the vessel thickness, at the position of the weld root. The remaining ligament was of only 1 mm. A gas leak was about to occur if no remedial action were taken.

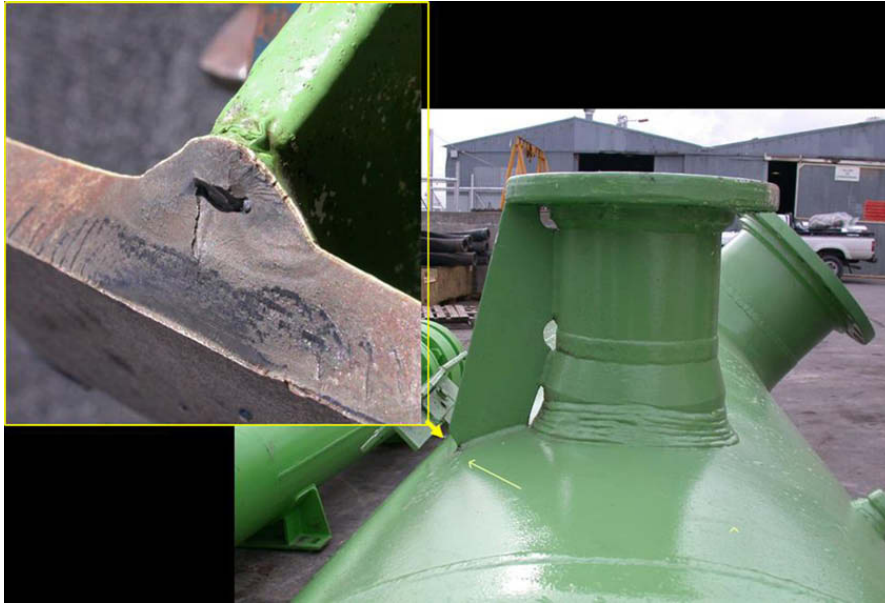
After the first failure, the plate reinforced flange was replaced by a weldolet – type welded flange, see Fig. 3. However, this new flange connection was also built with a lengthwise reinforcement welded with discontinuous fillet beads. A new failure occurred, this time in a shorter time, at the same position, see insert in Fig. 3. As expected, a finite element model of stresses due to dead weight and internal pressure (Fig. 4) shows that the end of the weld between reinforcement plate and saddle is the highest stressed region.

Fig. 3. Welded flange in the second vessel, replacement of the failed vessel.

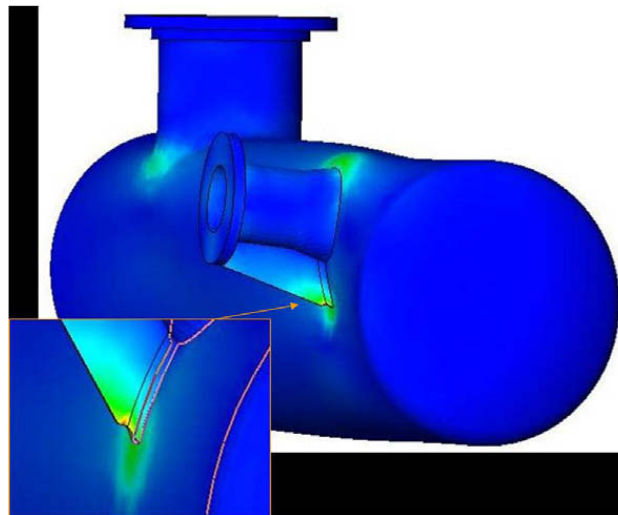
The failure of this partial redesign was due to the incomplete understanding of the stresses that were being generated at the initiation site. The stress concentration at the end of the pipe reinforcement was left unresolved. In this case crack growth occurred solely through the vessel wall, which led to an even reduced fatigue life. This study reveals that:

Fig. 4. Finite element model of stresses due to dead weight and internal pressure.

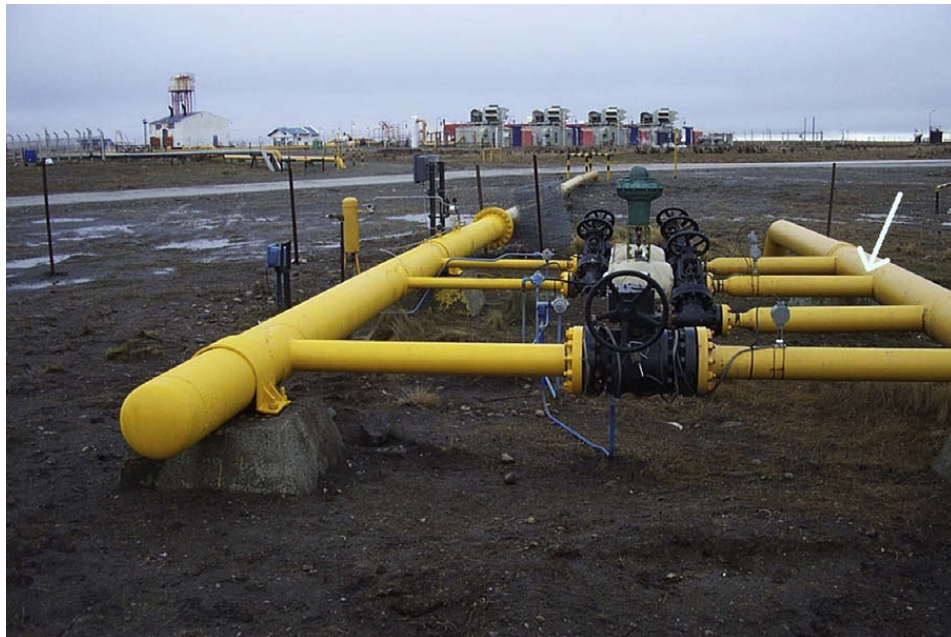
Dehydrated natural gas at 63 bar flows through this discharge piping system at a natural gas turbine-compressor plant [6], see Fig. 5. A longitudinal fracture occurred in the weld joint between a 300 mm (12") diameter collector and a 150 mm (6") diameter venting pipe, see arrow in Fig. 5, after many years of service. Four hours before, discharge pressure of the compressors increased to 77 bar, for less than half an hour. This was due to a faulty valve. The section fractured in

Fig. 5. Case 2: Location of element failed in collector pipe.

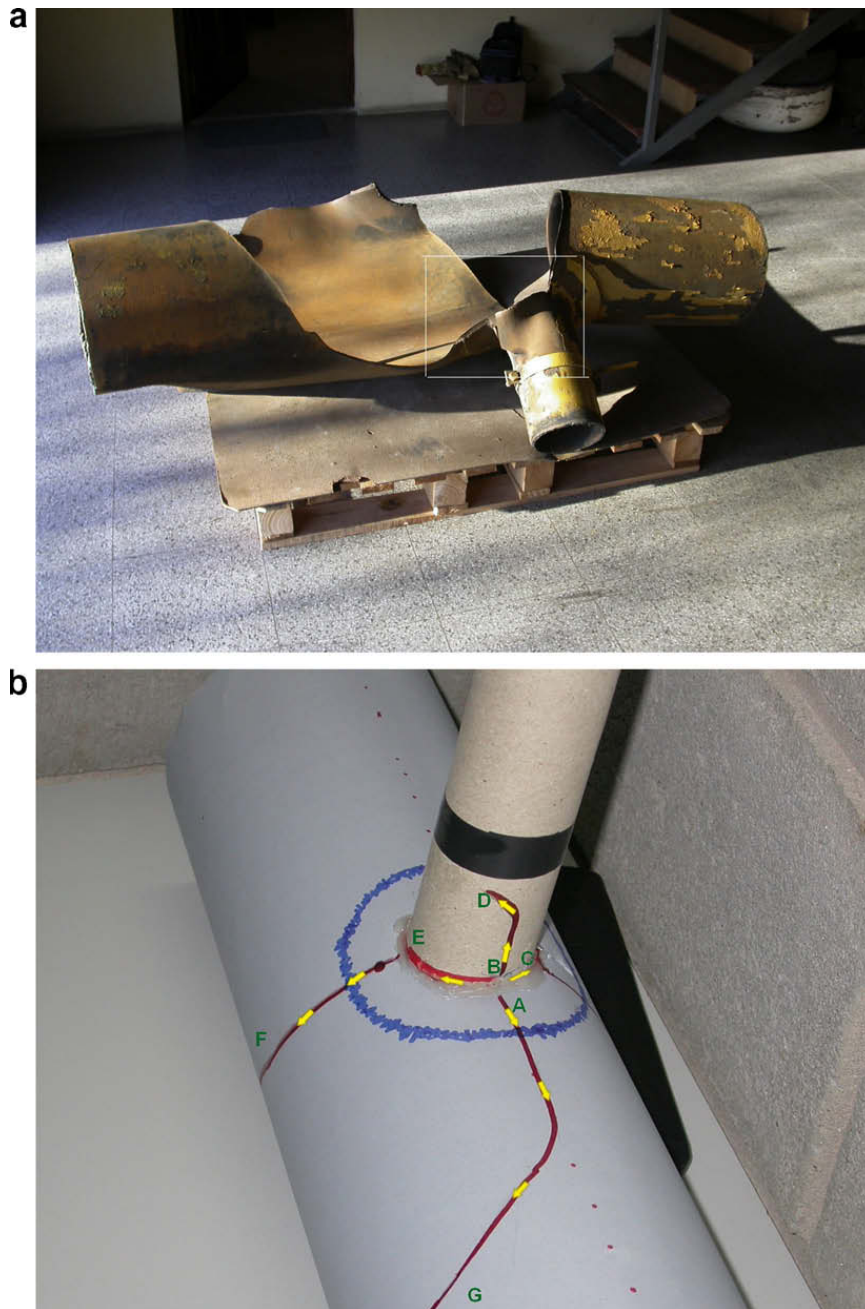
Collector material has a SMYS of 400 MPa, probably an API 5L X56, SMYS for tube material only gets to 312 MPa. The upper end of the tube section adhered to the weld shows around 20% reduction of thickness due to plastic deformation. The root of the tube-to-reinforcement weld shows small tears and fractures that indicate lengthwise traction of the tube. Fig. 6a shows the failed section. The severe deformation after the failure, typical of pressurized gas containers following a blow up, makes it difficult to pinpoint the path for crack growth. The physical model in Fig. 6b allows defining fracture initiation.

Fig. 6. (a) Section 12 of the collector, fractured into two sections. (b) Fracture initiation.

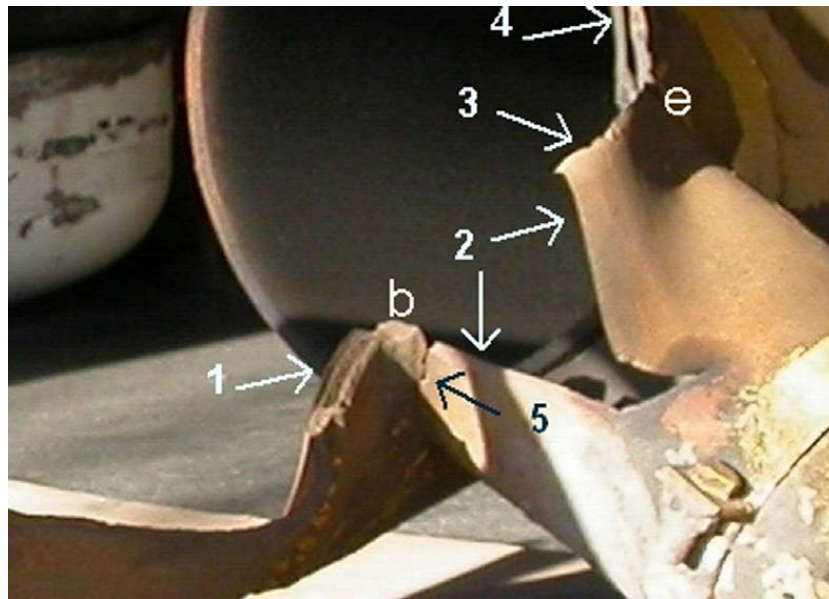
As seen in Fig. 7, "fracture 1" is approximately longitudinal to the collector, and continues longitudinal in the tube. This "fracture 2" becomes circumferential and arrests when coming near to the bolted jacket of the tube, after crossing a distance of 150 mm. The other fracture in the collector is approximately circumferential. This "fracture 4" curves in the weld between reinforcement and tube, and continues circumferential in the tube. This "fracture 3" seems to cross fracture 2 and continues 20 mm, until arresting in tube material. Fracture 1 from point B until the reinforcement-to-collector weld is mode one (tension), ductile with shear lips. When crossing the weld between reinforcement and collector, the fracture is brittle, with chevron marks, see Fig. 8, and immediately becomes ductile again. Fracture 3 (sections B–E), took place in mode three (anti-plane shear), with signs of tear by loads normal to the surface of the plate.

Fig. 7. Details of the zone box in Fig. 6a.

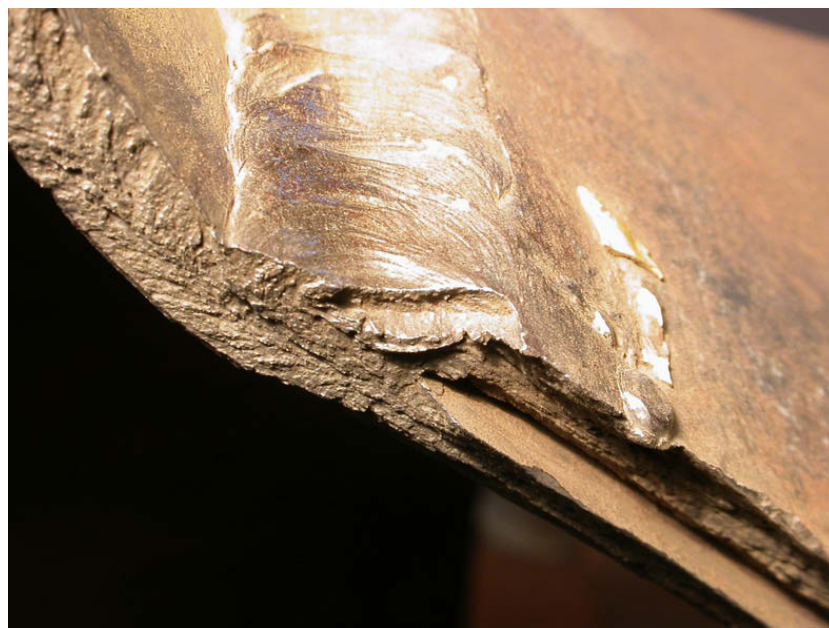
Fig. 8. Brittle fracture with chevron marks in the collector material.

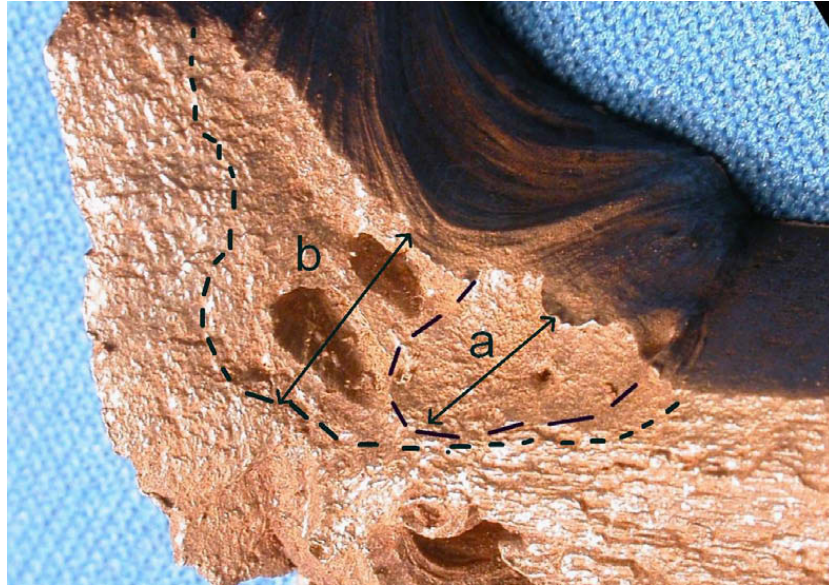
Fig. 9 shows in detail zone B of initiation. Fracture initiation occurred at severe defects in the weld between reinforcement and pipe. Although somehow masked by corrosion, Fig. 9 shows a fish eye type of crack, named 'a' in the figure, which is typical of a hydrogen crack (cold crack during welding). Several pores coalesced to form another small crack, named 'b' in the figure. Fractographic analysis showed that these two cracks eventually coalesced to form a single surface crack, indicated by the dotted line. This first propagation was brittle, coalescence occurred either during the preoperational hydrostatic pressure test, or during the overpressure event.

Fig. 9. Details of Zone B of initiation.

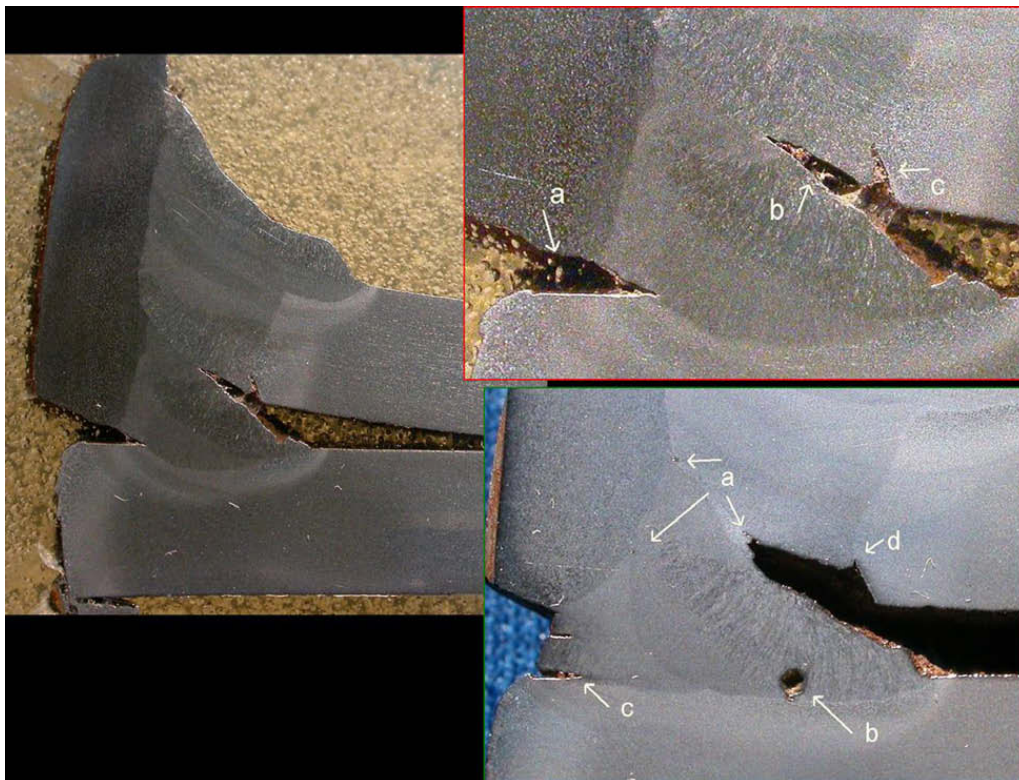
Some of the root causes related to weld defects can be seen in this Fig. 9, but these were not the only construction flaws. The cross sections depicted in Fig. 10, for example, show numerous aspects of weld manufacture that do not match standard quality requirements: large pores, cracks, undercuts, weld toes of different size, etc. The welds between tube and collector and between tube and reinforcement would have to be rejected if evaluated under the requirements of, for example, API 1104, due to the presence of a great amount of large defects [9]:

- The hole in the collector and the tube end were flame cut.
- The tube-to-collector and tube-to-reinforcement welds show great amount of pores and large undercuts.
- The end of the tube does not cross the hole in the collector pipe, but tops its outer surface; this is an error in the design of the joint.
- The fillet weld shows legs of different size, their sections in some cases are below the thickness of the welded elements.
- Arc strike marks were found throughout the surface of the reinforcement.
- The purge hole of the gap between collector and reinforcement was filled with a weld of very bad quality; the weld detached during failure and remained at one side of the fracture.
- The inadequate welding sequence caused craters at weld start and stop regions, and cold cracks.

Fig. 10. Several cross sections of defective reinforcement.

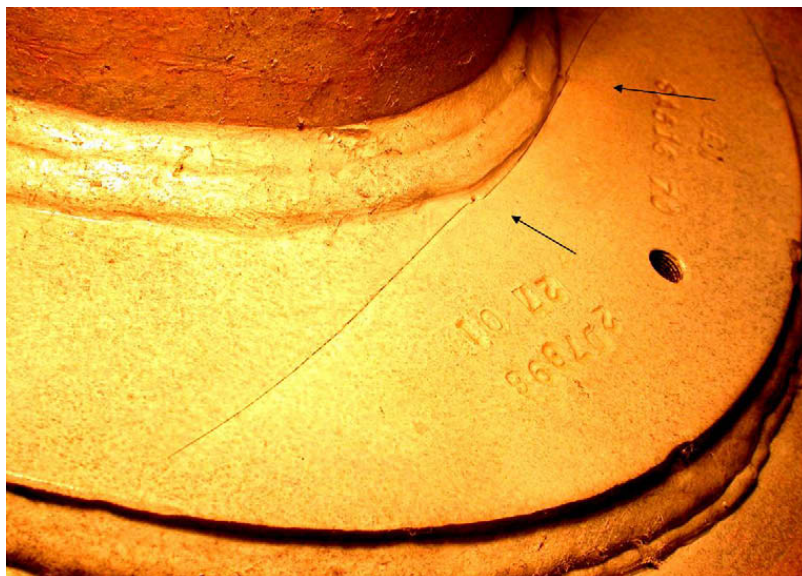
Repeated cracking in plate reinforced welded flanges of several suction vessels in identical natural gas compressor plants presumed design, construction or operation problems [10]. In two of such failures investigated, cracks in the reinforcement saddle of the flange connections were detected before gas leak. Cracks initiate at the toe of the pipe to saddle weld, see Fig. 11, somehow similar to those found in Case 1 (Fig. 2). The root cause analysis of the problem included:

Fig. 11. Case 3: Crack initiation in the reinforcement saddle of the flange in suction vessel.

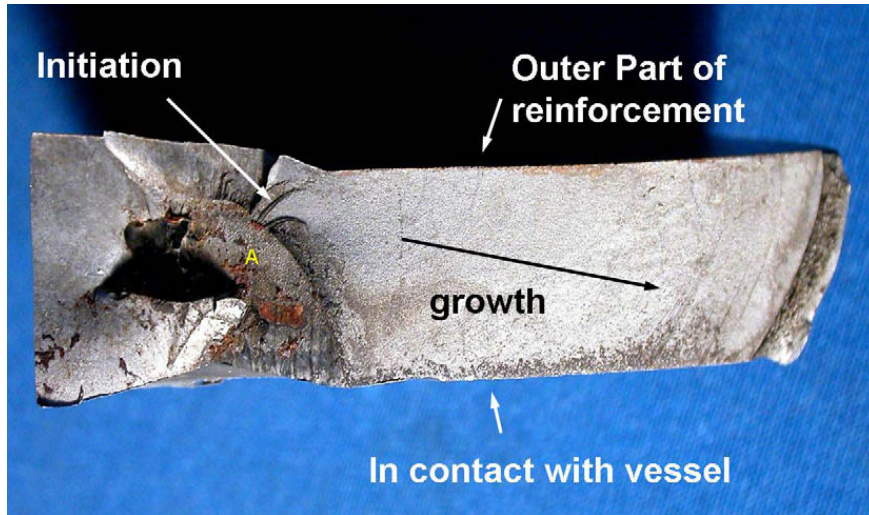
Evidences proved that, as expected, the cracking mechanism was mechanical fatigue, controlled by the cyclic variations of stress in the welded joints, with origin in variations of internal pressure and in dynamic phenomena related to vibrations and pulsations. The two analyzed failures have common characteristics, as depicted in Fig. 12: they initiated in the same zone in both large bottles; in both cases cracks started off large defects in the welds; the quality of the welded joints was found deficient.

Fig. 12. Characteristics of the two analyzed failures in suction vessels.

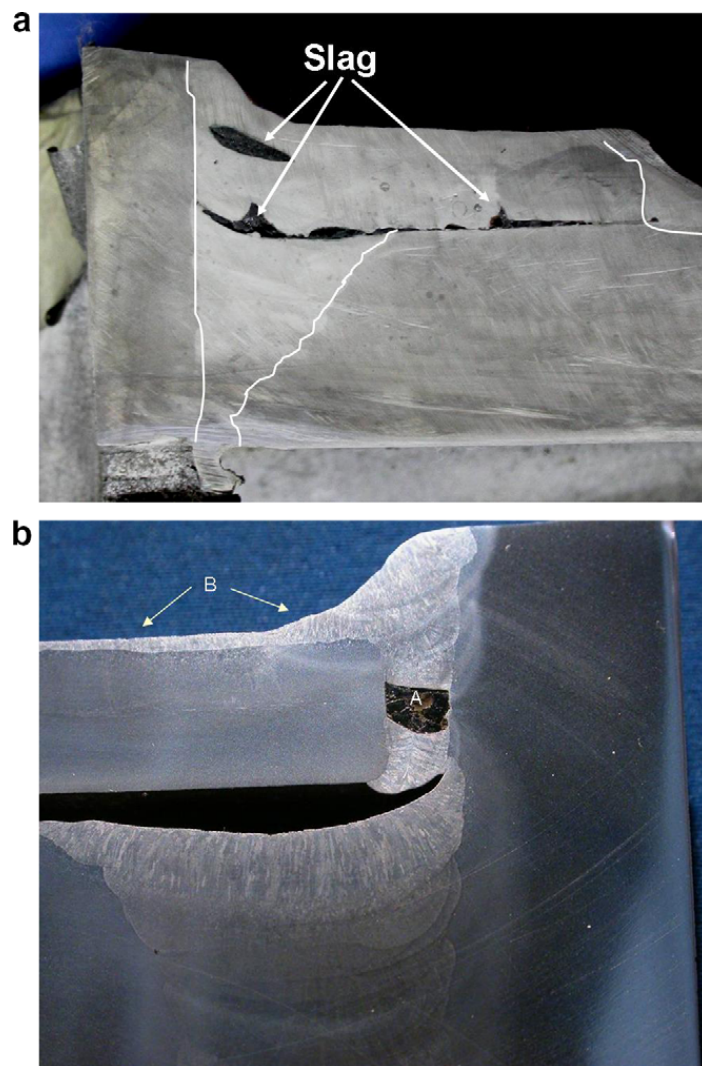
In the outside, the reinforcement looked very well. Since according to ASME VIII Div. 1 these welded connections do not require NDT inspection, embedded defects stayed undetected. Cross sections (Fig. 13a) revealed many weld defects, in one case a weld bead over the entire surface of the reinforcement was made to comply with thickness specification (Fig. 13b).

Fig. 13. (a) Cross section, note slag inclusions and the size of the heat affected region. (b) Further details of the cross section of the reinforcement welds.
