Influence of old rectangular repair patches on the burst pressure of a gas pipeline

Pablo Gabriel Fazzini, José Luis Otegui *

Mechanical Engineering, INTEMA, University of Mar del Plata, Juan B. Justo 4302, 7600 Mar del Plata, Argentina

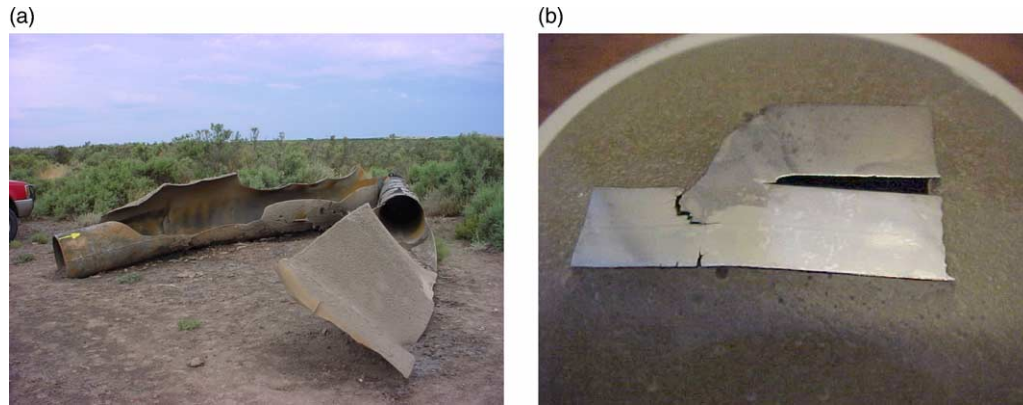
The burst of a 24 in. gas pipeline, which occurred at the beginning of 2002, was initiated by a fillet welded rectangular repair patch, see Fig. 1(a) [1]. The burst was caused by the propagation of two consecutive longitudinal fractures, with a total length of 12 m, separated by two sleeve reinforcements that did not fracture. Crack initiation was related to lamellar tearing at the toe of the longitudinal weld, as shown in the cross-sections of Fig. 1(b) ($\times 10$) and Fig. 2 ($\times 100$). The patch was covering a large microbiologically induced corrosion defect, with a depth of 81% of the wall thickness, located in the bottom part of the pipe. The installation date of the repair is not known. Failure occurred at a pressure of 5.6 MPa, 6% less than the maximum allowable pressure for this line (6.0 MPa).

This failure was clearly related to inadequate design and installation of the repair, the fillet weld was of very poor quality, with severe undercuts. This is not the only patch welded to this particular gas pipeline. Fillet welded patches were widely used in gas and oil pipelines for many years, and several have been found responsible for pipeline failures [2–5]. The most common problems associated with these failures are:

Fig. 1. (a) Burst of a 24 in. gas pipeline, started by a rectangular repair patch. (b) ($\times 10$) Secondary crack initiated at the weld toe of the failed repair patch.

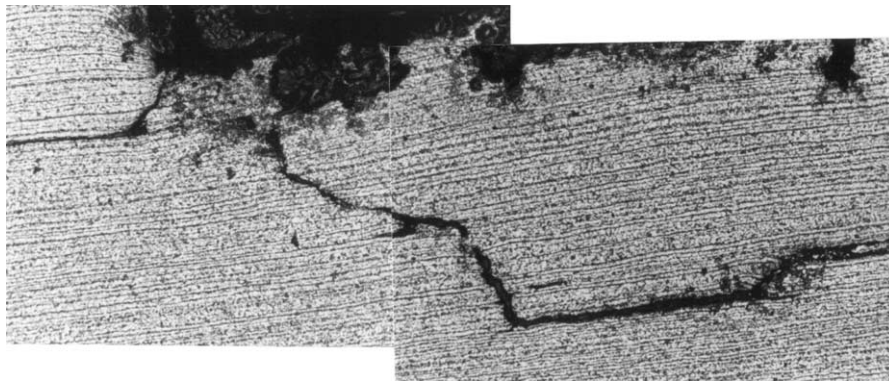
- Very poor through the thickness strength of the old pipe materials, due to severe microstructural banding, high impurity levels and sometimes also lamination defects from aligned non-metallic inclusions (Fig. 2)
- High through-thickness stresses at the toes of the longitudinal patch to pipe fillet welds.
- Welding defects, mostly undercuts and lacks of fusion.

Fig. 2. ($\times 100$) Stepped cracks at weld toes follow microstructural banding.

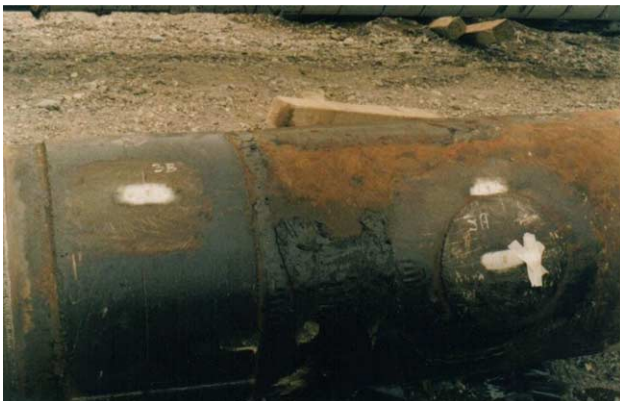
The test on pipe 1, that contained two repairs (Fig. 3), ended after the propagation of a 25 mm long longitudinal crack, initiated at the indentation apparently originated by the friction of a steel wire during the construction or repair of the pipe. Fig. 5 shows a circular patch and the weld repair in pipe 2. The

Fig. 3. Repairs installed in pipe 1: a circular patch and a sleeve reinforcement.

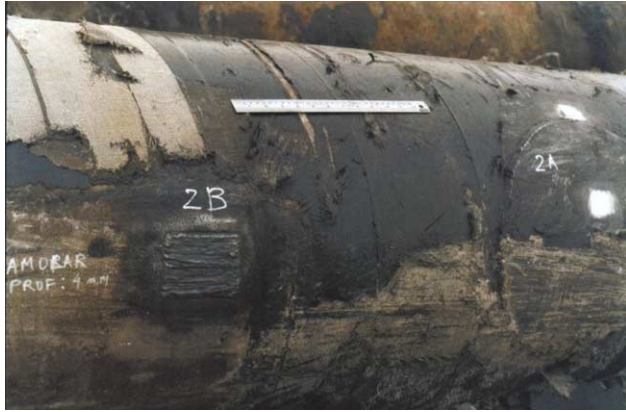
test was stopped when the pressure was almost 13.72 MPa. The square patch in pipe 3, although of poor geometry, did not fail. Final fracture started in a small corrosion defect, located close to the patch but not within the stress field of the fillet welds. Fig. 6 shows the circular patch in pipe 4 (repair 4A), and the fracture that ended the test. Again, initiation of this fracture was not related to the repair.

Fig. 5. Circular patch and weld repair of artificial defect in pipe 2.

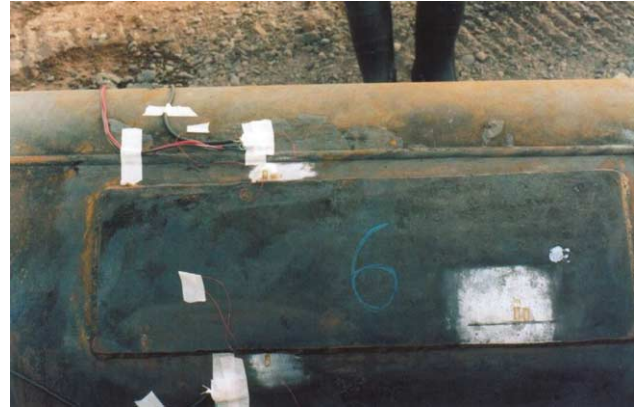
Residual stresses were measured in the rectangular patch placed in pipe 6. Due to its geometry, this patch is the most similar to the one that produced the in-service fracture in 2002. After a longitudinal 2 mm deep groove was cut on the patch surface, a relaxation of 69 microstrain (10^{-6} m/m) was measured. When the groove depth was 3 mm, a relaxation of 97 microstrain was measured. If we consider similar longitudinal and circumferential components of the residual stress field in the patch material, we obtain a residual circumferential stress of 28 MPa. These residual stresses are unexpectedly low, less than 10% of the yield stress of the pipe material.

Fig. 7. Rectangular patch in pipe 6 and its instrumentation.

Residual stresses measured in this patch of pipe 6, the most critical in terms of geometry, are unexpectedly low. The other main factor influencing σ_{emb} is the internal pressure of the pipe at the moment the patch was welded. If the patch is installed with the pipe subjected to a pressure sufficiently near MAOP, a large part of the stresses taken by the patch material is relaxed due to the contraction of the pipe that contains it. If installation pressure is low (less than half MAOP), then the patch is kept strained (and therefore stressed) even after complete pipe depressurization.

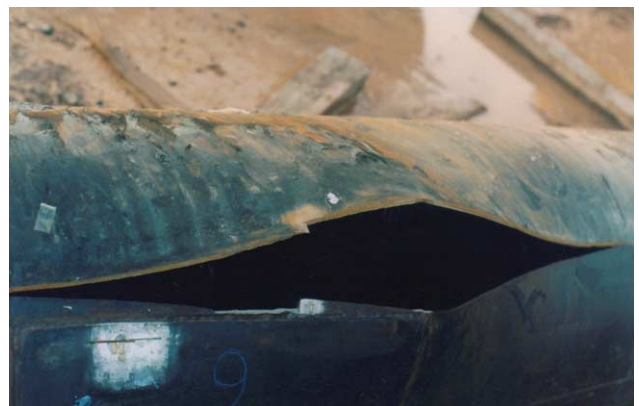
Fig. 8. Final fracture in test of pipe 6.

It is worth noting that the only patch that was directly influencing fracture initiation is the one on pipe 6, this is a long and thin rectangular patch, similar to the one that originated the 2002 failure. All other patches, whether rectangular or circular, did not represent a discontinuity severe enough, and the failures initiated

in other defects. Figs. 8 and 9 show the initiation of the fracture in the corner of the patch in pipe 6, adjacent to the weld toe (site 1). Here we can see a faceted fracture surface, normal to the pipe surface, indicating brittle fast fracture. Later the fracture surface becomes less wrinkled and slants at 45° from the pipe surface, indicating typical ductile crack propagation. As the crack grows it moves away from the weld toe. Near the centre of the longitudinal weld a second initiation is produced. Crack arrest is produced, as in all the tested pipes, following the rapid depressurization due to the loss of water through the fractured area.

A reasonable geometric parameter is to ensure that any patch remaining in the line has the largest dimension in the circumferential direction. This would ensure enough flexibility in the direction where the stresses in the pipe are larger. It is also desirable to eliminate all patches with sharp corners and notches, which would generate strong geometric stress concentrators. Again, these factors have long been recognized, and present repair procedures involving patches recommend the application of elliptical patches, with the longest side in the circumferential direction.

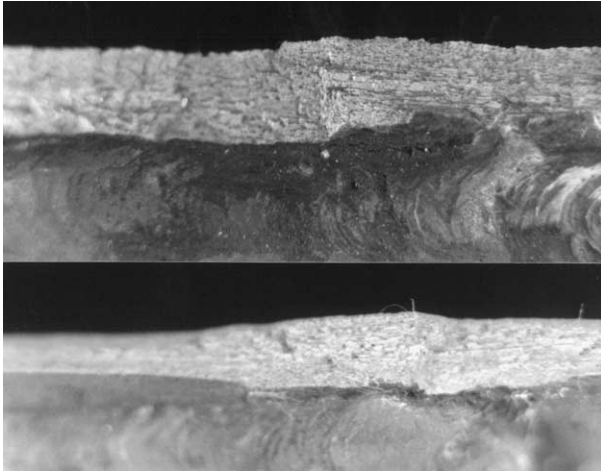
Fig. 9. ($\times 5$) Detail of the fracture in pipe 6.
