Oil well drill bit failure during pull out: Redesign to reduce its consequences

P. Cirimello^{a,*}, J.L. Otegui^{a,b}, J. Martinez Sanchez^c, G. Carfi^a

^a YPF Tecnología S.A., Argentina

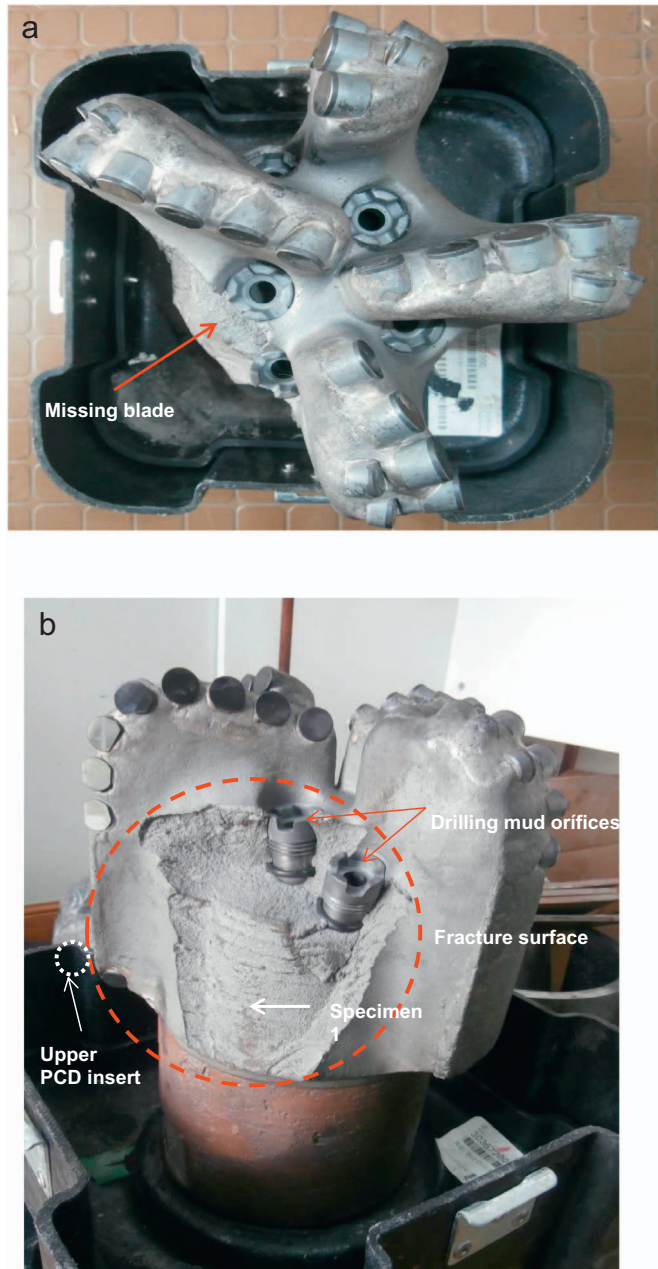
Fig. 1. (a,b) Failed 8,5" oil well drill bit.

An 8,5" oil well drill bit with PDC inserts lost one of its five blades when operating in an oil well, leading to a costly failure (Fig. 1). The drill bit is built around a central tubular, into which a strong metallic body is cast and machined. This body can have

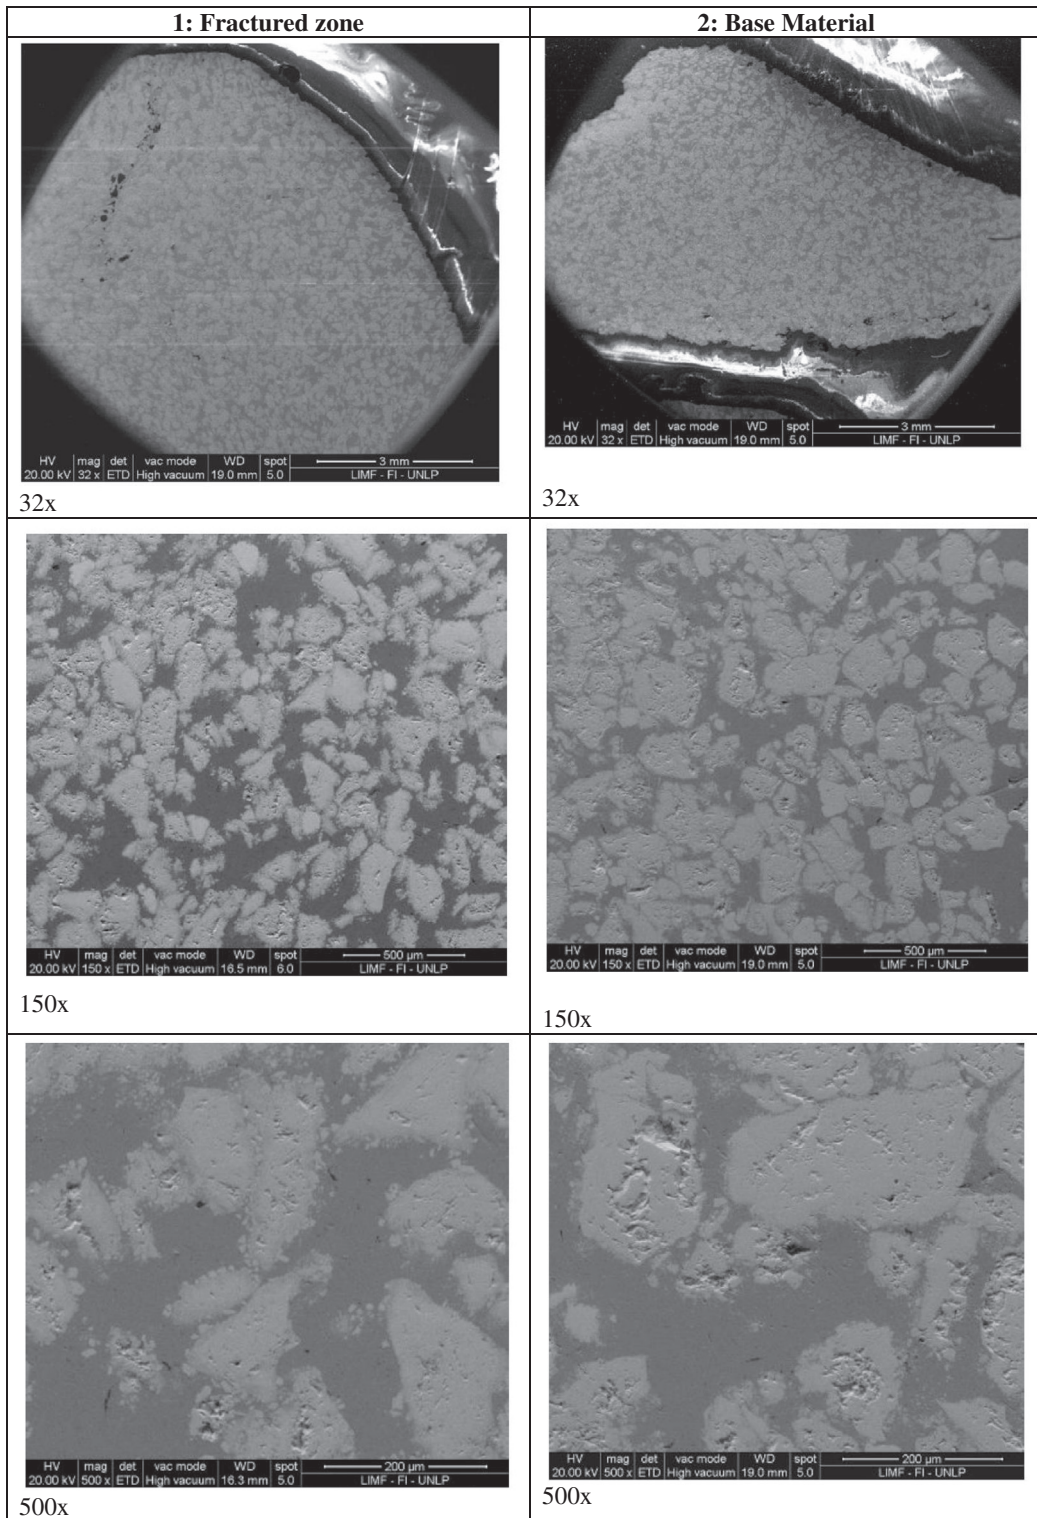
Results from the metallographic analyses of samples 1 and 2 as per ASTM E 3 [13] are depicted in [Fig. 2](#). The drill bit material is a matrix metal (binder) plus a dispersion of tungsten carbides; microstructures are similar in both samples. This design gives a material with high wear resistance but poor impact toughness. An alternative frequently used is a fully metallic base material, which is usually less wear-resistant but tougher.

Fig. 2. Fractured zone and base material microstructures.

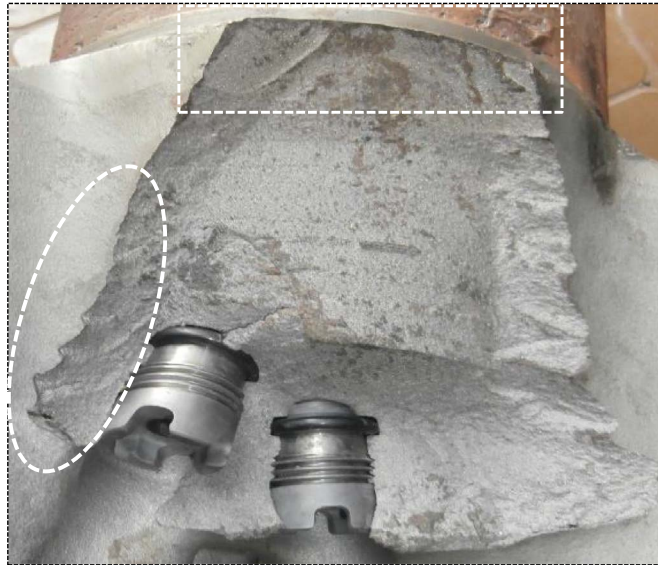
- The edges of the fracture surfaces have sharp, faceted characteristics. The smooth, curved central surface in [Fig. 3](#) corresponds to

the interface between the central tube and the drill bit material applied to it.

- Close to the transition with the tubing (top of Fig. 3) the edges of the fracture surface are straight; the upper part of the fracture shows ratchet marks indicating initiation sites.

Fig. 3. Fracture surface of failed 8,5" oil well drill bit: initiation sites at the top.

- In the area of the lubrication holes (bottom of Fig. 3) there are oscillations, which indicate decay in fracture energy, and thus, represent the last part of fracture propagation.
- The fracture is brittle and symmetrical, which suggests that the failure was not torsional (due to torque), but rather due to traction forces.
- Cleavage rivers (Fig.4) indicate the final fast propagation areas.

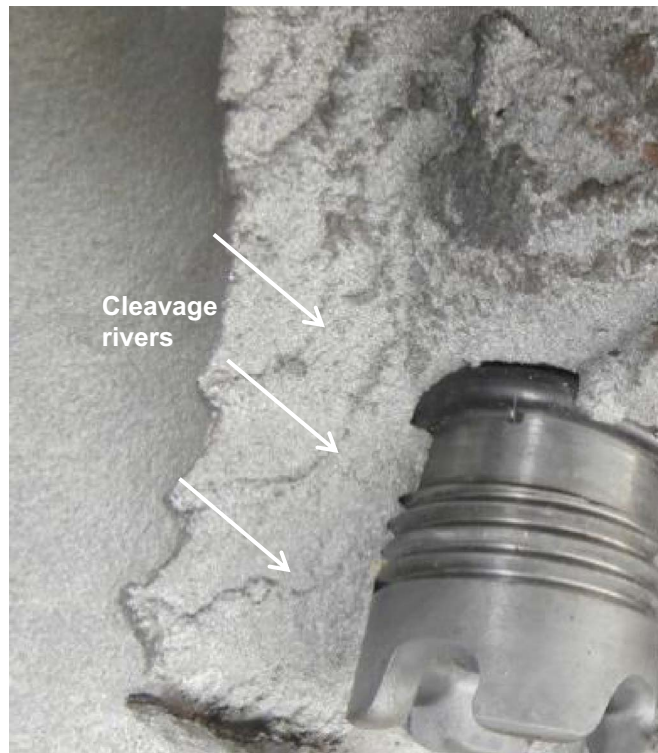
Fig. 4. Fracture surface, cleavage marks in the last part of fracture propagation.

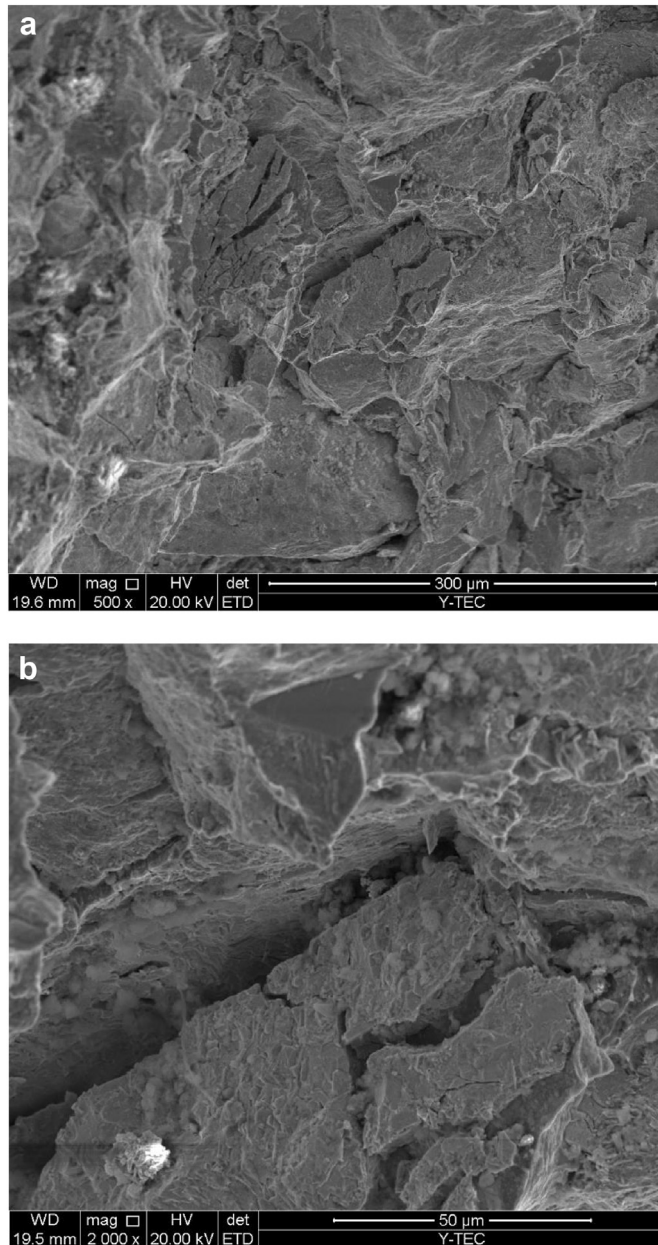
Figs. 5–8 show results from the fractographic analysis by scanning electron microscopy (SEM). Fig. 5 (a: $\times 500$, b: $\times 2000$) shows the fracture surface near crack initiation, at different magnifications. Fig. 6: ($\times 500$), taken half way into crack propagation shows

Fig. 5. (a $\times 500$, b $\times 2000$) SEM fractography near crack initiation.

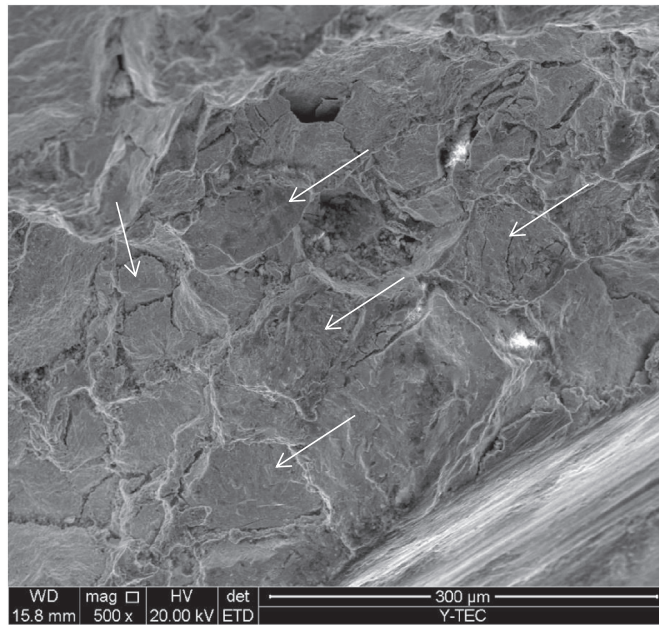
Fig. 6. ($\times 500$) SEM fractography of crack propagation, decohesion of tungsten particles.

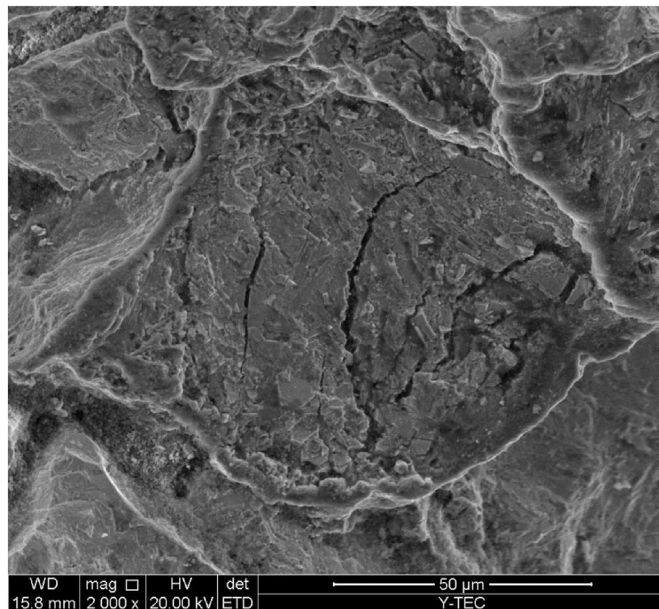
some decohesion of tungsten particles. At a larger magnification, Fig. 7: ($\times 2000$) allows identifying secondary cracks, typically formed as a result of the inability of the collapsed to accommodate lateral contraction as being broken in traction. An even closer look (Fig. 8, $\times 8000$) gives a good image at some neatly defined cleavage planes.

Fig. 7. ($\times 2000$) SEM fractography of crack propagation, note secondary cracks.

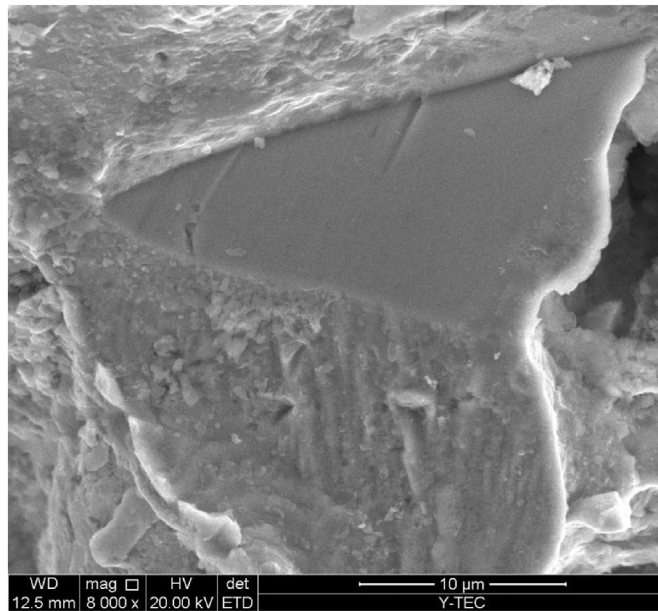
Fig. 8. ($\times 8000$) SEM fractography of crack propagation, note cleavage plane.

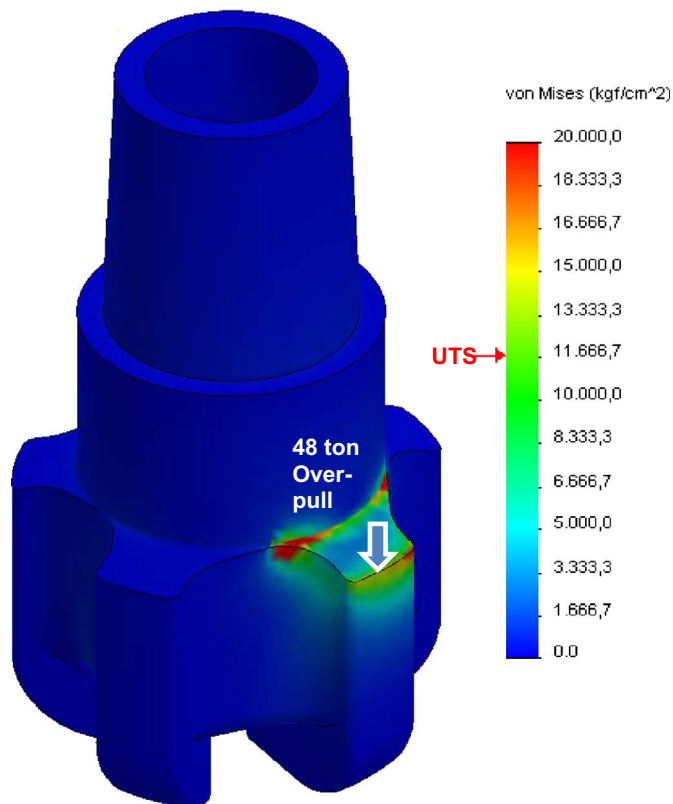
A linear elastic finite element model was performed, in which the 28 ton overpull force defined in in Table 2 was applied to the top of a single blade. This load was applied on the top surface of the blade, as shown in Fig. 9.

The stress map in Fig. 9 shows that maximum predicted stresses are located in the joining radius between the inner tube and the drill bit material, are normal to the trace of the fracture, and located at fracture initiation. Disregarding any load transferred by friction by the other blades, a 28 ton. Overpull load would lead to a maximum tensile stress of 2000 MPa, which is almost twice the breaking strength estimated for the drill bit material (1200 MPa). Therefore it is inferred that the measured overpull load was enough to cause the fracture under study.

Fig. 9. Linear elastic FEM; stresses at failure initiation site due to overpull load.

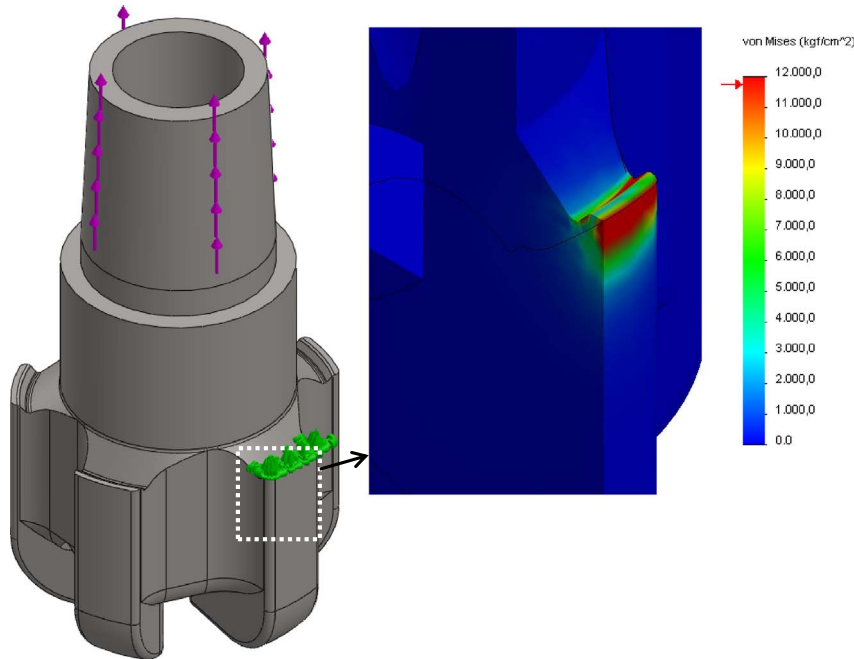
Fig. 10. Proposed redesign, with taper and sacrificial protuberance, maximum stresses localized at “fusible” protuberance.

A stress analysis for this type of piece is shown in Fig. 10. Mechanical loads and constraints are analogous to those that would cause the studied fracture, see Fig. 9.

The proposed redesign includes a tapered upper blade shoulder, on top of which the sacrificial protuberance houses the upper PDC insert. Note that maximum stresses in the case of an overpull impact load as the one that provoked the failure has been reduced to around the strength of the material, and pretty much localized in a plane close to the “fuse” tip.
