Crack detection in prestressed concrete structures by measuring their natural frequencies

G. D. Ercolani, D. H. Felix & N. F. Ortega

Journal of Civil Structural Health Monitoring

J Civil Struct Health Monit (2018)

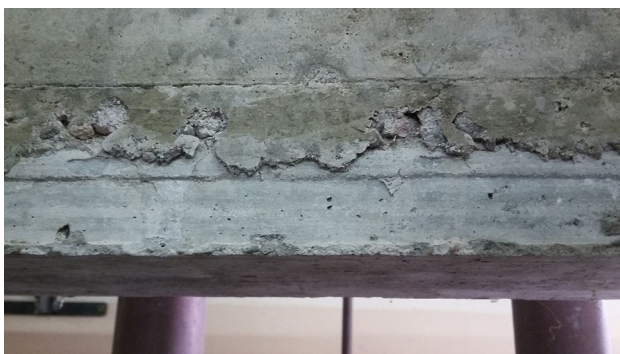
Fig. 12 Zone of the crack in Beam 01 after unloading. The crack is closed and not visible

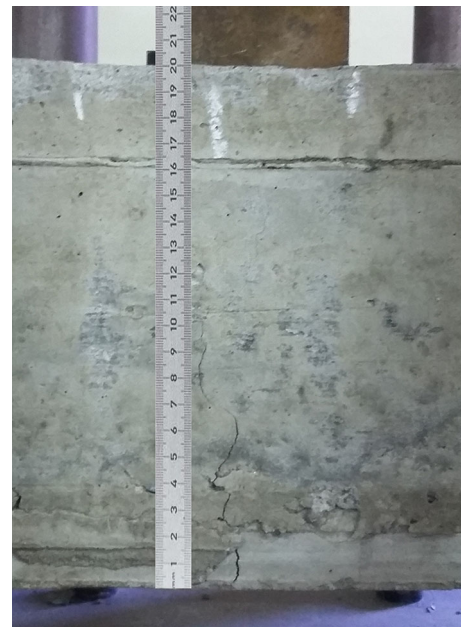
Fig. 13 Crack of Beam 02

On the other hand, for Beam 02, the crack depth was $r = 0.535$ (Fig. 13) and the position $\alpha = 0.80$. Table 1 summarizes the position and magnitude of the cracks for both beams.

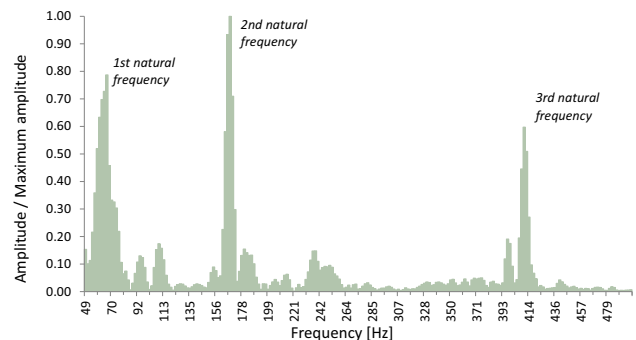
Fig. 14 Frequency spectrum of Beam 01 without damage

After measuring the acceleration in the time domain, this signal was processed by the software “Logger Pro” [25], in which the amplitudes in the frequency domain were obtained through Fourier transform. Thus, the first three natural frequencies of vibration were observed. The frequency spectrums are shown in Figs. 14 and 15 for Beam 01 without damage and that with crack, respectively. It is highlighted that to obtain frequencies up to 500 Hz, it was necessary to use a data acquisition speed of 1000 samples/s, according to the Nyquist [26]–Shannon [27] sampling theorem. The values of the natural frequencies obtained for Beam 01 are shown in Table 2. It can be noted that the second natural frequency was the least changed by the cracking because the crack is close to a node of this mode shape.

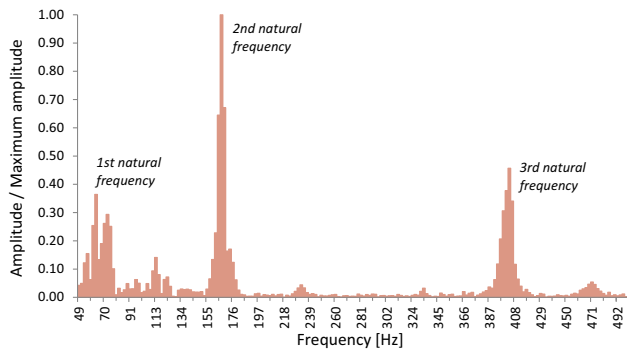
Fig. 15 Frequency spectrum of the cracked Beam 01

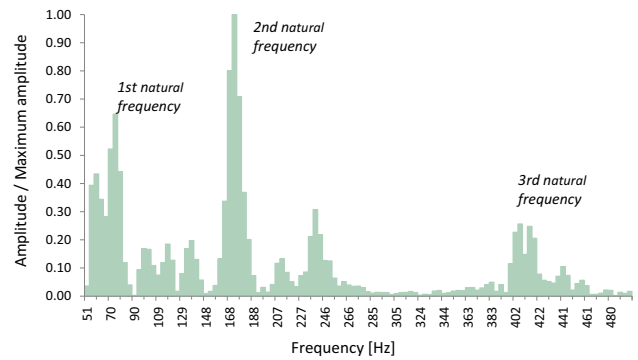
Fig. 16 Frequency spectrum of Beam 02 without damage

On the other hand, Figs. 16 and 17 show the frequency spectrums for Beam 02, while Table 3 shows the values of its first three natural frequencies. In this case, it can be noted that the second natural frequency was the most changed by the cracking, because the crack is close to an anti-node of this mode shape.

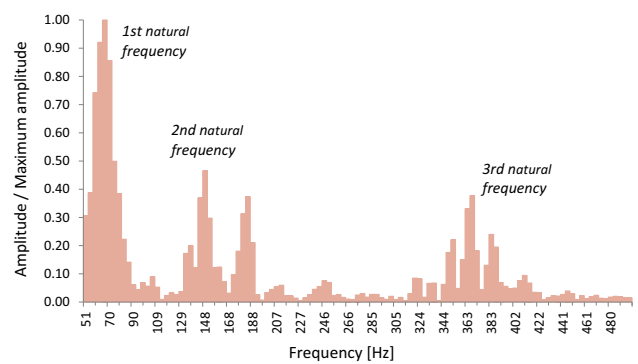
Fig. 17 Frequency spectrum of the cracked Beam 02
