# Wattle and Daub Experimental Workshop: Durability Testing after 14 years of Uninterrupted Use

**Abstract**—An important factor to analyze when studying the useful lifetime of earth constructions is the detection of any constructive pathologies that may occur; an important consideration when building a house; yet in Argentina information on building with wattle and daub is scarce. This paper describes a durability test conducted on an experimental workshop built with wattle and daub technology in 2004, in the city of Mendoza, Argentina. The building has a floor area of 33.63 m<sup>2</sup> (5.70 m x 5.90 m), and houses an experimental workshop for thermal energy research and the construction of solar equipment. During the 14 years that the workshop has been in use, the wattle and daub walls have been exposed to various environmental forces, such as rain, wind, and earthquakes. However, its thermal behavior has remained constant over time, maintaining a difference in temperature of 5.8°C between the inside and outside without auxiliary heating. In general, the construction has been well-preserved and serves the purpose for which it was built, thus proving that wattle and daub const

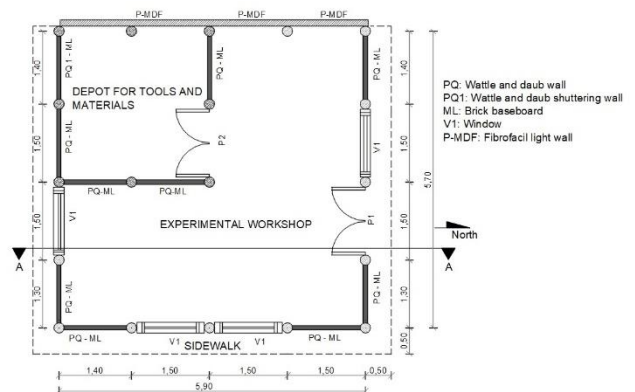
Fig. 6. Experimental Workshop floor plan.

The E.W. consists of an area measuring 5.70 m wide and 5.90 m long. The interior is divided into two sections, one for manufacturing and assembling equipment and the other a depot for storing valuable materials, machinery and tools (see Fig. 6 and Fig. 7).

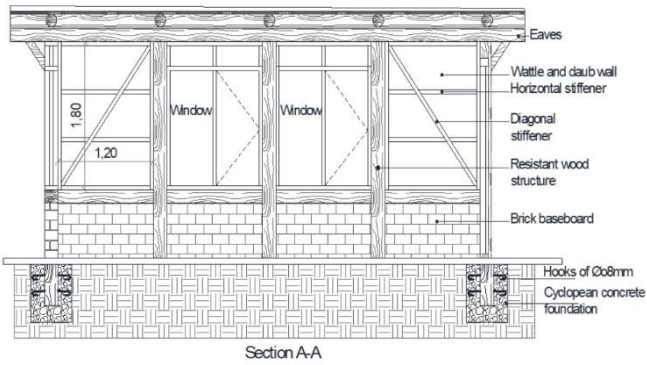
Fig. 7. Section plane of Experimental Workshop (E.W.)

The constructive technology and materials used are the following: a) structure, poplar wood (*Populus nigra*) columns and beams, with an average diameter of 0.20 m for columns and 0.16 m for beams. The columns have two edges that allow them to fit into the slats more easily. The beams are edged on one side to provide support for the ceiling. The lower part of the columns are painted with solvent-based asphalt paint and are supported diagonally by several ribbed steel braces, 0.008 m in diameter that extend 0.25 m on each side. Each one is anchored into a cyclopean concrete block 0.60 m wide x 0.60 m long x 0.70 m deep (Fig. 7).

To avoid moisture ascending by capillarity from the soil into each wall, a small wall consisting of six rows of bricks laid with water-repellent concrete was assembled between the columns and poplar logs were placed on top (see Fig. 7 and Fig. 9).

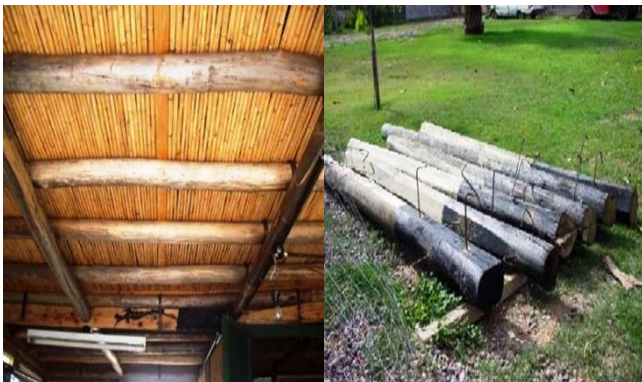
Fig. 8. a-Cane roof and b- Eucalyptus wood columns.

The roof structure (Fig. 8), consists of poplar logs with a minimum incline. The ceiling was made of Castile cane *Arundo donax* and laid across the poplar logs along with the vapor barrier, 150-micron polyethylene sheeting, the thermal insulation of 1.5 cm of expanded polystyrene and 8 cm of volcanic granulate with concrete, and the waterproof insulation of a rubber membrane with embossed 4 mm thick aluminum.

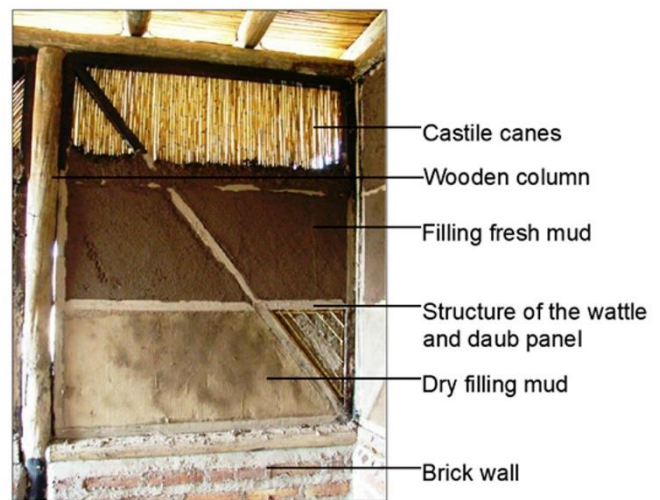
Fig. 10. Detail of wattle and daub wall infill techniques.

The width of the wattle and daub panel is equal to the distance between the structure's columns. For the infill for the framework Castile cane [15] was used (see Fig. 10) and was then covered with mud prepared with clay, horse dung and water, to a final thickness of 7.5 cm. The PQ1 wattle and daub framework is devised by fastening the canes together leaving a space between them, which is then filled with a mixture of pomeca puzolánica and concrete, thus forming a thermally improved wattle and daub.

The walls consist of two different types of wattle and daub: PQ and PQ1 wattle and daub panels. The PQ type was used on the northern and eastern facades and on the inside walls and the PQ1 type was used on the southern facade. In both cases poplar wood was used for the frame, but the PQ type required diagonal braces and two horizontal reinforcements (see Fig. 10 and Fig. 11).

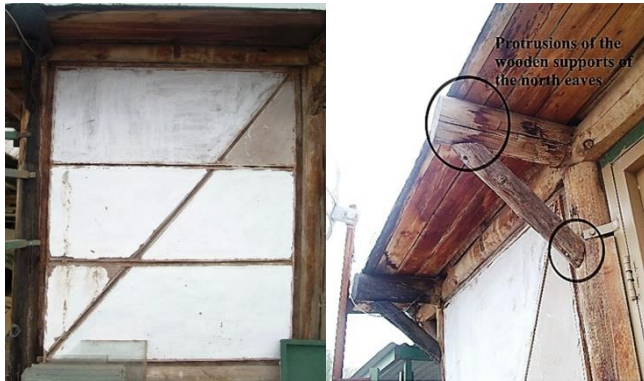
In order to preserve the constructive integrity of the E.W, throughout the years maintenance work was carried out on the opaque wattle and daub walls that had suffered damage, as shown in Fig. 12. The image on the left shows the front north-facing wattle and daub wall affected by moisture, and where some of the cane became exposed. One problem that arose after construction was that as the wooden supports for

the north and south-facing eaves protrude a few centimeters from the eaves, (see Fig. 12b), on rainy days they caused seepage from the wooden support down to the columns, creating a partial deterioration of the wood and the wattle and daub walls. This problem was solved by plastering the wattle and daub walls on the north-facing façade with a lime mixture.

Fig. 12. Pathologies in front north-facing wattle and daub panels of the E.W.

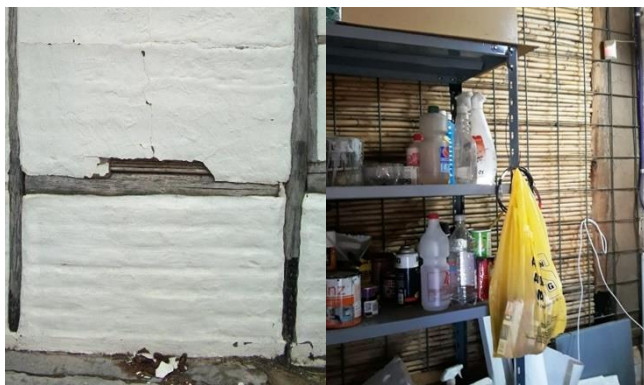
Fig.13 shows the small amount of mud that came loose and minor cracks that formed in the thermally enhanced wattle and daub wall. On the south-facing wall a cement mixture was used for added protection, and was also used to render the entire brick wall. Despite the outside damage, the interior surface of the wall is in perfect condition, as shown by the fact that the cane has retained its natural color and has suffered no deterioration. However, it is necessary to keep up with maintenance and to repair the wooden eaves that show moisture damage. On the eastern facade, the ceiling has suffered no damage as it has been protected by a roof that was built on that side in 2008.

Fig. 13. Pathologies in south-facing wattle and daub panels, a-outside and b-inside surfaces.

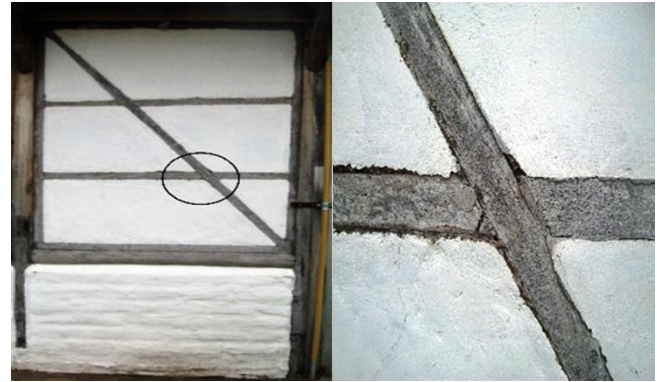
The second pathology found was cracks of no more than 3 mm wide along some edges where the mud and the wooden frame join to form the wattle and daub wall (Fig. 14). In the interior no such cracks appeared. The solution was to seal the cracks with silicone sealant, which with its characteristic flexibility and durability is perfectly suited to the expansion and contraction of the materials used in wattle and daub walls.

Fig. 14. Pathologies in joints on wattle and daub walls: a- Northern wall. b- Detail exterior joint.

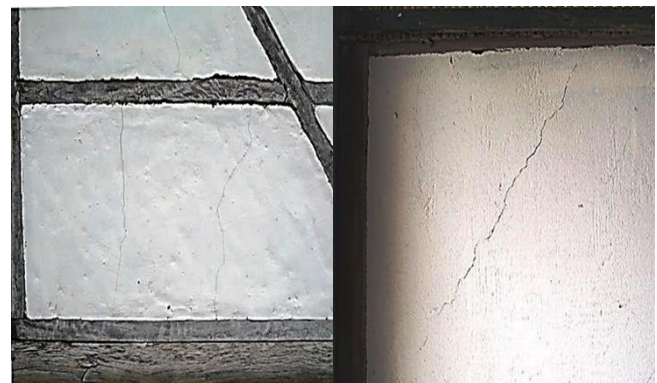
Although after 14 years of operation micro cracks have appeared in some sections of the walls of the E.W., (Fig. 15), these do not present any structural risks and can be easily sealed with a little mud or by repainting the walls.

Fig. 15. Micro cracks on wattle and daub walls.

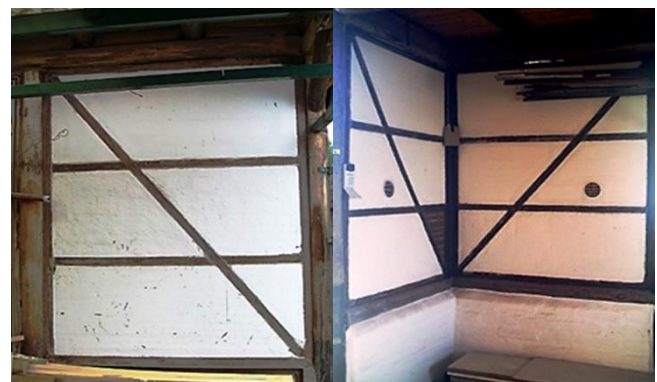
It is important to note that few pathologies have been found in the E.W. building, and it has generally had a satisfactory response behavior, as shown in Fig. 16 and Fig. 17, bearing in mind that it was not conceived as a typical family home and has been exposed to damage from workshop activities.

Fig. 16. Actual state of E. W's wattle and daub North walls

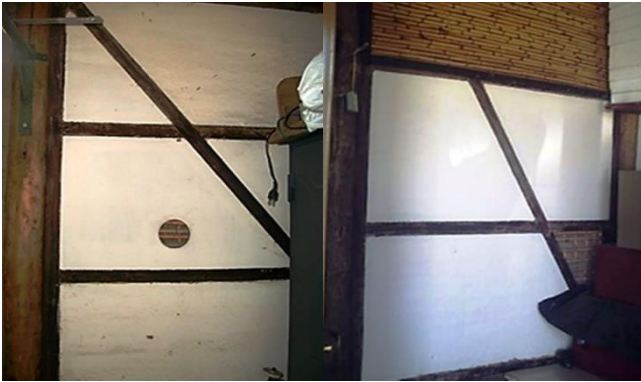
Fig. 17. Actual state of E. W's wattle and daub South walls

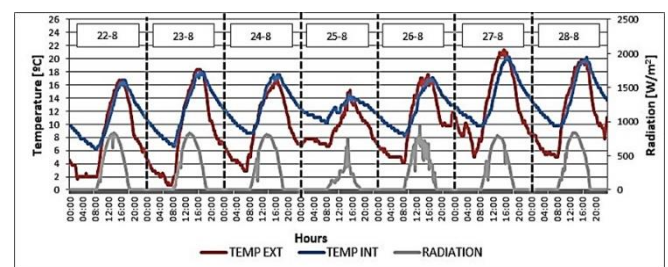
In the second phase, a data logger with temperature and relative humidity sensors was placed both outside and inside and registered temperature data every 15 minutes, while at the same time recording solar radiation and wind (direction and speed). The reading was taken between August 22<sup>nd</sup> and August 28<sup>th</sup> (winter in the southern hemisphere), see Fig. 18.

*Phase 1:* The graph clearly shows that the maximum temperatures on both curves are even due to air filtrations in the carpentry section of the workshop and the opening and closing of the entrance door during working hours, excluding weekends. During the early morning a difference in both temperatures is registered, and while outside the minimum is between  $1^\circ\text{C}$  to  $3^\circ\text{C}$ , inside it is between  $6$  to  $8,3^\circ\text{C}$  for the first three days, making a difference of nearly  $5^\circ\text{C}$ . Outside the thermal amplitude is between  $16$  to  $18^\circ\text{C}$ , while inside it is between  $9$  to  $11^\circ\text{C}$ .

*Phase 2:* On the cloudy day, the outside thermal amplitude is  $7^\circ\text{C}$ , while inside it is  $4^\circ\text{C}$ . It is interesting to note that as solar radiation peaks near midday, while the outside temperature increases the inside temperature does not, due to the thermal inertia of the building. On the partially cloudy day the outside thermal amplitude is  $13^\circ\text{C}$ , while inside it is  $8^\circ\text{C}$ .

*Phase 3:* two clear days with thermal behavior similar to Phase 1, the outside thermal amplitude being  $15$ - $16^\circ\text{C}$  while inside it is  $10^\circ\text{C}$ .

All of the days registered show that the indoor temperature decreases much less than the outdoor temperature and this helps to rapidly increase indoor temperatures the next morning. It is important to point out that these measurements were made without auxiliary heating.

Fig. 18. Thermal behavior of the E.W.

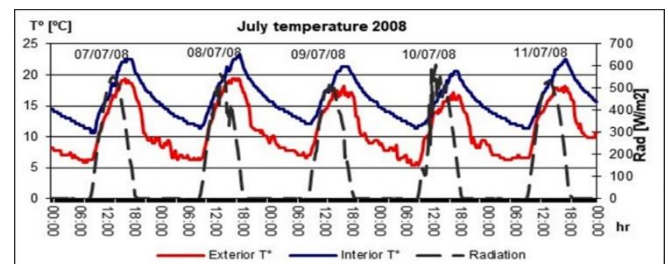
Furthermore, and in reference to the fact that measuring and recording the interior of the E.W. has been an ongoing process, in the paper presented in 2010 [20] about the hygrothermic behavior of wattle and daub constructions based on measurements taken at the E.W. in 2008, (see Fig. 19), it can be observed that the interior thermal amplitude for winter was  $9^\circ\text{C}$ , compared to  $12^\circ\text{C}$  on average in the exterior: after fourteen years and several pathologies, the interior thermal amplitude is  $9^\circ\text{C}$  on average compared to  $14^\circ\text{C}$  in the exterior. This response shows the thermal reliability of wattle and daub and its durability over time, thus providing stable thermal behavior throughout the years.

Fig. 19. Interior and exterior temperatures of the E.W.
