## Engineering Failure Analysis

## Common root causes in recent failures of cranes

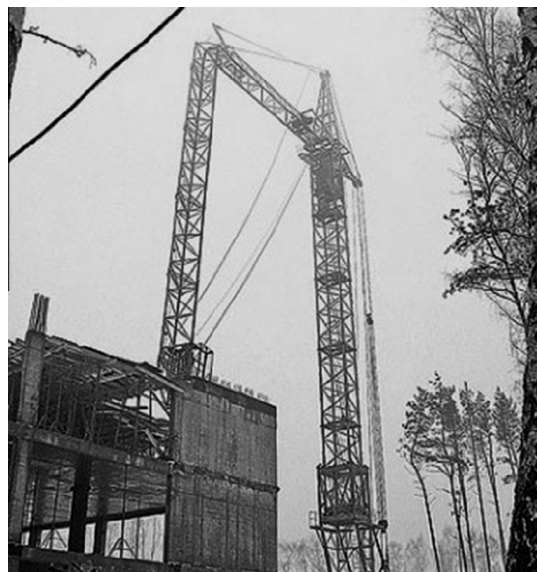
Fig. 1. Example of failure in crane structure, when hoisting a heavy load [1].

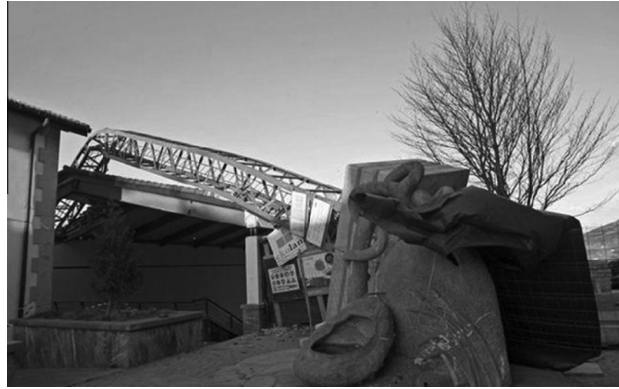
Fig. 2. Example of crane failure from problems in foundation [10].

Many mechanical failures of crane structures are related to the configuration of the mast and the horizontal arm of the crane. Often, these collapse when subjected to loads greater than those calculated by the design engineer. This often happens when hoisting a heavy load in extreme crane geometries, or under conditions of unexpected winds, see for example Fig. 1 [9]. Less often, failures are not related to the steel structure of the crane but with problems in its foundation; see for example Fig. 2 [10].

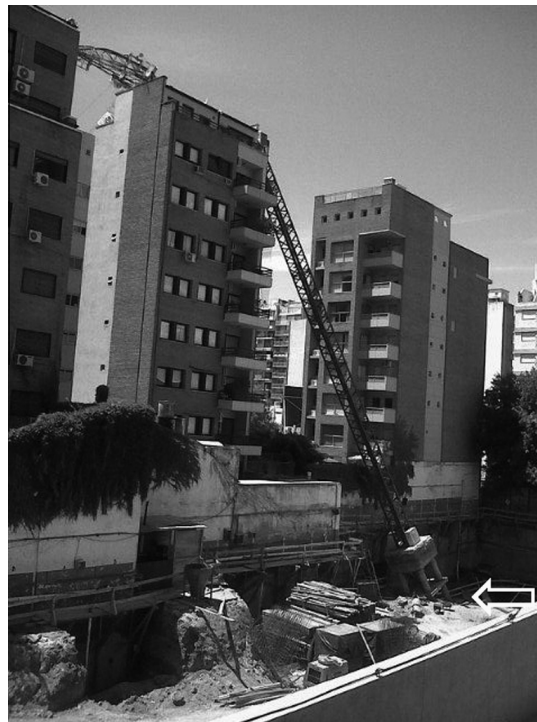
Fig. 3. Collapse of tower crane used for constructing a building.

ballasts. The failed crane has a horizontal arm or “boom” composed by three 10 m long sections followed by one 1 m long section, which supports a 2.5 ton maximum load. As indicated by the arrow in Fig. 3, the failure is localized in the foundation.

The first case is the collapse of a tower crane used for constructing multi-storey buildings, Fig. 3. Its design relies in equilibrating the mechanical moments of the tower with ballasts. These are calculated to optimize the loads on structural members in all conditions from fully loaded to unloaded. As most tower cranes, this is a very slender, counterweighted structure. Slewing is on uppermost part of the tower. The tower is anchored in the foundation or basement, which includes concrete

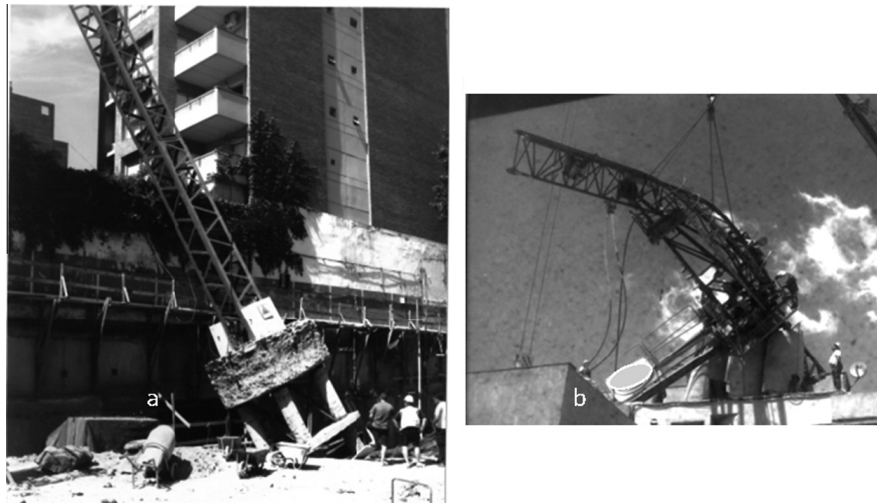
The foundation failed and the tower fell over four buildings, destroying the roof of an apartment, Fig. 4a. Fortunately, three aluminum water tanks absorbed energy, Fig. 4b, so the counterweight did not make its way down all through the building, possibly up to street level. Fortunately no one resulted injured.

**Fig. 4.** Fall of crane. (a) Over building roof. (b) Water tanks absorbed crane's kinetic energy.

The failed foundation described in the first case has a particular condition: is a temporary structure (Fig. 4). These foundations are purpose built every time a new building is started, and a standard crane is attached to it. Once the building is finished, the crane is brought down and sent to a new job. Loads for temporary structures are different in type and magnitude from loads on permanent structures. Designer should include not only final anticipated loads on the temporary structure, but also loads during different phases of construction (such as trench shoring), and even accidental loads to a certain extent [6].

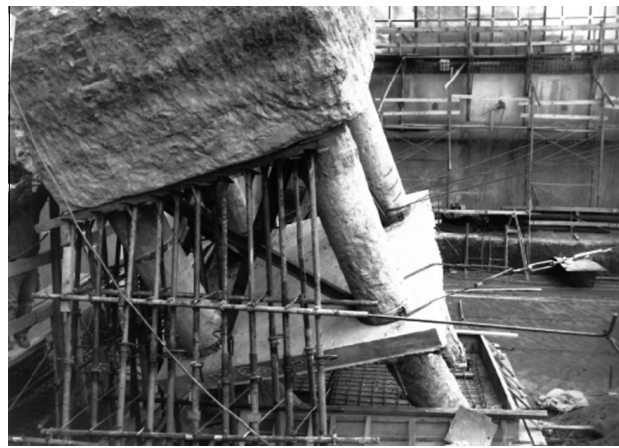
The foundation was composed by piles 12 m deep below the embedding block. Fig. 5(a and b), taken during cleaning and repair after the failure, show how the four columns were bent and displaced. The building was to have several underground levels, so as construction went on digging was done around the piles. During excavation, the crane was considered fully operative. Even in the absence of live loads, the counterweight exerts as much moment as fully loaded.

**Fig. 5.** Detail of bent and displaced foundation columns (piles) after crane failure.

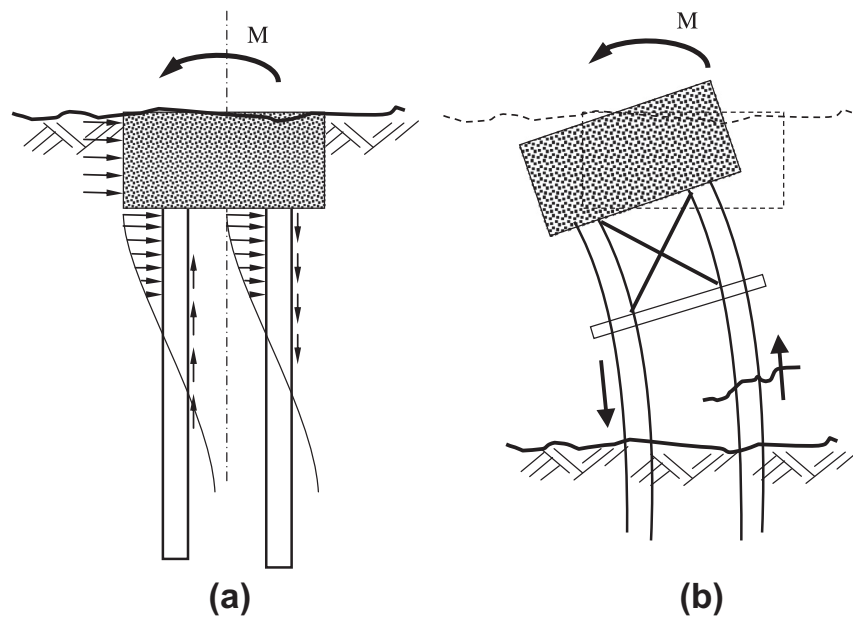
A simple mechanical analysis of the foundation allowed understanding the immediate physical cause for the failure, see sketch of Fig. 6(a and b). Fig. 6a shows how the foundation was designed to displace when subjected to the mechanical moment applied by the eccentric vertical load in the arm. After removing the ground around the pile cap, the cap was no longer laterally restricted. As piles lost skin friction, the four piles did not act as a cluster, this is depicted by Fig. 6b. Bending loads sustained by individual piles increased because of the modification of boundary conditions.

**Fig. 6.** simple mechanical model of foundation. (a) As designed. (b) Bending loads by individual piles after loss of ground support.

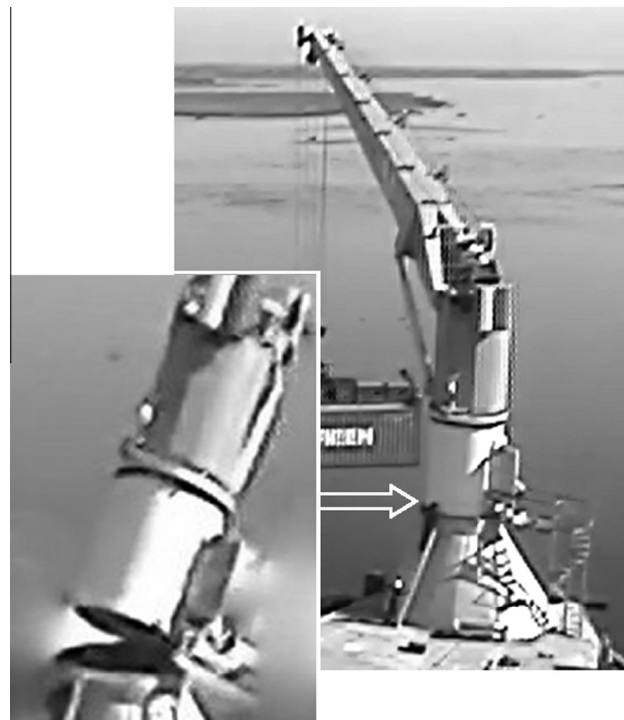
The second case under study is a cylindrical luffing crane designed to handle containers and general cargoes at a river port, Fig. 7. This kind of crane has no counterweight; vertical loads and moments are withstood by a large slewing bearing anchored to the foundation. The crane was mounted on a concrete base built for the purpose. The insert of Fig. 7 was taken from an occasional witness video footage, taken at the time of the failure. It is seen how the failure occurred at the joint with the concrete structure.

**Fig. 7.** Collapsed luffing crane at a river port. Inset: actual video footage of failure at joint with base.

The failed crane base shown in the second example (Fig. 7) was intended to be permanent. It works with a strong bending component as it has no counterweight. The bending plane rotates with the rotation of the arm, generating alternating loads at any position around the base. All bolted joint must be preloaded with a compressive load that exceeds the loads, to which the joint will be subjected under operational conditions. Otherwise, the bolts are susceptible to fatigue [15]. This is normally accomplished with an appropriate tightening of the bolts, resulting in tensile stress close to the maximum allowable material strength (Fig. 11(a)). Thus, bolts work tensioned, but at a constant stress, at any operating load. Fatigue cracking is initiated by cyclic loads at stress levels significantly lower than overload critical stress. In the crane under study, bolts did not have any preload below the lower nut, so they were subjected to tensile and compressive axial stress during every rotation of the arm (Fig. 10).

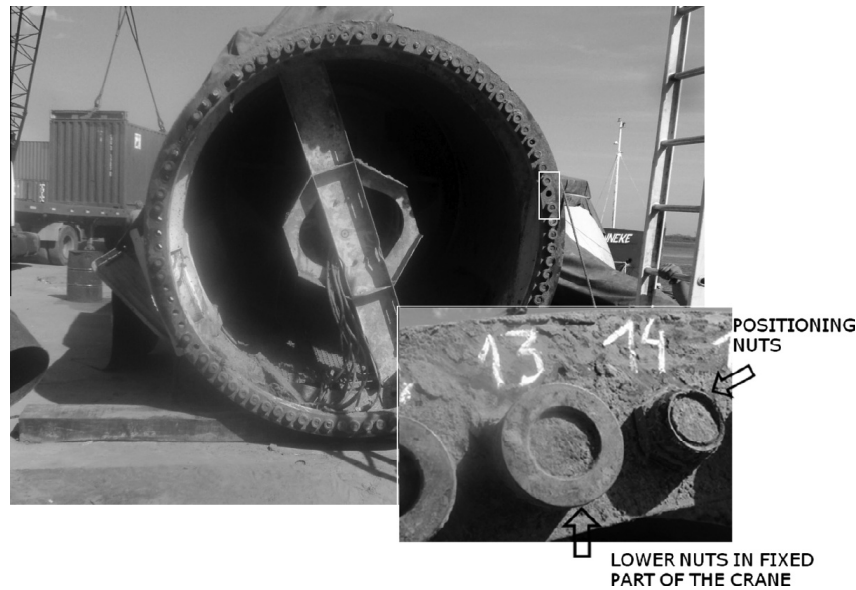
All bolts of the joint broke and also fell into the river. These bolts fixed the non-rotating part of the crane to the concrete base (Fig. 8). The crane rotation system includes a 2.6 m diameter flange, containing 90  $1\frac{1}{2}$  diameter bolts. It was found that all bolts failed in a section just under a cylindrical nut (see inset in Fig. 8). This kind of nut is suitable to be used in combination with a hydraulic tightening device.

Visual inspection showed that some nuts are different from the others, see inset in Fig. 8. These special nuts have a tapered end. Going back to fabrication data, it was found that these were used for positioning the upper and lower template, when aligning the bars at the erection site, see Fig. 10. There is a series of high nuts connecting some sort of extension studs. All this was confined within the grouting configuring a double nut joint (see inset in Fig. 10). There was not a leveling plate used during the erection of the tower on the foundation.

**Fig. 8.** Failure of bolted flange with base. Inset: some failed bolts, note two types of nuts, both part of the “lower nut” assembly.

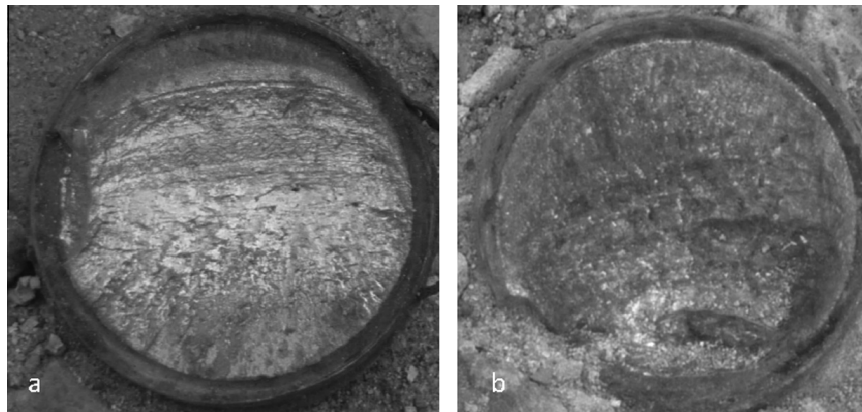
Most of the other parts of the bolts were recovered from the water, and analyzed in the lab. Fig. 9(a and b) shows typical fracture surfaces in bolts. There are signs of fatigue in most of the bolt fracture surfaces. This means that fatigue damage occurred prior to catastrophic failure [13]. This reduced the number of bolts that transferred the load from the crane to the foundation. Fatigue crack growth accelerated in the remaining bolts, until remaining sections were not enough, causing collapse due to overloading of the remaining bolts. In all inspected bolts, fatigue occurred in a section below the lower nut.

**Fig. 9.** (a and b) Typical fatigue fracture surfaces of bolts recovered from river bottom.

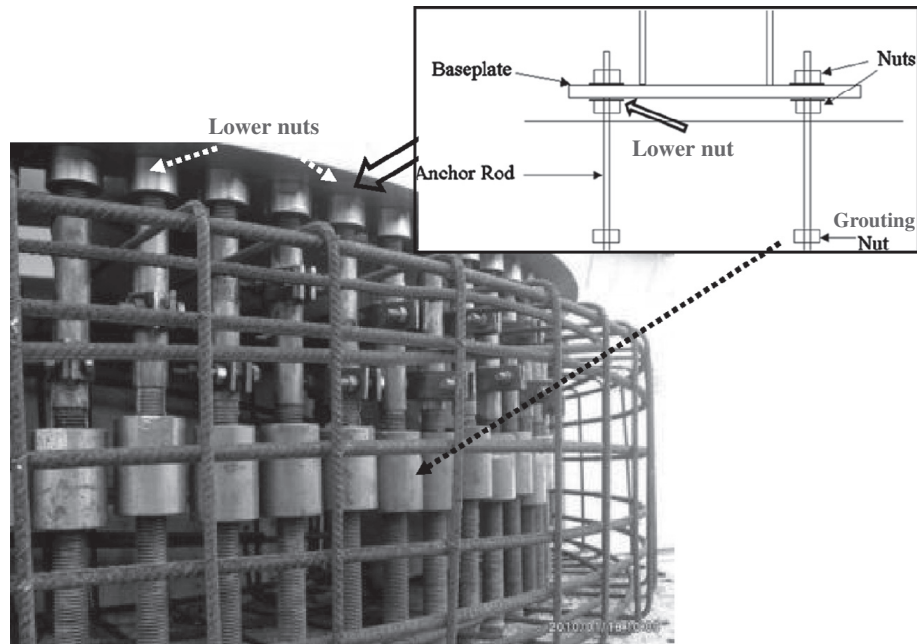
Fig. 10. “Lower nuts” that support crane, as placed during base construction, before grouting.

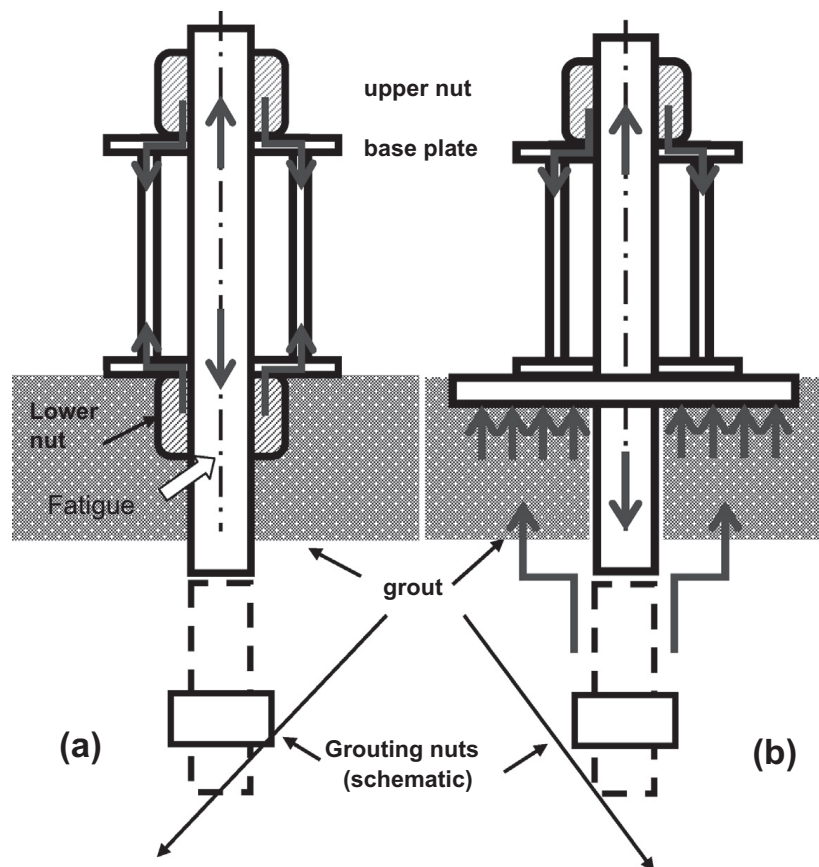
A simple mechanical analysis of load transfer shows that these sections were not subject to the preload applied by the upper nuts, precisely due to the presence of lower nuts [14]. This is a determining factor in the joint failure, and is schematized in Fig. 11(a and b). To the left the present case, in which the lower nut closes the clamping forces generated by torquing of the upper nuts. On the right, the case without lower nuts is shown. It can be seen that bolt tightening generates compressive loads in the base and tensile preload in the bolt, which prevents it from being subjected to the cyclic loads that generate fatigue.

Fig. 11. Bolting scheme and “force circuit” between grout and base plate along one single bolt: (a) as in failed crane, (b) according to design, without “lower nut”.

Due to the presence of the lower nuts, bolts could not be tensile preloaded, the upper nuts just clamped the crane base to the lower nuts. This creates a “floating” condition of the base under which the tensile loads cause the incipient separation of the surfaces and the appearance of cyclic loads on the bolts. In this case, upper nuts can be tightened but tensile stress ends in the lower nut. So, when tensile stress is applied to that part of the joint, it is fully transferred by the rod to the lower part or the lower nut, Fig. 11b. There, the load is transferred by shear to the grouting. Only few threads are fully loaded. Properly preloaded bolts do not sustain cyclic stress and are fatigue safe.

In this type of structures no lower should nut have been added, and the crane should have been supported on a metal bearing plate included in the grouting. The positioning and leveling of the platform should be done by other means than the bolts. Bolts should penetrate this platform and be anchored in the concrete far below the joint surface and, if possible, free from shear stress against the concrete by jacketing or other effective way [16]. The preload must be applied by hydraulic methods to reduce the uncertainty of the torquing.

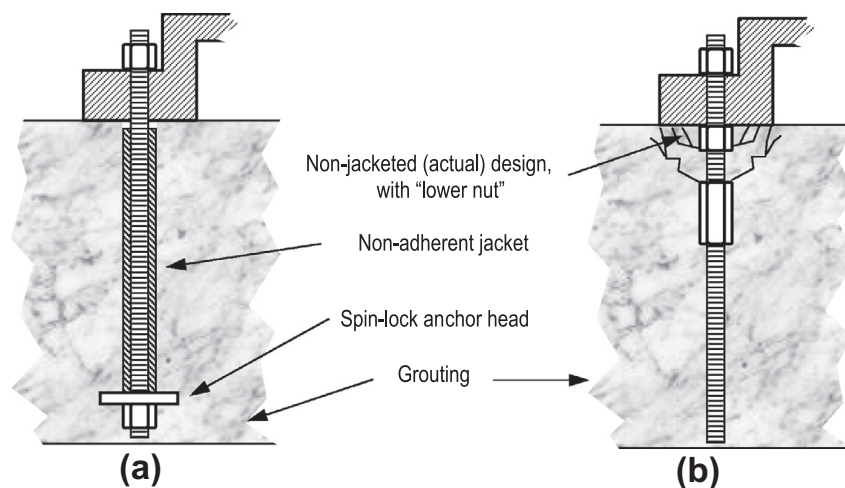
Fig. 12. (a) Non-adherent jacket to avoid shear stresses between bolt and grouting, (b) actual design.

To avoid shear stress between grout and bolt, and consequently future cracking in the bolts, a non-adherent jacket could be covering the bolt; see Fig. 12. This arrangement generates a compression zone in the grouting and a tensile stress along the full length of the rod. In the “two-nuts” arrangement (which in fact have three nuts per bolt, if the lower nut inside grouting is counted) the bolt has no preload below the second (“lower”) nut. This leads to the bolt taking alternative loads that could eventually produce fatigue
