The technical and the social: challenges in the conservation of earthen vernacular architecture in a changing world (Jujuy, Argentina)

Abstract

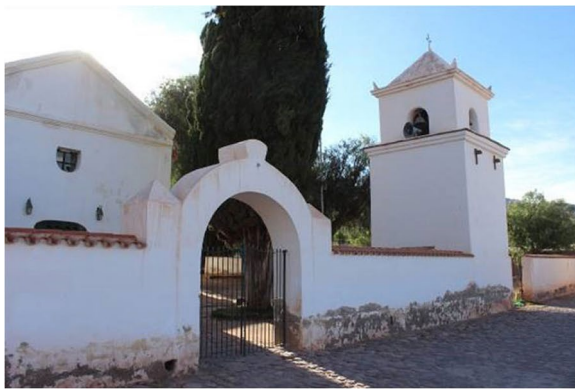
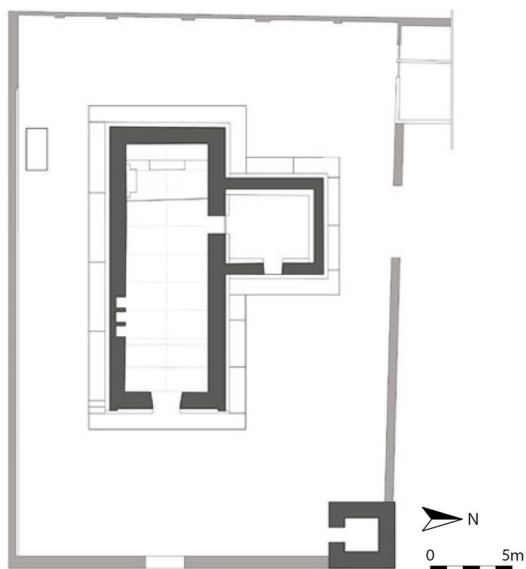
Fig. 2 Façade and ground plan of the Church of Uquía (Source: the authors)

variation, to the ecclesiastical typologies recognisable in the area (Gisbert and De Mesa 1997). Specifically, it has a single nave of $17\text{ m} \times 7\text{ m}$ from the outside and was built with stone and mud foundations and adobe walls formed with $60 \times 30 \times 10\text{ cm}$ blocks with a thickness of 1 m. The nave has only one enclosure, which forms the sacristy on the north end (Fig. 2). Both the nave and the sacristy are gable-roofed with wooden A-frame trusses with a lower tensor. On the walls, the nave has a wooden collar beam that runs around the entire perimeter on which the tensors and trusses rest. The roof is finished with mud (*torta de barro*), a characteristic technique in the region that requires periodic maintenance. Finally, the chapel as a whole has an enclosed atrium and a separate tower, also made of adobe, on one of the corners.

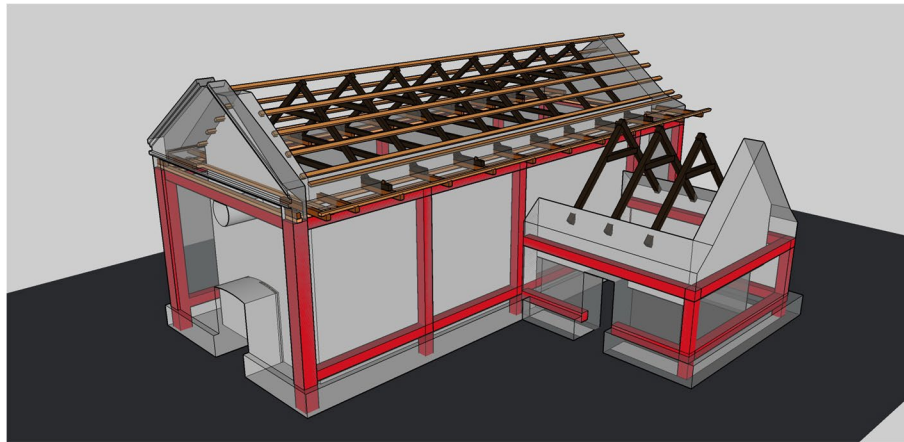
Fig. 3 Diagram of the reinforced concrete structure, shown in red, incorporated into the adobe walls at the beginning of the 20th century (Source: the authors)

The transformation of the materiality of the roof, the introduction of integral concrete structural reinforcement in the walls and the change in the top of the tower were solutions that not only did not improve the stability of the building but actually generated new pathologies. In the case of the roof, the integral transformation of its materiality led to a malfunctioning of the cover, with cracks in the upper layer allowing water to seep into the mud that was then unable to evaporate through exchange with the environment due to the presence of the cement and the upper membranes (Cornerstones Community 2006). Thus, the roof had serious humidity problems, allowing leaks into the interior of the church that damaged the adobe and wooden elements. As for the concrete structure, it is not connected to the adobe wall, and the section is insufficient to reinforce walls as thick as those of this particular church. Thus, the structure has not solved the problems observed in the form of the cracks

and has actually increased the weakness of the structure in the case of a seismic event² (Tomasi and Barada 2021). Likewise, the changes to the top of the tower involved not only the incorporation of foreign material into a structure that, due to its substantial weight on such a slender element as the tower, also increases the weakness of the general structure and also constitutes a complete change in the appearance of the church.

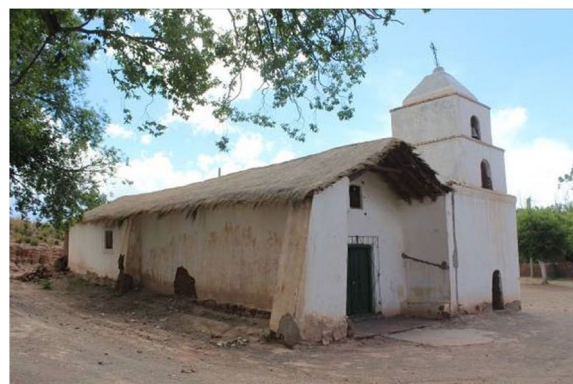
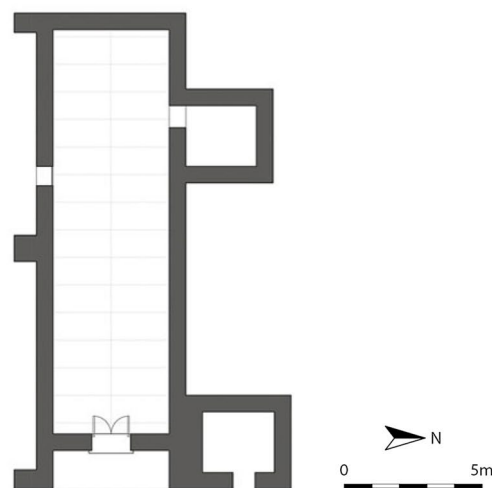
Fig. 4 View and ground plan of the Church of Tabladitas (Source: the authors)

Tabladitas is also a chapel with a single nave open to the east that is 17 m long and 7 m wide and has a small lateral enclosure, the sacristy, to the right (Gisbert and De Mesa 1997; Tomasi and Barada 2020). At the front, the church has an open chapel, a very characteristic element of chapels in the region, where the projection of the side walls and the roof generates a semicovered space linked to religious rituality (Fig. 4). Similar to the Church at Uquía, Tabladitas has a single tower, although in this case, it is attached to the nave and not to the perimeter wall of the atrium. In fact, at Tabladitas, the atrium is not closed, as it is in Uquía and other chapels in the region.

The church in Tabladitas was also built with adobe masonry, with walls approximately 80 cm thick on foundations of mud-laid stone. The structure of the roof also reveals a system of A-frame trusses, without a lower tensor and boards of *cardon* wood tied with leather straps. On top of this structure, mesh, also made of leather, supports a continuous layer of straw that is finished with *guayado* (Fig. 5). This technique is characteristic of the region and consists of a series of superimposed horizontal strips of straw embedded in viscous mud, which provides excellent water and thermal insulation. Due to its specific characteristics, this technique requires the periodic renewal of the material to ensure its adequate performance. In different parts of the region, thatching has historically been a community conservation practice through which collective ties are established. In many cases, the institutionalisation of heritage has involved the action of other actors, such as construction companies. In the case of Tabladitas, however, the conservation of the thatch roof has remained a community practice, which is repeated periodically, within the framework of certain relationships the local people have with their architecture.

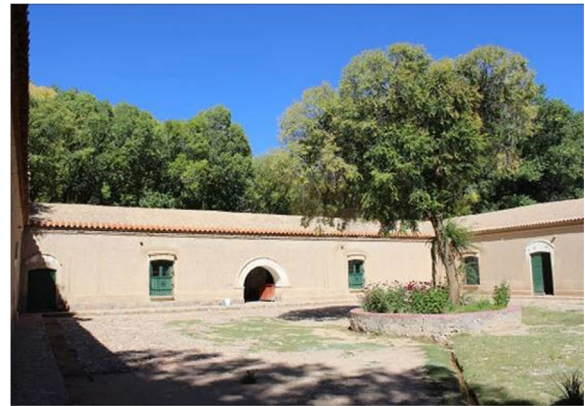
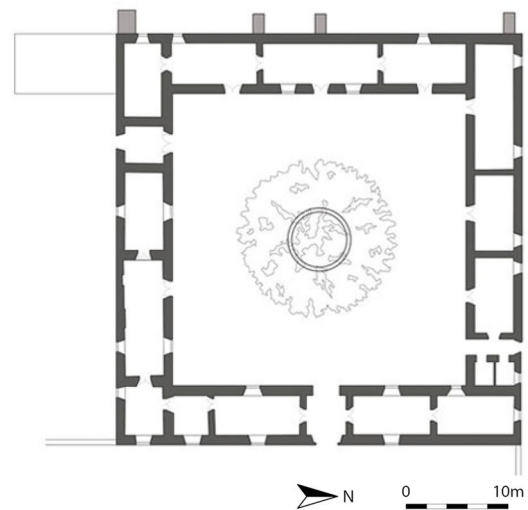
Fig. 6 View of the courtyard and general floor plan of Casa del Marqués (Source: the authors)

As we have mentioned, the house's morphology corresponds to that of other rural farms. It has a central courtyard and a square floor plan of 818 m² of covered area on a single level made up of successive enclosures arranged around the courtyard (Fig. 6). Constructively, it has stone and mud foundations with adobe walls up to 1 m wide that were historically plastered with mud. The roof has A-frame trusses with a lower tensor, over which cane weaving was deployed and then finished with the mud roof technique, as in the Church of Uquía (Barada and Tomasi 2020).

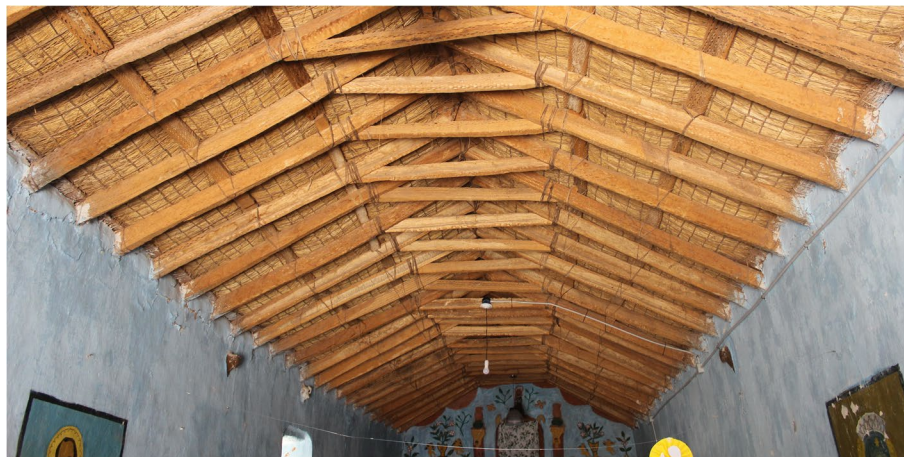
Fig. 5 Details of the *cardon* wood and thatch roof seen inside the nave (Source: the authors)

of the durability of materials and a sense of authenticity based on their periodic renewal and change. In recent years, the failure of the trusses has caused an increase in horizontal stresses on the lateral walls, one of which was partially overturned and had a large horizontal crack at the base. In response, the community incorporated buttresses into the wall, but this only partially constrained the deformation. The degradation mechanism probably started with the leaks in the roof, which contributed to the deformation of the trusses as a result of delays in changing the thatch or the poor execution thereof. Changes in the temporalities of construction within the framework of new social dynamics have an impact on the conservation of buildings.

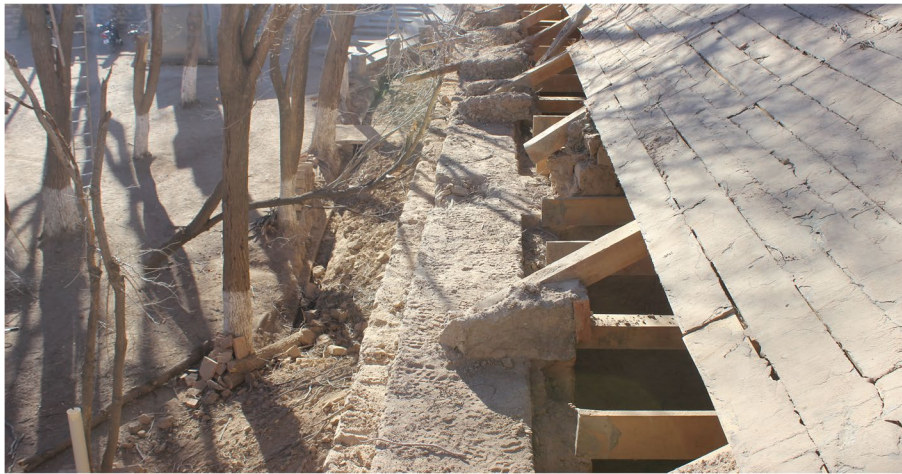
Fig. 7 Details of the reinforced concrete beam incorporated into the adobe walls (Source: the authors)
