Engineering Failure Analysis

Effect of coking in massive failure of tubes in an ethylene cracking furnace

Jose Luis Otegui^{a,*}, Jeremías De Bona^b, Pablo G. Fazzini^b^a YPF Tecnología S.A., Conicet, Argentina^b GIE S.A. Integrity of Assets, Argentina

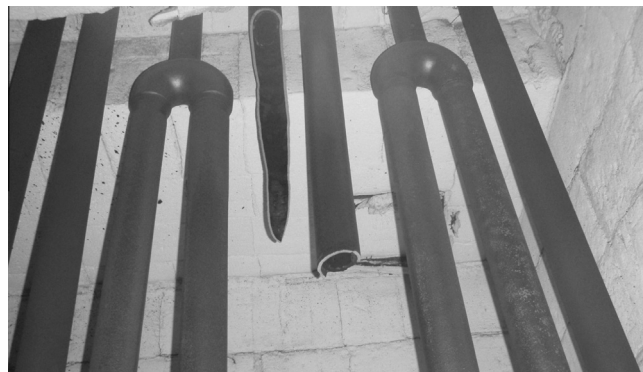
During an emergency stop the furnace was taken out of service, letting it cool down from service to room temperatures. The day after, plant personnel realized that all the radiant coils in the furnace suffered cracking, leaving the furnace completely useless (Fig. 1).

Fig. 1. Failed tubes within the furnace after emergency stop.

The causes and characteristics of the massive failure of the radiant coil tubes in an ethylene cracking furnace, which failed during an emergency non-programmed stop, are investigated (see Fig. 1) [1]. This analysis leads to establish material, manufacturing and assembly quality on one hand, and to determine operative conditions that contributed to the failure, on the other. As there are similar components operating in the same plant as well as in other plants, this study aims to identify failure mechanism/s, to determine the causes that created the conditions for this mechanism to cause premature failure of the material, to establish the likeliness for this failure to happen again on similar components and to establish possible mitigation measures.

In this case, the controlled displacement is given by the differential thermal contraction between the tubes and the thick, stiff coke layers within them. When comparing results from Eqs. (1) and (2), it is noted that the coke layer restrained a very small portion of the thermal contraction of the pipe material (about 5%), and yet, it was enough to provoke massive longitudinal cracking in the tubes. In some sections the propagation rate, combined with any in-homogeneities in the pipe material and the effect of longitudinal stresses due to dead weight, made the cracks split in two. When the cracks joined back, they cut sections of the tubes, as can be seen in Fig. 1.

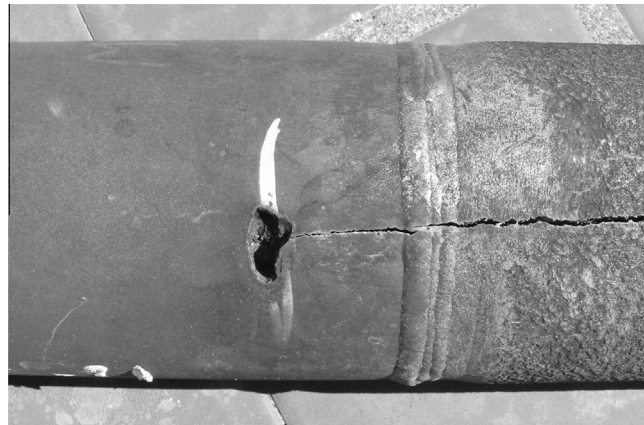
Analyzed samples show cracks that are mostly longitudinal and quite open, with about a 2 mm wide maximum surface opening, see for example Fig. 2. After findings, in-situ arresters were flame cut to avoid the cracks to propagate further into the U-shaped pieces which connect the tubes. As seen in Fig. 3, some cracks eventually deviated from their axial paths, leading to complete separation of the tubes. This is frequent in fast running axial cracks in pressurized pipes, especially when crossing a discontinuity such as a weld. Cracks tend to branch and form two hellical cracks that quickly coalesce into a circumferential crack. The crack detailed in Fig. 4 developed as a wholly circumferential fracture surface; brittle behavior is evident.

Fig. 2. Open longitudinal crack, arrester to stop crack propagation.

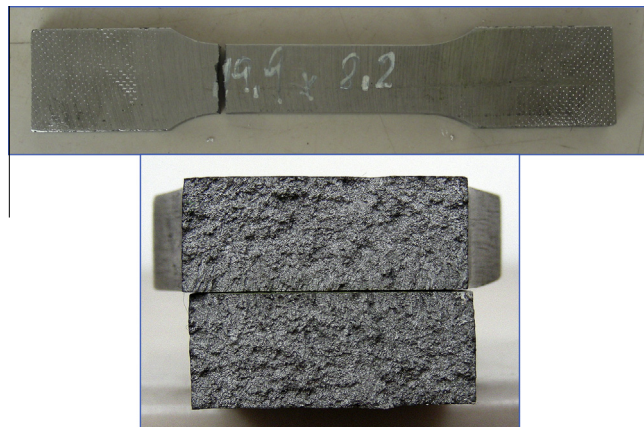
Tensile properties for base material of failed tubes are summarized in [Table 1](#), where are compared with nominal material properties. Note the reduced strength and ductility. Fracture surface of test samples is brittle, as shown in [Fig. 8](#).

Fig. 8. Tensile test specimen (longitudinal) and fracture surface.
