Lydia Elena Espizua and Jorge Daniel Bengochea

Landslide Hazard and Risk Zonation Mapping in the Río Grande Basin, Central Andes of Mendoza, Argentina

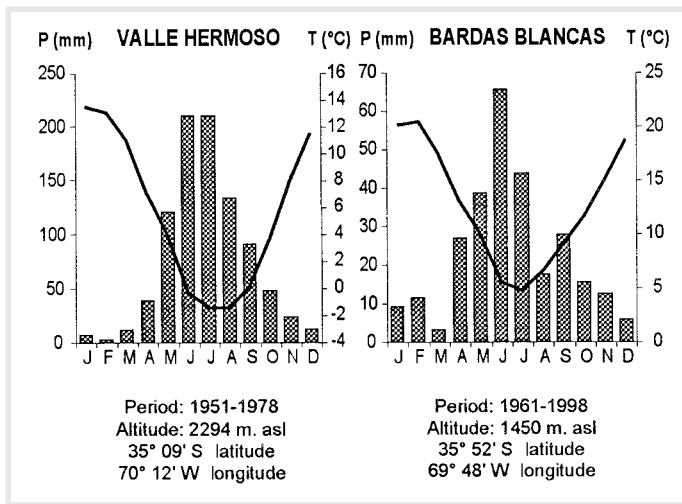
FIGURE 2 Monthly mean precipitation and temperature in Valle Hermoso and Bardas Blancas meteorological stations.

There are 2 meteorological stations in the zone, with interrupted records: (1) Valle Hermoso (35°09'S, 70°12'W) at 2294 m, and (2) Bardas Blancas (35°52'S, 69°48'W) at 1450 m. The mean monthly precipitation and temperature records show 2 well-defined periods, one in winter and the other in summer (Figure 2). The monthly mean maximum precipitation coincides with the monthly mean minimum temperature. In Valle Hermoso the mean monthly temperature from June to August is below 0°C. At this station the higher monthly precipitation occurs in the winter as snow, whereas in Bardas Blancas it can be snow or rain and occurs from May to June. Annual mean precipitation varies from 400 mm in Bardas Blancas to 940 mm in Valle Hermoso.

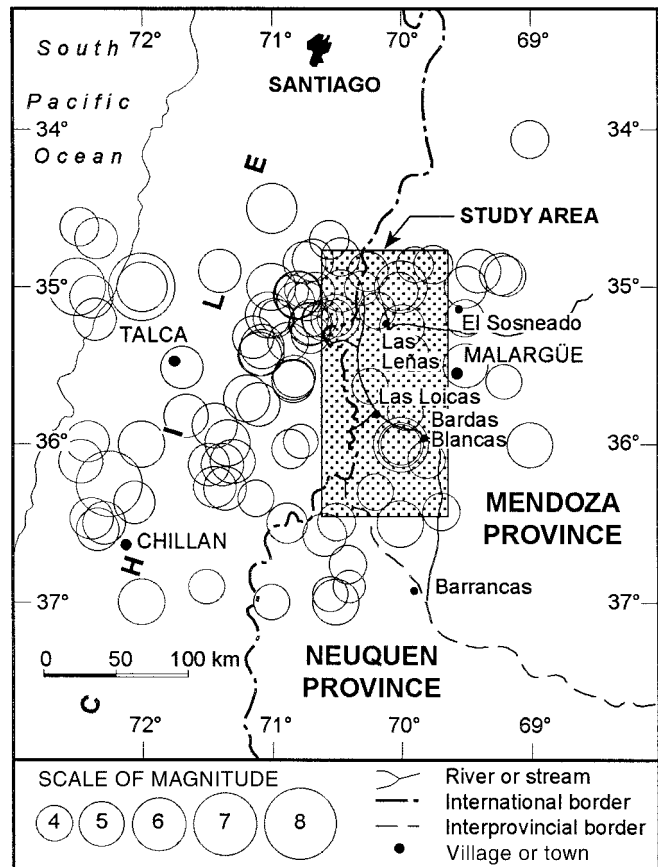
FIGURE 3 Location of earthquakes (epicenters and magnitudes).

sity of Chile. Ninety earthquakes with magnitudes greater than 4 have occurred in the area. Figure 3 shows the location of the epicenters and magnitudes in the study area and the surrounding zones; the figure shows that there is an increase in the number of earthquakes and in their magnitudes toward the west.

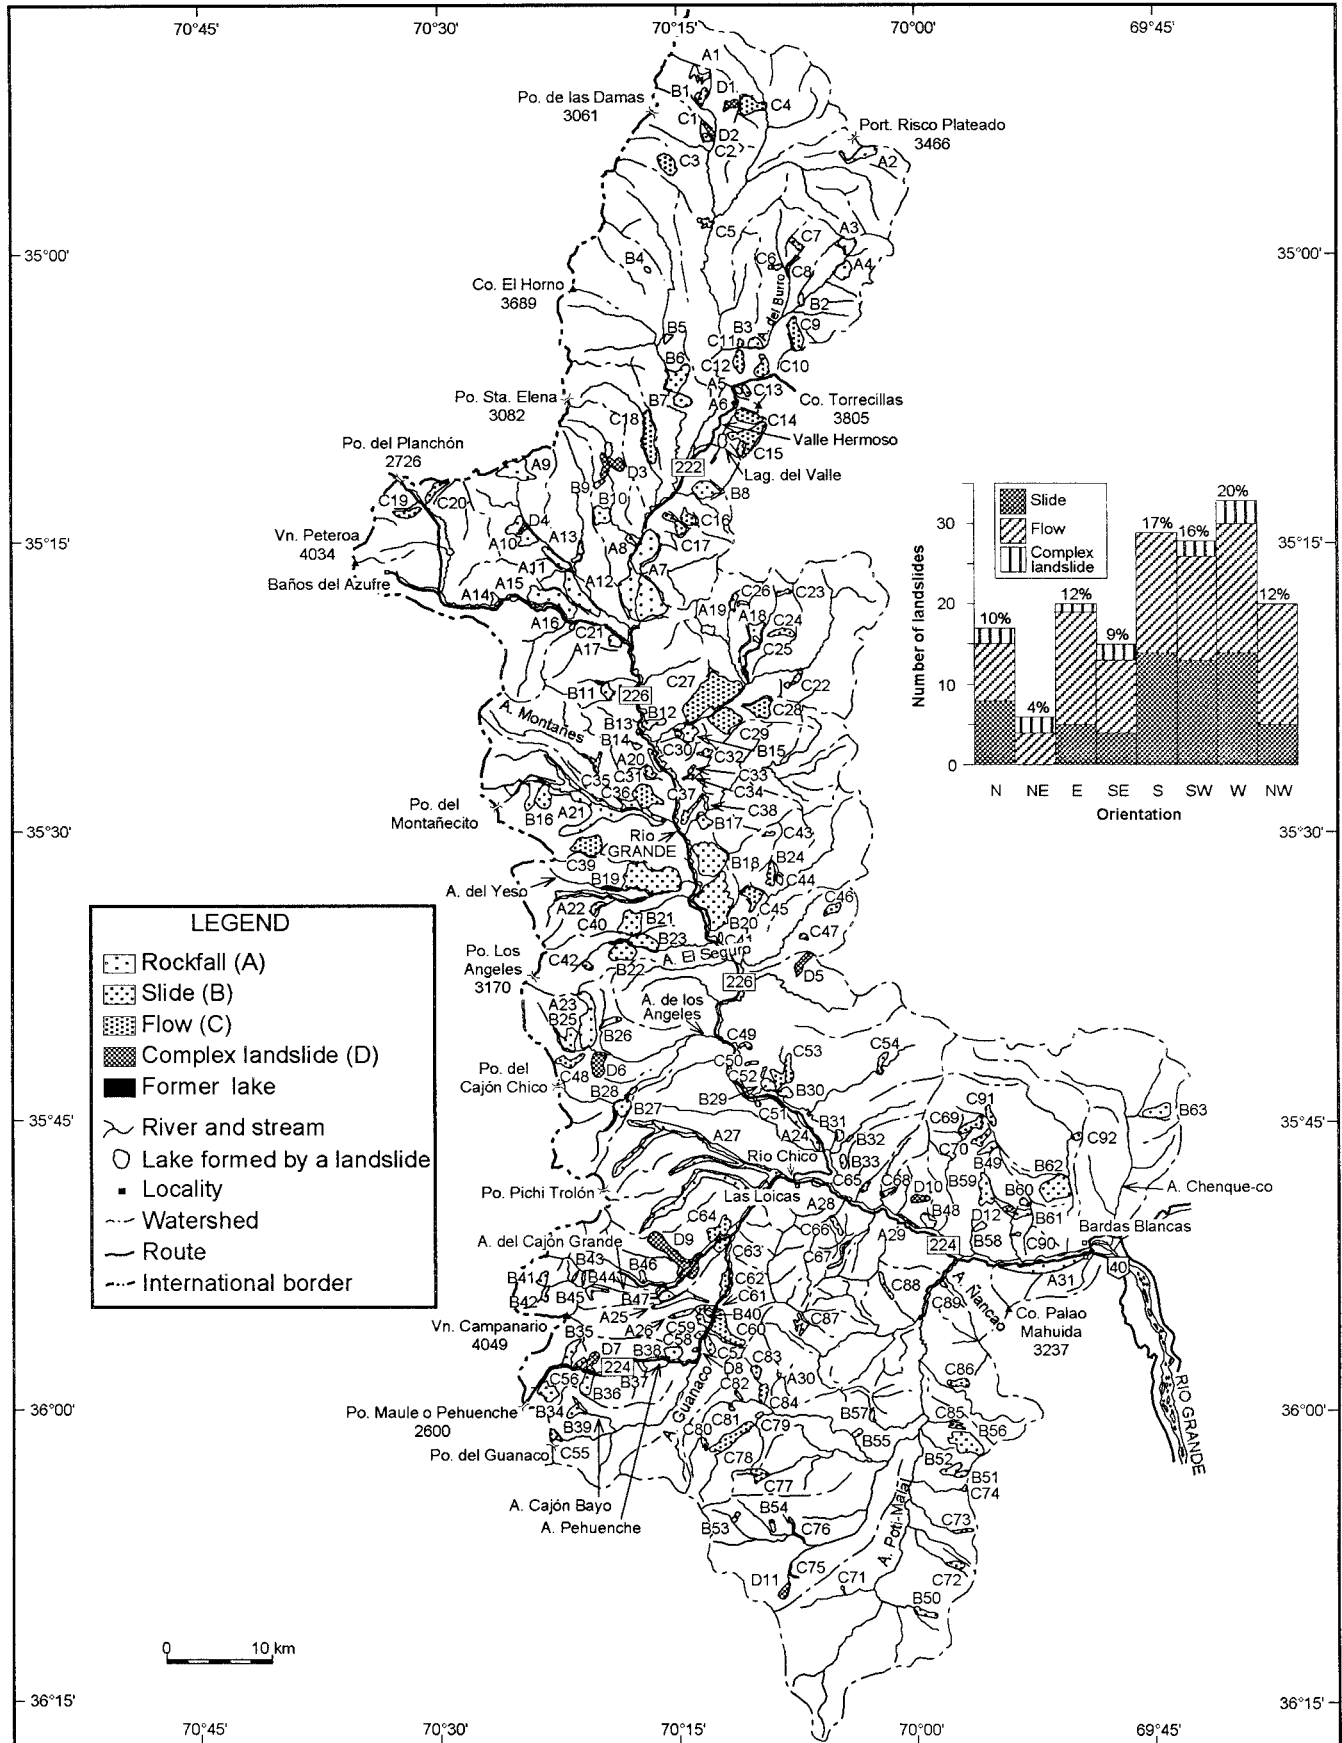
FIGURE 5 Inventory and location of landslides in the study area in the Río Grande basin.

The Río Grande valley has a north–south trend. Analyzing the orientation of 198 landslides represented in Figure 5, the flows, slides, and complex landslides are preferably oriented toward the west, south, and south-west. The predominance of flows and slides oriented toward the south and to the west is partly the result of those slopes being colder; they accumulate more snow and it remains there longer. Therefore, during the snowmelt season the amount of water is higher. The snow that remains in the cold slopes produces a more intense chemical and physical weathering of the rock, because of the presence of water in cracks and caverns, which freezes and thaws, and the hydration of clays and anhydrite.

We prepared 2 maps. The distribution and classification of landslides are shown on the first map (inventory map; Figure 5). The second—a landslide hazard and risk zonation map (Figure 6)—was prepared taking into account the zones subject to landslide hazard and the degree of loss to a given element or set of elements at risk in the region because of the occurrence of a particular phenomenon of a given magnitude (Coburn et al 1994).

Landslides are identified on the maps and classified according to Varnes (1984), on the basis of the type of movement and material involved, and they are individualized as follows: (A) rockfalls, (B) slides, (C) flows, (D) complex landslides. The number following each capital letter indicates the number of the landslide in each category.

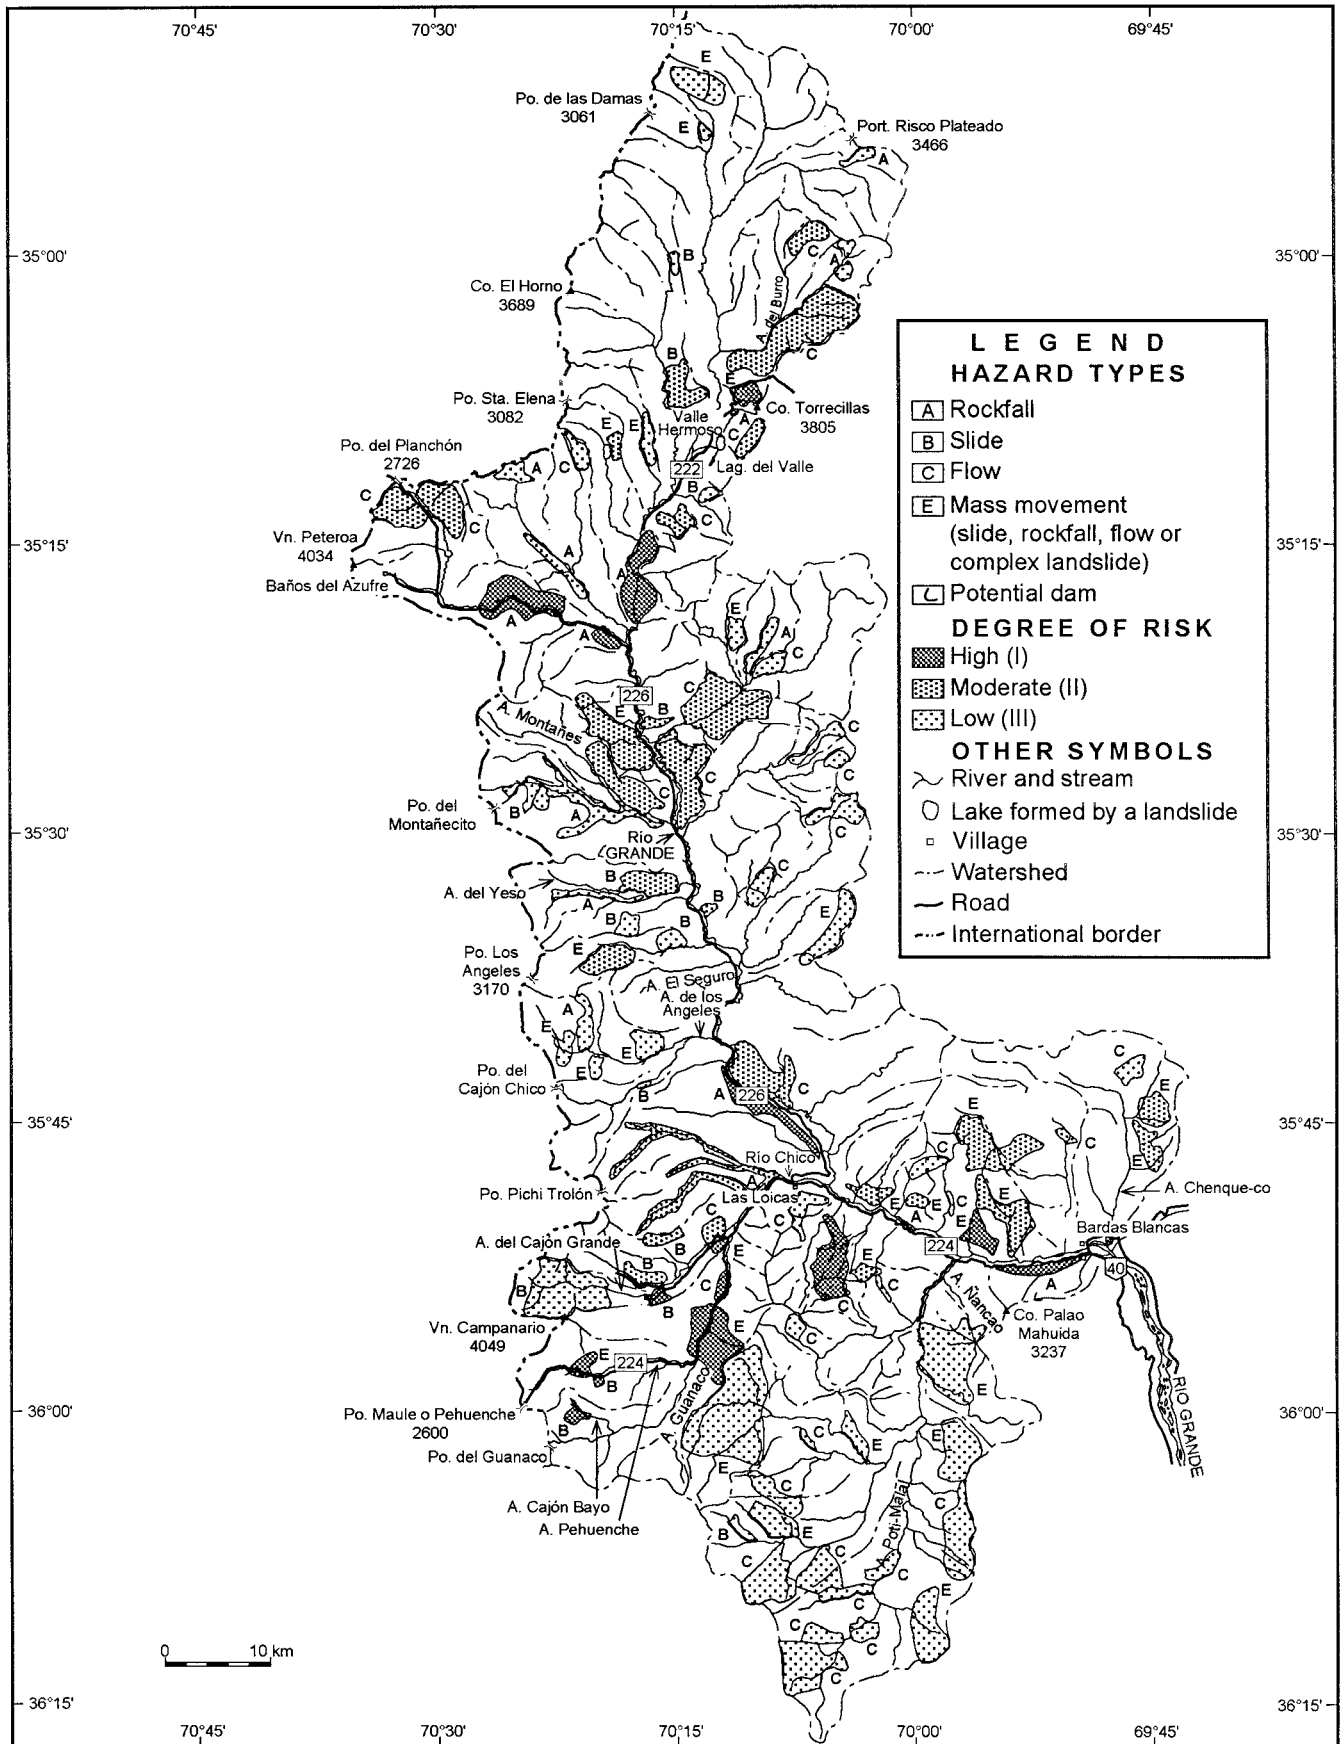
FIGURE 6 Map of landslide hazards and risk zonation in the Río Grande basin.

A landslide risk map was obtained showing the hazards and elements at risk according to UNDRO/UNESCO (See Coburn et al 1994) definitions. The risk map shows that the major hazards and the greatest potential risk are concentrated along the Río Grande valley and its tributaries where the roads, routes, and settlements are located. Three risk degrees were distinguished as follows (Figure 6):

- *Degree I (high risk)*. This is the category with the highest degree of hazard and risk, where rockfalls, flows, or slides that could occur would affect Provincial routes 222 and 224, roads, bridges, or small, populated centers. Rockfalls are probably the most frequently observed mass movements in mountain areas. The areas where rockfalls occur are subject to events of lesser magnitude that occur more frequently; therefore, construction should be avoided.

- *Degree II (moderate risk)*. This category covers areas vulnerable to the potential occurrence of landslides, but the threat to infrastructure in the area is not as great because the hazard zones are far away. Through field observations in March 1996, it was possible to detect the occurrence of a debris flow that flowed from the headwaters of Arroyo Chenque-Co after a heavy rainstorm (Degrees II and III; Figure 6). Highway No. 40 and a small bridge were damaged (Degree I; Figure 6).

- *Degree III (low risk)*. The occurrence of a potential landslide is relatively remote, and the expected damage to the infrastructure is very slight.
- *Potential dam*. The potential occurrence of a specific hazard induced by large mass movements that could cross the valley floor up to the opposite slope, thus damming a river or a creek, was considered as a slide hazard zone. In case the dam is broken, a catastrophic flood could occur, posing high risk to inhabited areas and infrastructure located downstream.
