Geomorphic and vegetation changes in a meandering dryland river regulated by a large dam, Sauce Grande River, Argentina

Ana Casado^{a,b,c,*}, Jean-Luc Peiry^{a,b}, Alicia M. Campo^c

^c Departamento de Geografía y Turismo, Universidad Nacional del Sur – CONICET, Bahía Blanca 8000, Argentina

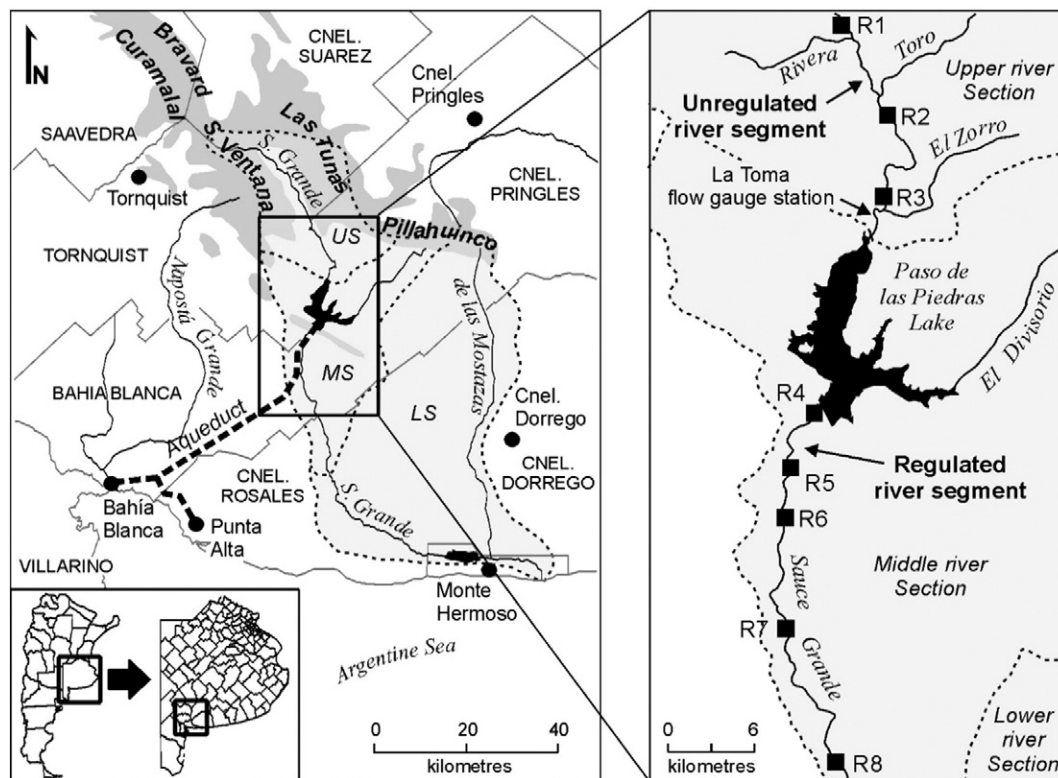
Fig. 1. Map of the Sauce Grande River basin showing main regional features (left) and the river segments selected for analysis (right). The location of reference river reaches (R) along each river segment is also illustrated. US, MS and LS in the left map designate the upper, middle, and lower river sections, respectively.

The Sauce Grande River collects its waters on the eastern slope of the Sierra de la Ventana Range and flows down into the Atlantic Ocean draining a basin area of $\sim 4600 \text{ km}^2$ ([Fig. 1](#)). The climate in the majority of the river basin is dry-subhumid. Mean annual rainfall decreases from 800 mm in the uplands to 640 mm in the lowlands, and mean annual potential evapotranspiration is 1030 mm ([Paoloni et al., 1972](#)). Interannual rainfall variability is marked and linked primarily to alternating phases of ENSO ([Scian, 2000](#)), inducing episodes of drier- and wetter-than-normal climate ([Campo et al., 2009](#); [Bohn et al., 2011](#)). Recurrence of drought and increasing water demand owing to population growth very seriously impact on local water resources ([Andrés et al., 2009](#)).

This paper quantifies post-dam geomorphic and vegetation changes across multiple scales (Fig. 4). Changes with time were inspected using a chronological sequence of historical aerial photographs (1961, 1981) and high-resolution imagery (Ikonos, 2004) defining two comparative periods. The first period (1961–1981) spans a pre-disturbance phase, characterized by unregulated flow conditions, and a phase of early disturbance linked to dam completion in 1978 and initial filling of the reservoir (Fig. 2). The second period (1981–2004) spans the post-disturbance phase where the dam controls the magnitude, frequency, duration, and variability of downstream flows. Changes from unregulated to regulated river conditions for a given time step were inspected by contrasting two river segments located above and below the dam (~26- and 41-km length, respectively). In addition, field-based descriptions of present channel conditions (2011–2012) were performed for eight reference reaches of 1-km length located above (3 reaches) and below (5 reaches) the dam (Fig. 1).

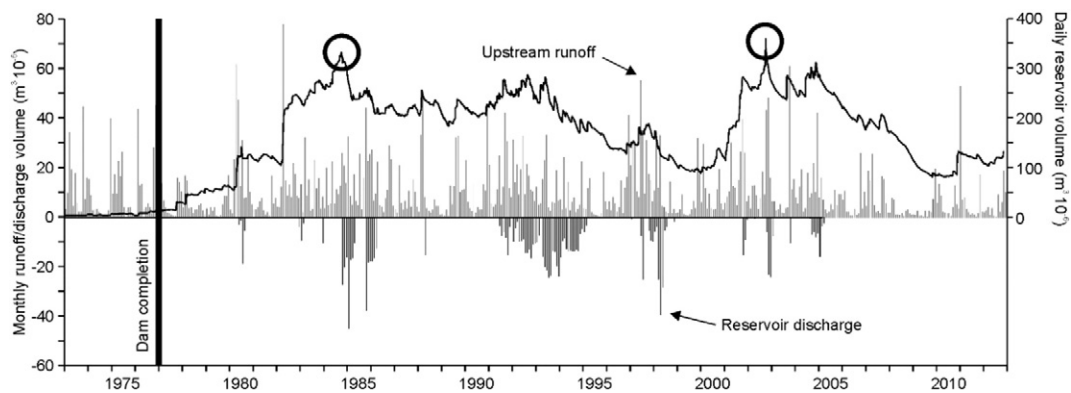
Fig. 2. Monthly runoff volume upstream from the dam and monthly volumes of reservoir discharge over the period 1973–2012. Upstream runoff volumes were estimated from rainfall using the GR2M model (Makhlouf and Michel, 1994). Monthly volumes of reservoir discharge over the period 1973–1988 were calculated by solving the reservoir water balance equation (missing data). Daily reservoir volumes were illustrated to provide an idea of the hydrological magnitude of the dam relative to that of the river. Circles indicate episodes of overflow spills.

Fig. 2 illustrates monthly runoff volumes at La Toma (Fig. 1) and monthly volumes of reservoir discharge as a surrogate of flow magnitude upstream and downstream from the dam. Gauged and estimated reservoir discharges indicate that the reservoir has absorbed the full range of inflow volumes over 19 years of record (48%). In years recording reservoir discharges, annual runoff volumes were reduced by 54%, annual maxima were reduced by 42%, and annual minima were reduced by 86%. The reservoir history registers only two episodes of overflow spills (1984 and 2002), during which the flood wave was attenuated by 31 and 34%, respectively. In the absence of flow release, downstream flow averages $0.26 \text{ m}^3 \text{ s}^{-1}$ and originates from reservoir seepage below the dam structure. Except for some ephemeral tributaries, the Sauce Grande River receives no permanent flow inputs until its confluence with de las Mostazas Creek (lower river section; Fig. 1) about 110 river km downstream from the dam closure.

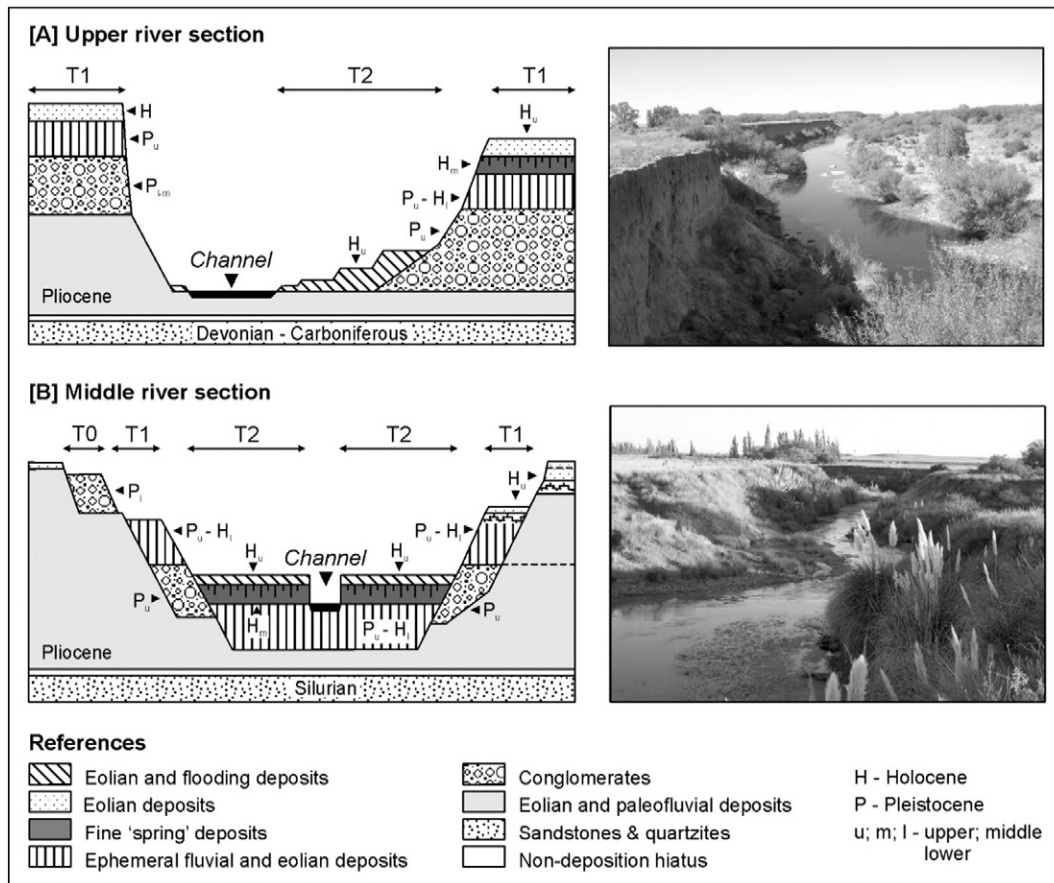
Fig. 3. Schematic cross sections of the Sauce Grande River showing typical geomorphic and geologic characteristics within the upper and middle river sections. Geologic features were modified from [Borromei \(1991\)](#); [Zavala and Quattrocchio \(2001\)](#), and [Quattrocchio et al. \(2008\)](#). Not to scale.

Downstream variations in channel forms and size are apparent (Fig. 3) and conceivably linked to the attenuation of floods and flow transmission losses characteristic of dryland environments (Tooth, 2000a). In the upper section, the river channel is wide, shallow, and develops on the bottom of the incised valley. Migration of the meanders and point bar building outward led to formation of small terrace steps that have changed the original configuration of the valley bottom. In the middle river section, the valley broadens markedly, the terraces lose altitude, and the degree of confinement decreases. The river flows through a narrow, deep, and tortuous channel that constitutes a remnant of an ancient braided morphology (Borromei, 1991). Former braids were covered by aeolian deposits, and the present floodplain constitutes an abandoned portion of the original braided channel.

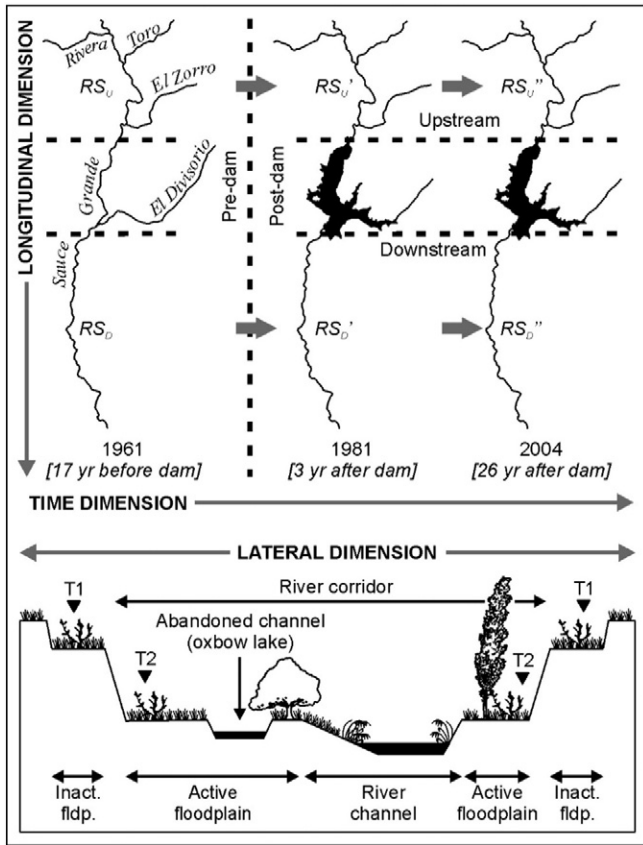
Fig. 4. Spatial and temporal scales used in geomorphic and vegetation analysis. Quantification of change within the regulated river segment (RS_D) is performed with time ($RS_D \rightarrow RS_D''$) and with respect to the unregulated river segment upstream (RS_u). Upstream and downstream river segments were delineated by the extent of the river corridor in each time step.

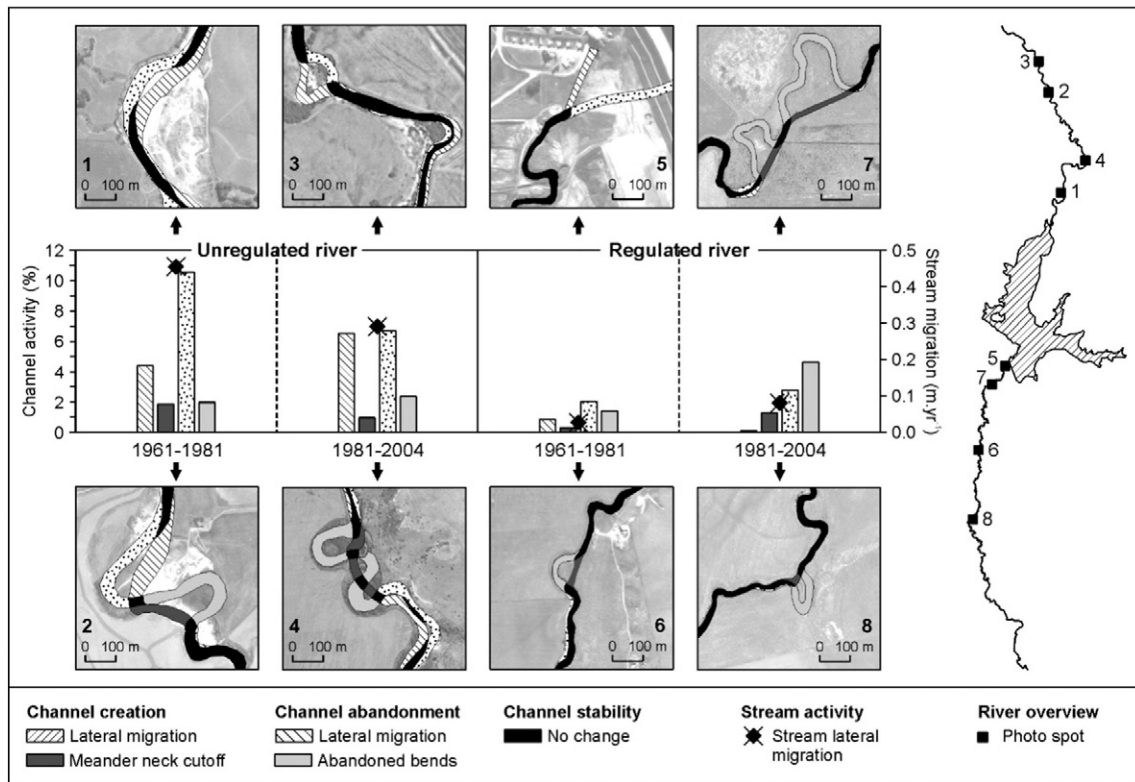
Fig. 5. Channel and stream activity within the unregulated and regulated river segments by comparative period. Boxes provide an overview of major planform changes above and below the dam per comparative period. The scheme on the right shows the relative situation of major planform changes within each river segment.

The unregulated river exhibited marked channel activity (Table 1; Fig. 5). Although new channel surfaces were created by meander migration (10.6%) and cutoff (2.1%), the period 1961–1981 was characterized by abandonment of channel surfaces owing to meander translation (15.1%; Fig. 5, Ex. 1) and abandonment of meander bends (3.1%; Fig. 5,

Ex. 2). Channel activity during the period 1981–2004 was clearly dominated by meander extension and translation. High percentages of channel abandonment (19.8%) indicate a tendency to channel straightening. Yet increased bend amplitude in some river sections was notable (Fig. 5, Ex. 3), and three major cutoffs in the middle-lower river segment (Fig. 5, Ex. 4) give evidence of the geomorphic effectiveness of floods during the second comparative period.

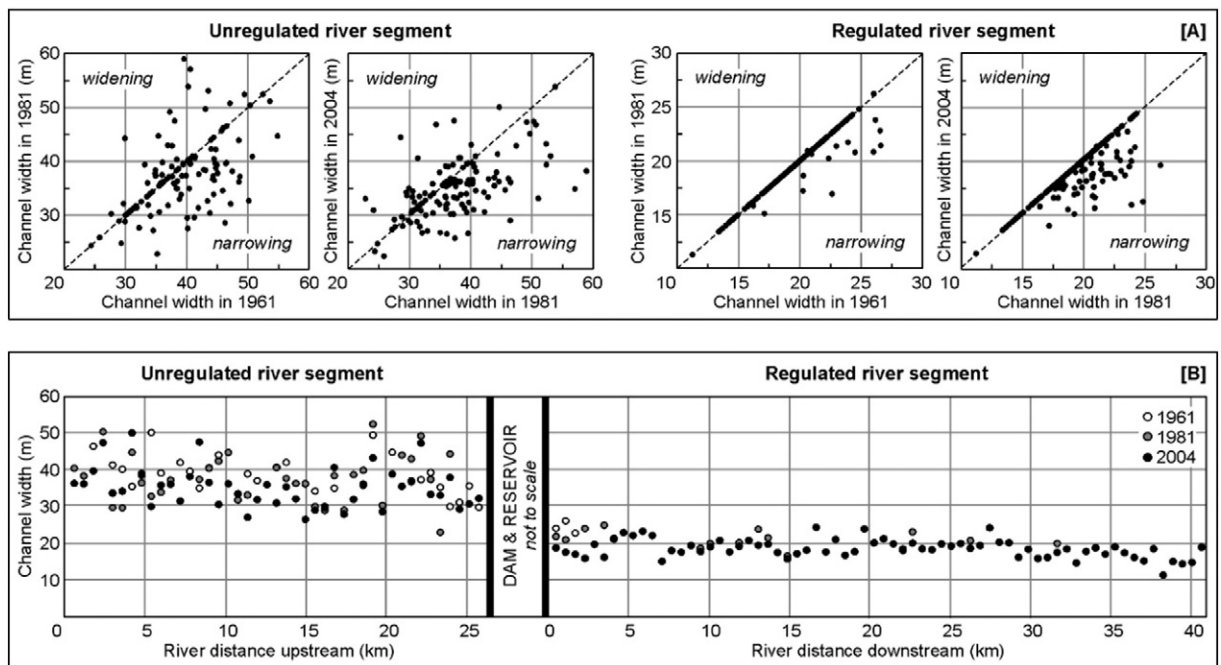
Fig. 6. [A] Scatterplots comparing the river channel width between consecutive time steps, and [B] river channel width as a function of time and distance downstream. Channel width was calculated as a function of channel area divided by 200-m length along each river segment. The hashed central line in [A] indicates a situation of no change between consecutive time steps. Data in [B] were reduced to improve readability (1 point every 600 m of channel length). The error margin for an exceedance probability of 10% is 4.8 m.

Upstream from the dam, coupled channel widening and narrowing occurred during both comparative periods with a tendency to narrowing during the second comparative period (Fig. 6). Width changes occurred most likely in river sections exhibiting active lateral migration. Thus, many channel sections narrowed owing to lateral accretion and outward migration of meander bends (up to 50% during 1961–1981, and up to 60% during 1981–2004), and river sections dominated by cut bank erosion increased in width by up to 62% (1961–1981) and 55% (1981–2004). Below the dam, the channel revealed a tendency to narrowing during both comparative periods (Fig. 6). The period 1961–1981 was characterized by marked contraction of the channel width (12 to 33%) owing to deviation and artificial straightening of the river course in the vicinity of the impoundment. During the period 1981–2004, the channel width contracted in 31 sites (15% of cases). The percentage of channel narrowing decreased in the downstream direction from 44 to 4% and responded to two distinct, localized processes. Immediately below the dam and over ~4 river km, the channel narrowed by between 9 and 44% owing to artificial meander cutoff, building of artificial levees, and other dam-related waterworks. Downstream from river km 4, the position of bank lines remained relatively unchanged. However, contraction of the channel width (6 to 30%) was inferred by vegetation encroachment over former bare channel surfaces.

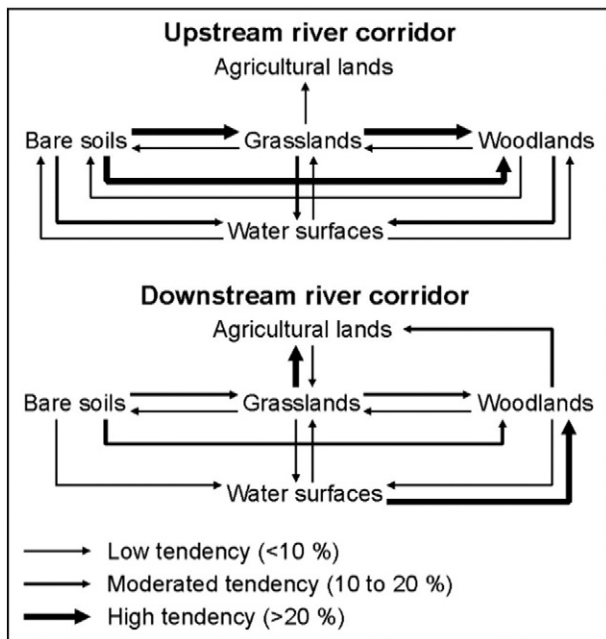
Fig. 7. Trends in vegetation dynamics within the river corridors upstream and downstream from the Paso de las Piedras Dam. Trends were calculated from transitional diagrams of landscape units by comparative period.

Second, the river corridors upstream and downstream from the dam revealed contrasting trends in vegetation dynamics (Fig. 7). Other than the expansion of agricultural lands over grasslands (583% between 1961 and 2004; Table 2), the most important transitions downstream occurred from water surfaces to woodlands (38%). This suggests a tendency for woody vegetation establishment within the river channel, near to the water surface. A moderated tendency for woody vegetation growth over former bare banks (18%) and grasslands (16%) was also identified. Yet the expansion of woodlands over these landscape units was notably less significant than that observed within the river corridor upstream from the dam (Fig. 7). Upstream, woodlands expanded within the river channel and the floodplain, covering 33% of former grasslands and 57% of former bare banks.

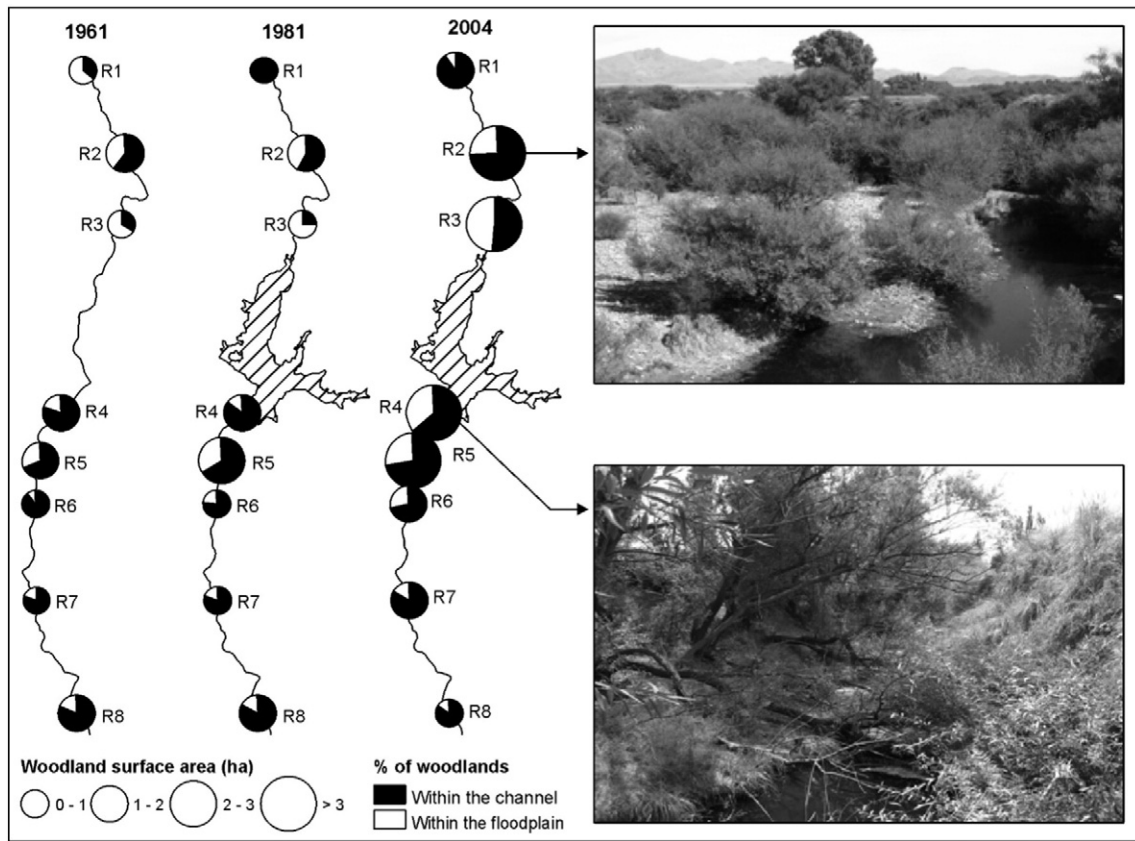
Fig. 8. Surface area occupied by woodlands by river reach (R) and time step. Pie charts differentiate percentages of woody vegetation developing within the river channel and the floodplain. Photos provide an example of vegetation encroachment within the channel upstream and downstream from the dam.

Third, woody vegetation establishment within the river corridor downstream from the dam was discontinuous, decreased in the downstream direction, and constrained almost exclusively to the river channel. Analysis at the scale of the reference reaches (Fig. 8) revealed three distinct patterns of woody vegetation establishment with distance

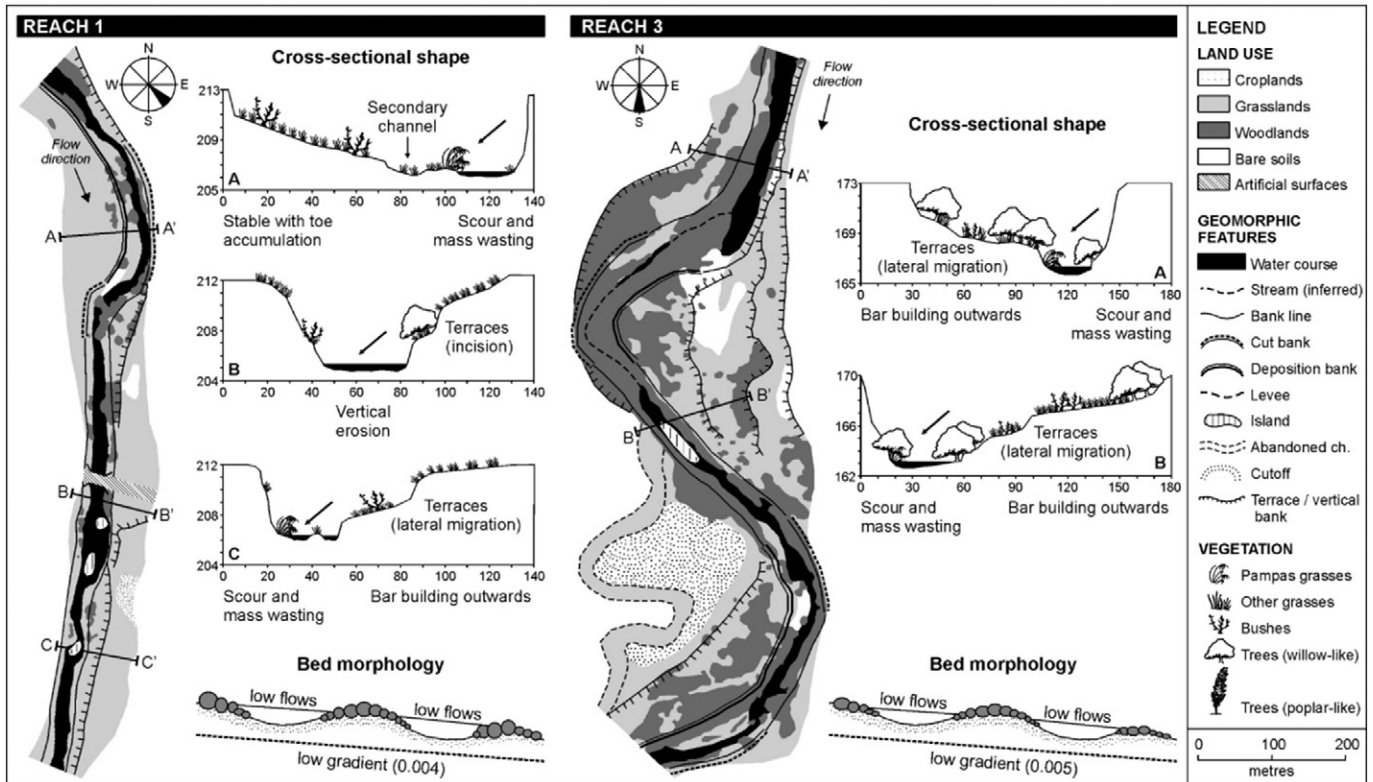
Fig. 9. Geomorphic features, land cover types, and representative cross sections for two reference reaches located upstream from the Paso de las Piedras Dam. The locations of the reference reaches along the unregulated river segment upstream are shown in Fig. 1.

Present channel forms clearly differentiate river reaches located above and below the dam. The river channel above the dam (Fig. 9) is broad and shallow ($27 < w:d < 37$), and the floodplain is well developed for much of the river course. Channel width averages 53 m (± 16 m), and floodplain width averages 135 m with high variation (± 94 m). The channel morphology is clearly meandering for all reaches; variations in sinuosity ($1.1 < 1.5$), meander wavelength (150 m $<$ 600 m), and meander width (20 m $<$ 200 m) are probably linked to local variations in slope and degree of confinement within the incised valley. Bed material is coarse in riffles (cobbles and coarse gravel) and finer in pools (small gravels, sand and silt); banks are composed of noncohesive deposits in point bars (sand and gravel) and of layered, cohesive paleofluvial and aeolian deposits in cut banks (fine sand, silt and clay). Bank profiles reveal active cut bank erosion including bank undercut and toe scour (especially in R3; Fig. 9); channel sections exhibiting vertical banks display coupled toe accumulation by mass wasting. Lateral accretion in point bars is a more dominant process. Outward migration of the meanders led to formation of terrace steps contained within the valley, and hence topographically lower than the preincision surface.

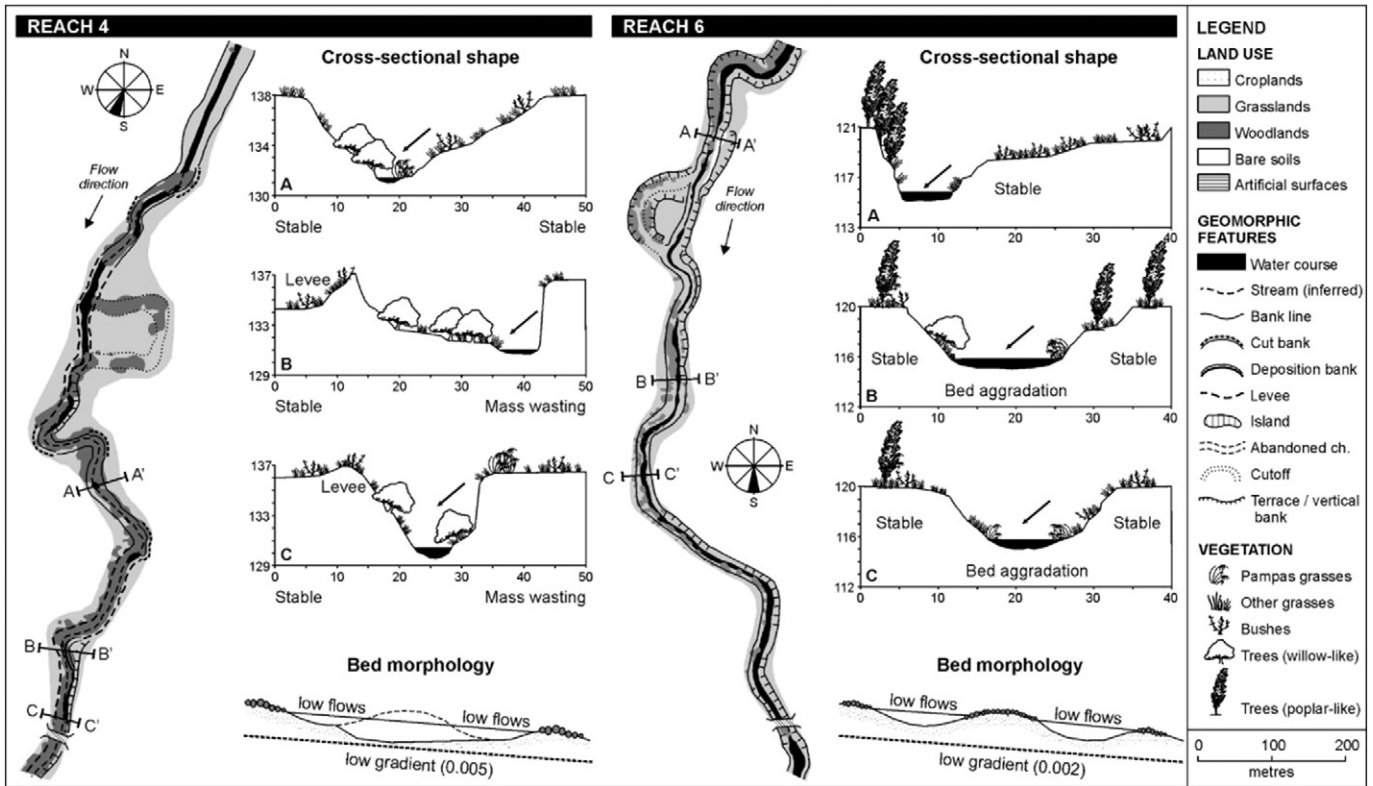
Fig. 10. Geomorphic features, land cover types, and representative cross sections for two reference reaches located downstream from the Paso de las Piedras Dam. The locations of the reference reaches along the regulated river segment downstream are shown in Fig. 1.

The river channel below the dam is narrow and deep ($7 < w:d < 10$), and the floodplain is much reduced (Fig. 10). Mean channel width is 21 m (± 6 m), and mean floodplain width is 53 m (± 30 m). Except for R5 where meanders are very tortuous ($S = 2.8$), sinuosity increases in the downstream direction from 1.3 to 2.2. Bed material is composed of small gravel in riffles and of silt/clay in pools; banks exhibit cohesive layers of fine 'spring' and ephemeral fluvial-aeolian deposits. Bank profiles display stable conditions for most river reaches, except for R4 where mass wasting occurs in vertical banks with little vegetation cover. Immediately below the dam, any evidence of channel activity is related to human intervention. For example, artificial bed deepening in R4 facilitates evacuation of dam outlets and spills, and artificial levees (built by dredging floodplain material) prevent bank overflowing. Outside the vicinity of the impoundment, bed deposition of very fine materials (silt/clay and organic matter) leads to localized reduction of the channel depth (e.g., R6; Fig. 10).

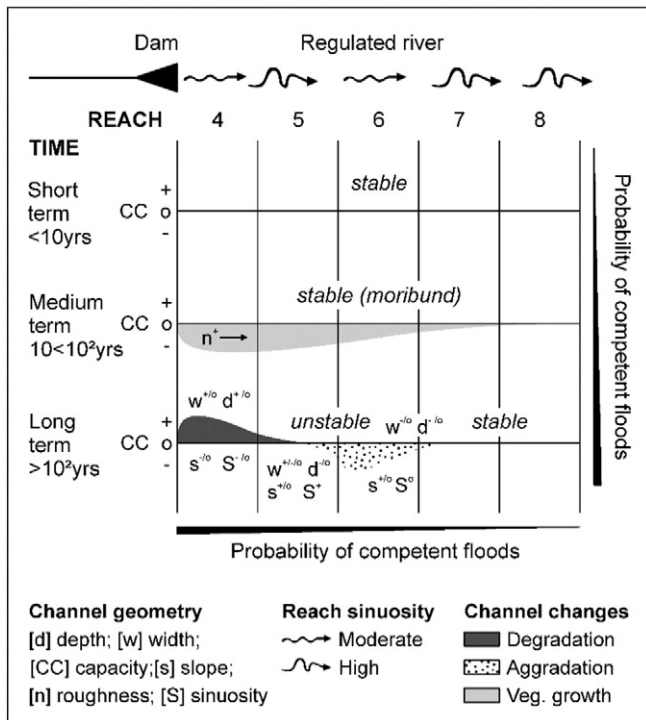
Fig. 11. Adjustment of the channel morphology to extreme flow regulation below water-storage reservoirs in drylands. The model of adjustment (modified from Petts, 1979) considers the potential for change relative to the frequency and intensity of competent floods with time and distance from dam closure. The direction of change is indicated by [o] no significant change, [+] increase, and [–] decrease.

In opposition to these assumptions, however, artificial levee building has been reported to increase rates of bank erosion because the unconsolidated sediment was easily eroded once bank-full flows occurred (Leeks et al., 1988). Furthermore, the comprehensive review of Tooth (2000b) on dryland rivers outlined that *even channels heavily vegetated with perennial or ephemeral trees, shrubs and grasses are sometimes subject to flood-related changes* (p. 83). These aspects raise two important questions. First, even if vegetation did provide an element of resistance to bank erosion, was the maturation of individuals rapid enough to prevent the levees from being eroded? Second, even if channel banks were biostabilised, was vegetation establishment significant enough to increase thresholds of geomorphic activity? As reported by Petts (1980), the potential for change in regulated rivers depends not only on the channel morphology and materials, but also on the frequency and intensity of competent discharges below the dam. In drylands, this aspect is particularly relevant because a 'competent discharge' may be an infrequent, large flood unrepresentative of a more common range of floods (Tooth, 2000b). Accordingly, marked channel stability within this highly regulated dryland river may be interpreted within a model of channel adjustment relative to the frequency and intensity of competent floods with time and distance from dam closure (Fig. 11).

The unregulated Sauce Grande is in a transient, unstable state (*sensu* Tooth and Nanson, 2000) where complete adjustment of form to process is inhibited until a geomorphically significant flood event occurs. After impoundment by a large surface-area, water-storage reservoir such as Paso de las Piedras, competent floods downstream are unlikely. The channel morphology will not change, and downstream flows will simply accommodate within the existing channel form. As the regulated Sauce Grande receives no major tributaries, the probability of competent floods decreases with distance downstream and so stability will prevail throughout all reaches (Fig. 11).

Yet the probability of competent discharges increases as the time scale increases (Petts, 1979) and a geomorphically significant flood is likely to occur with time (Fig. 11). If so, degradation may occur immediately below the dam (reach 4) increasing channel depth and width. Differential erosion by meander migration may produce localized changes of the channel width in reach 5. Given the low energy of the river section below the dam, the eroded material will be deposited in reach 6 and, within the distal reaches, the channel morphology will not change. Tooth (2000a) reported that in dry, lowland zones with absence of tributaries, channels were stable because of the effects of flow transmission losses and attenuation of flood hydrographs. Although the most obvious spatial comparison contrasts river reaches upstream and downstream from a dam (Braatne et al., 2008), channel stability in this low-gradient lowland river section probably existed prior to dam closure and will remain unless a high-magnitude, low-frequency flood event occurs.
