# Impacts to agriculture and critical infrastructure in Argentina after ashfall from the 2011 eruption of the Cordón Caulle volcanic complex: an assessment of published damage and function thresholds

**Keywords:** Volcanic ash, Puyehue-Cordón Caulle, Ashfall, Ashfall Impacts, Infrastructure, Agriculture

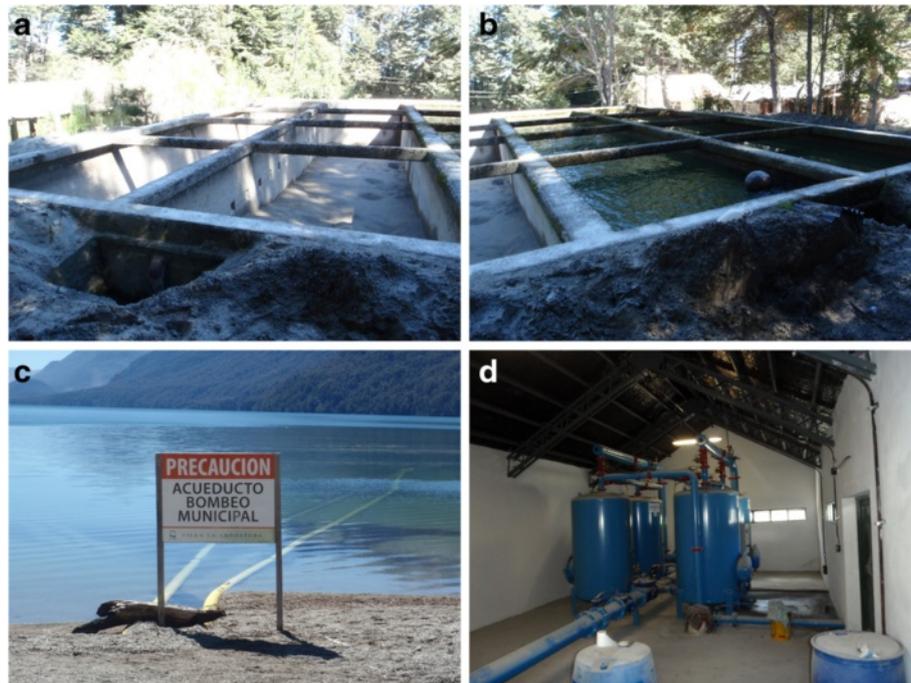
**Fig. 8** Villa la Angostura water supplies **a** non-operational sand filters of the Las Piedritas stream-fed system, filled with ashfall; **b** operational sand filters at the Las Piedritas treatment site; **c** Lomas del Correntoso intake from Lake Correntoso; **d** Chlorination plant

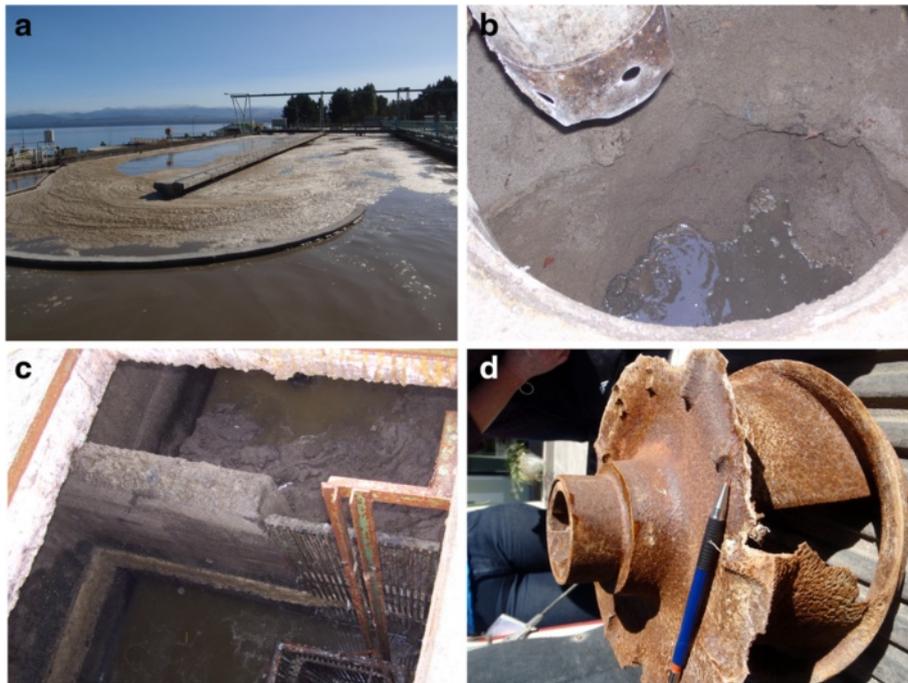
**Fig. 11** Bariloche wastewater treatment system **a** biological reactor showing some *Nocardial* foaming; **b** and **c** sewer lines and junctions inundated with ash; **d** ash-accelerated pitting and thinning damage to sewage pump impeller
