Case study

# Biofouling of crypts of historical and architectural interest at La Plata Cemetery (Argentina)

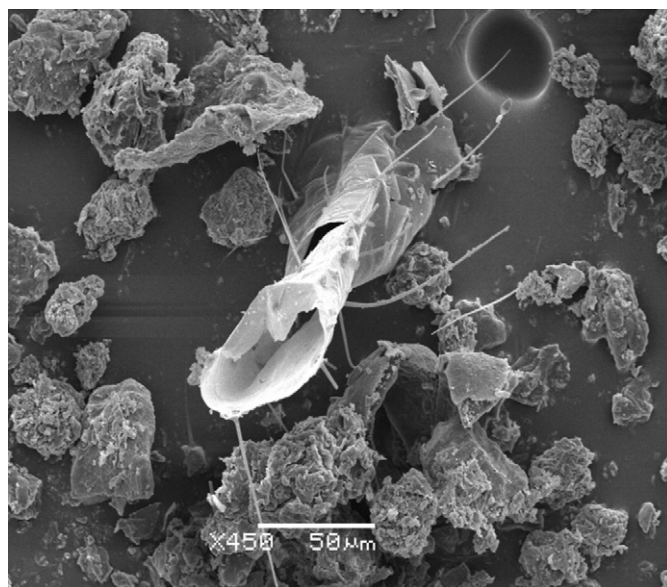
**Fig. 2.** Biofilm on the marble column of crypt C95.
