# Thermal Buckling Behavior of Open Cylindrical Oil Storage Tanks under Fire

Jean C. Batista-Abreu<sup>1</sup> and Luis A. Godoy, M.ASCE<sup>2</sup>

## Summary of the 2009 Accident in Bayamon

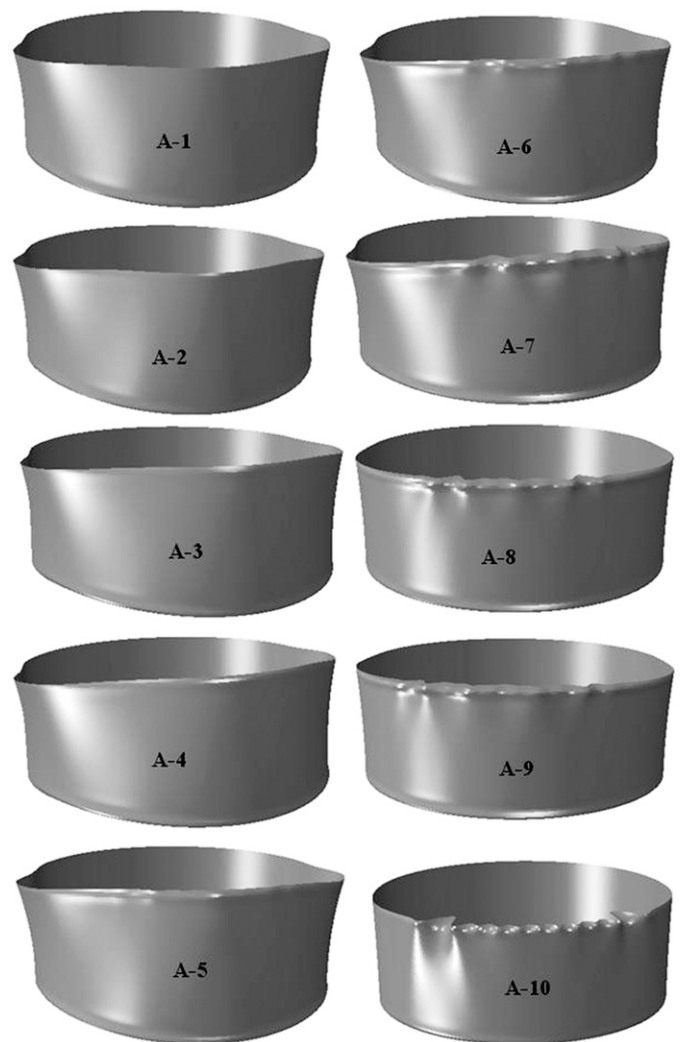
**Fig. 9.** Deformed configurations of empty open tanks under temperature and thermal gradient through the shell thickness (Case A scenario); thermal parameters for each case are given in Fig. 10

The tank was first subjected to a uniform thermal distribution through the shell thickness (case A-1 in Fig. 9). The computed response shows large radial and vertical displacements in the heated zone when buckling takes place at 500°C in the meridian of maximum temperature. The structure can hold a relatively high temperature, because it is free to deform at the top and is only restricted

by boundary conditions at the base. The heated zone undergoes an expansion until stresses and deformations in the transition zone (between the heated region and the region that is not affected by temperature) induce thermal buckling. Notice that large deformations occur in this case at about 90° from the meridian of maximum temperature.

Even though buckling occurs for a temperature level at which material degradation would be active, the structure develops low stresses in the cylindrical body; high stresses are concentrated at the base because of the restriction imposed by the boundary conditions. Therefore, geometric nonlinearity dominates thermal buckling.

Tanks with high thermal gradients through the thickness (see cases A-8–A-10 in Fig. 9) show local buckling in the free boundary along the heated zone, developing waves at the top of the cylinder. In the case of the tanks with low thermal gradient (cases A-1–A-4 in Fig. 9), buckling takes place in the transition zone between the region with high temperatures, which is in expansion, and the region that is not directly affected by temperature. The zone with lower temperatures acts as a constraint to the zone of high temperatures, with the consequence that the structure adopts a new geometric configuration to satisfy the equilibrium conditions.

Finally, for some failure scenarios, as in cases A-5–A-7 in Fig. 9, the deformed configurations have the simultaneous influence of both temperature and gradient effects.

The incidence of a temperature gradient is seen to affect not just the critical temperature but also the mode shape, as illustrated by the cases shown in Fig. 9. The buckling mode is induced by the expansion of a highly heated region, which attempts to deform but is restricted by boundary conditions and by other regions of the same shell that are subjected to lower temperatures.

Fig. 3 shows a tank affected by the Bayamon fire. Models A-7–A-10 have a configuration similar to the tank for which large deformations are observed along the free boundary at the top. From the modes at buckling shown in Fig. 9, such a displacement shape is more closely associated to scenarios in which there is a thermal gradient across the shell thickness rather than situations in which the temperature remains uniform in the thickness.

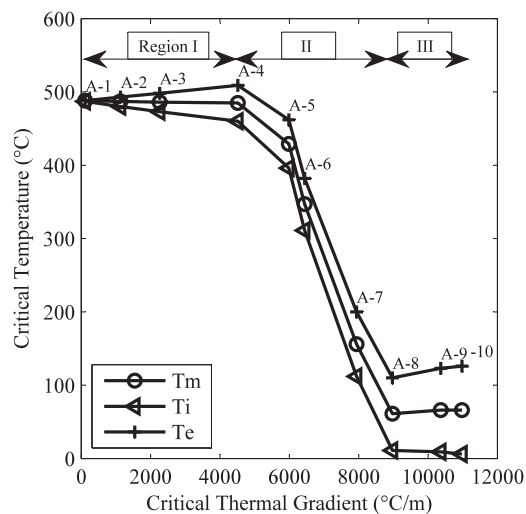
**Fig. 10.** Failure combinations of temperature and thermal gradient in terms of internal, mean, and external surface temperatures for Case A

Results are shown in Fig. 10, in which each point corresponds to a combination of temperature and temperature gradient leading to thermal buckling. The results are shown in terms of the temperatures at the inner and outer surfaces of the shell and their mean values.

Three regions can be seen in the curve of failure combinations (see Fig. 10). In Region I, buckling is controlled by the mean temperature of the shell. The thermal gradient in this region has little influence on the critical temperature of the structure. In Region III, buckling is caused by high gradients and low values of mean temperature, which imply significant differences in the temperature between the internal and external faces of the cylindrical shell. Finally, there is a transition in Region II, in which the response is controlled by both the mean temperature and the thermal gradient. The value of the mean temperature that causes buckling is highly sensitive to the thermal gradients.

In summary, the maximum temperature that the structure reaches when it buckles is about 500°C and occurs for low gradient levels (Fig. 10). For gradients higher than 5,000°C/m, buckling is no longer controlled by the mean temperature, but by the interaction of the mean temperature and the thermal gradient, corresponding to a temperature difference between the external and internal faces of about 50°C. Buckling is strongly controlled by the thermal gradient for values on the order of 9,000°C/m.

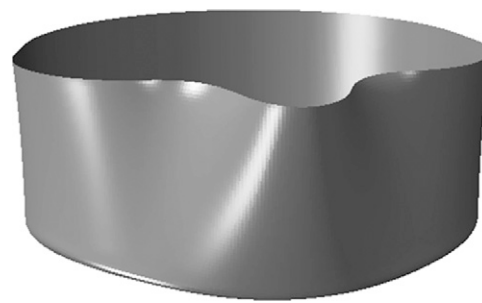
**Fig. 11.** Advanced postbuckling deformed configuration of the open tank, Case A-1

Evidently, tanks are not found just at the buckling state after a fire like that at Bayamon. During a fire, the temperature might rise almost continuously, causing the structure to deform beyond the onset of buckling, so that the final configuration may considerably differ with respect to the initial shape at thermal buckling. Thus, it may be illustrative to estimate possible shapes for advanced postbuckling states. Fig. 11 shows the deformed shape corresponding to case A-1 under a maximum temperature of 1,000°C. It can be seen that the geometry changes significantly with respect to the buckling mode initially observed and now has large displacements at the meridian with high temperatures.

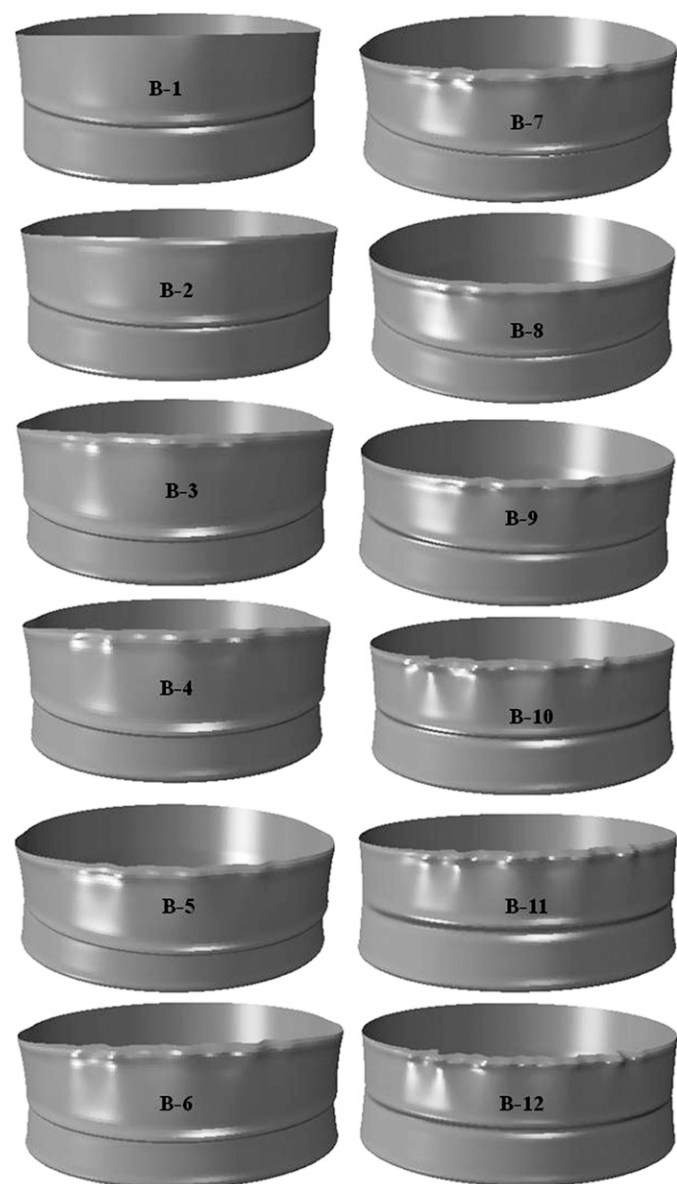
**Fig. 12.** Buckling configuration of tanks for Cases B-1–B-12

The results are shown in Fig. 12 for a liquid level that reaches half of the cylinder height. All the cases analyzed show that shell buckling takes place without the occurrence of plasticity. Large deformations are concentrated in the upper region right above the fluid level. Liu et al. (2008) also observed this pattern.

Cases in which the uniform thermal distribution through the shell thickness determines buckling (cases B-1 and B-2 in Fig. 12) show localized damage in the zone with direct heat, above the level of stored liquid. In other cases (B-3–B-12), the thermal gradient influences the results and generates a wavy pattern at the top.

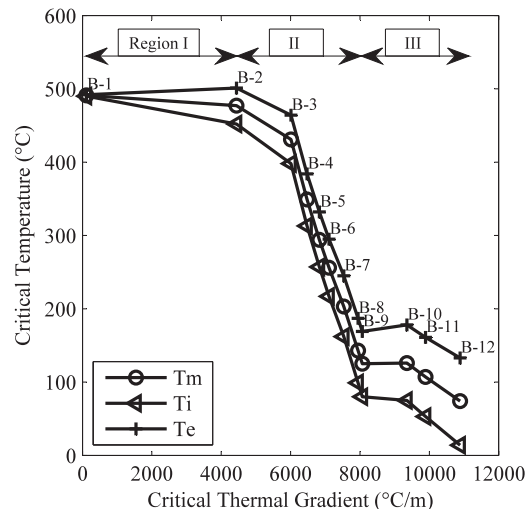
**Fig. 13.** Combinations of maximum temperature and thermal gradient that induce thermal buckling in terms of internal, mean, and external surface temperatures for Case B

A summary of the critical states, as given by temperature and thermal gradient, is presented in Fig. 13. In approximately half

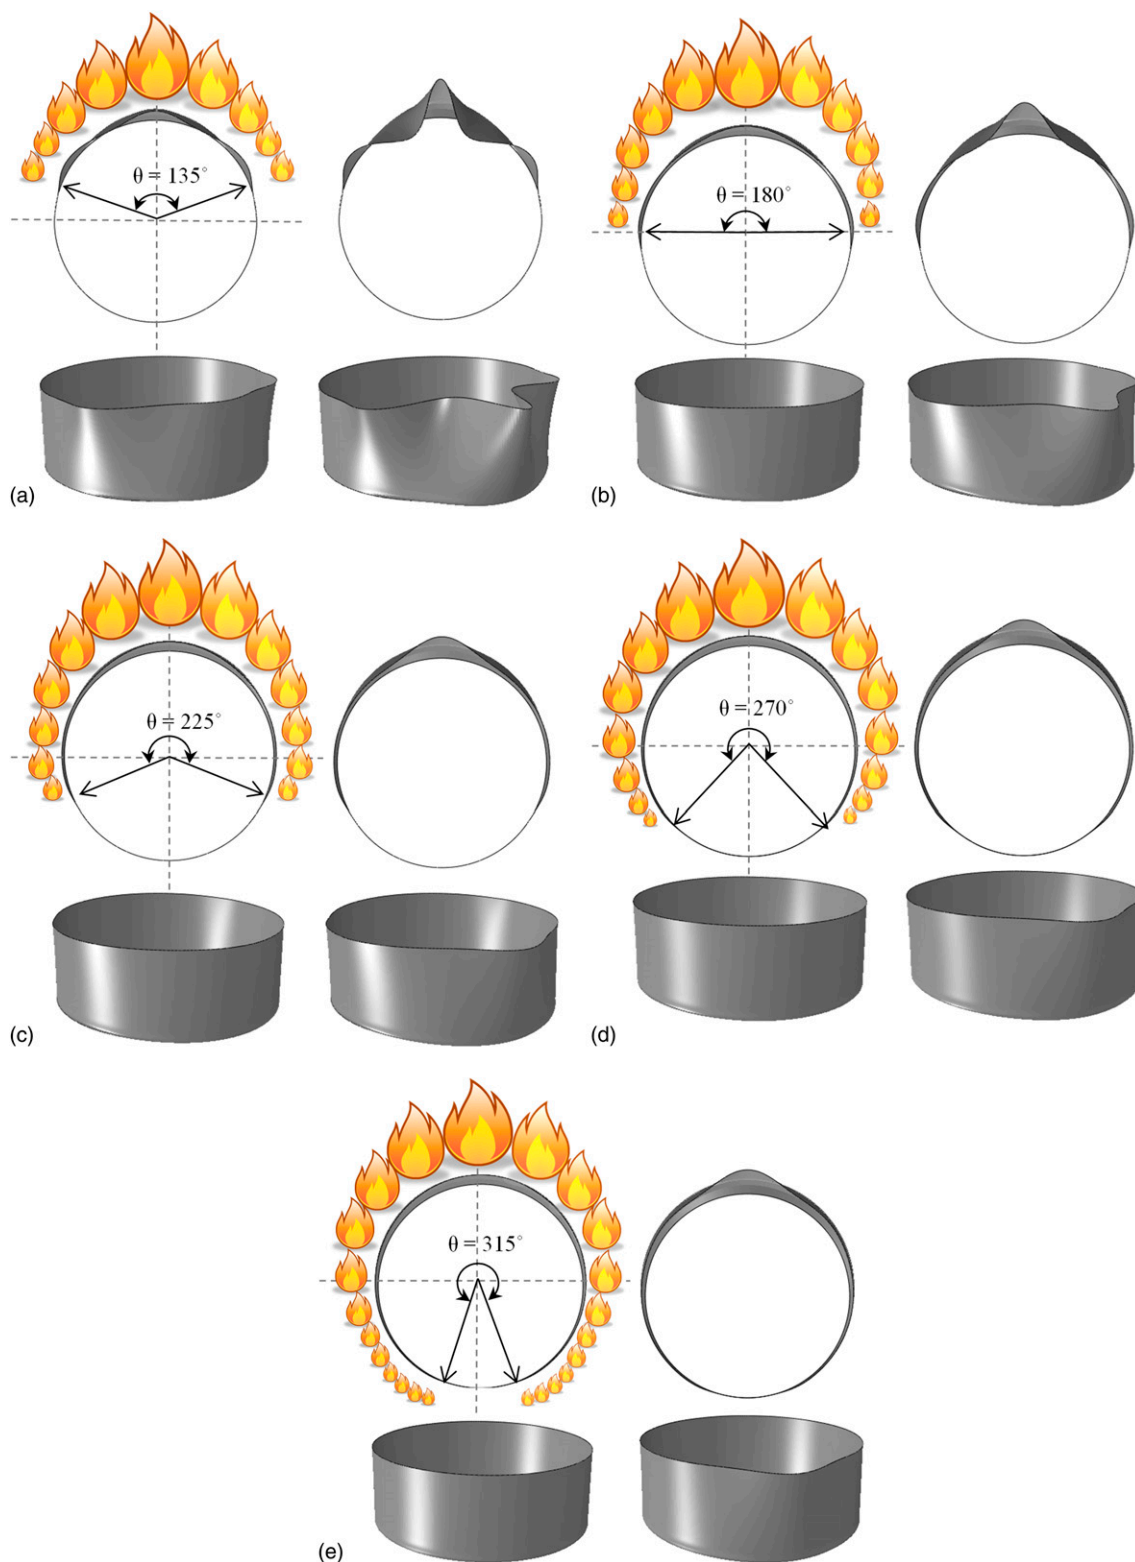
**Fig. 14.** Buckling (left) and postbuckling (right) deformed configuration of open tanks with different areas exposed to fire, corresponding to (a) 135; (b) 180; (c) 225; (d) 270; (e) 315°

temperature in the cross section. When buckling occurs, the displacements of the central node in the heated zone of the tank are 0.16 m approximately and vary between 6 and 16 times the shell thickness.

In all cases, fire acts along the complete height, affecting central angles of 135, 180, 225, 270, and 315° around the circumference. It can be observed that, not considering the size of the surface area on which the fire acts, the temperature needed to produce shell buckling is about 500°C. For this failure scenario, deformed configurations of tanks are shown in Fig. 14 at buckling (left) and postbuckling (right) states. In addition, the cross sections of buckled and postbuckled cylindrical shells attributable to thermal action are shown for each case. Common features in all cases are the formation of bulges on the sides of the heated zone and a pronounced bulge in the zone with higher temperatures. Buckling takes place inside the expanding region.
