Loss of a 30" directional crossing due to pipeline collapse during pullback

Janine Booman^a, Hernan Kunert^b, José Luis Otegui^{c,*}

This article concerns the loss of a Horizontal Directional Drilling crossing due to a failure that took place during pullback of the pipeline. The more than 500 m long drilling was meant to lodge a 30" pipeline that crossed a large river. The failure caused the total loss of the crossing, and the necessity to repeat the entire process in another, less favorable location. Root causes involved a difficult soil composition, and constraints at a populated bank that led to engineering solutions not proved before on a pipe of such diameter. Discontinuities on the tunnel and the use of a sacrifice pipe at the front end of the pipe column, which was related to the need for more pipes than originally calculated because of a series of problems at the beginning of the perforation, were also defined as root causes. Lessons learned are highlighted.

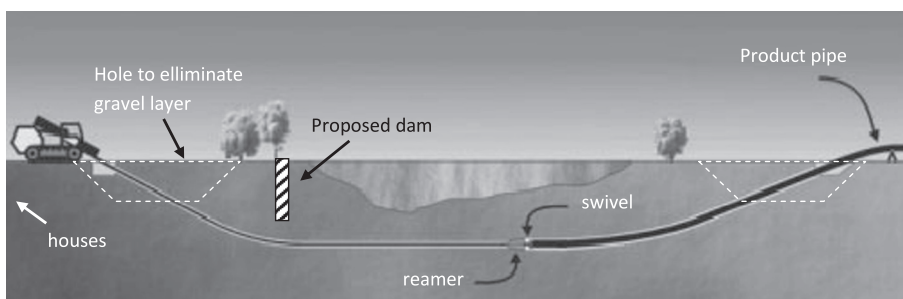
Fig. 1. Sketch of the initially proposed HDD, at the stage of pullback of the product pipe.

be dug too close to the river bank. At that time of the year, the water level in the river was closed to maximum. In order to avoid risk of a bank rupture and consequent flood, a deep concrete dam was required. Design was therefore changed; preliminary tests showed that the gravel layer could be safely bored at an adequate angle without digging the initial holes.

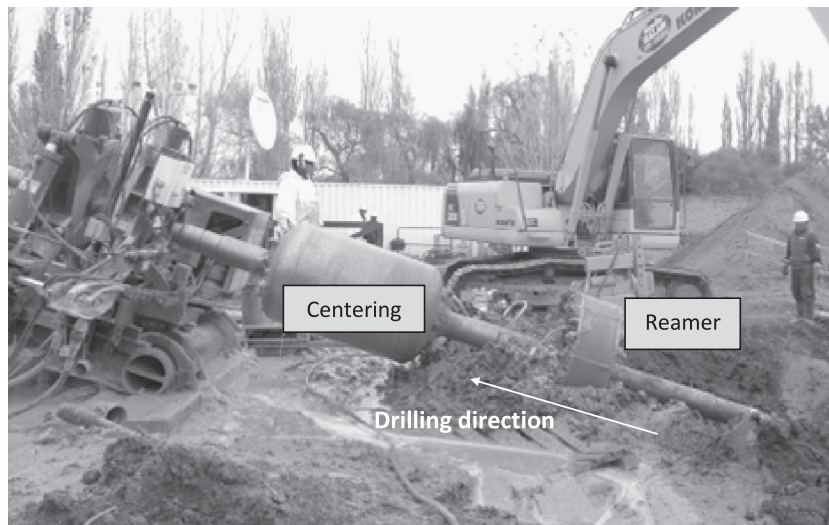
Fig. 3. Detail of the last drilling stage of the tunnel.

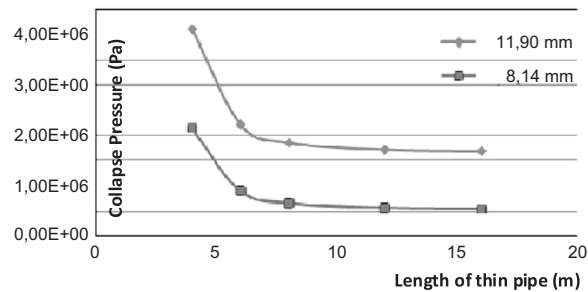
In order to study the influence of the length of the thinner pipe, the model [18] was applied with the geometries involved in the HDD. Fig. 10 shows that the collapse external pressure drops as the length of the thinner pipe increases and stabilizes for thin tracts longer than 6 m. The formula for this limit pressure is obtained from buckling theory [19]:

The reduction in thickness of the first pipe in the column lead to a stress state twice and a half more critical than for the rest of the column. Results of the numerical modeling also show that the influence of the thinner pipe in the collapse pressure, if the thin tube is more than 6 m long, is such that the strength of the pipe string is similar to that of the whole pipe string made with thin pipe. This is the present case (each pipe is about 12 m long).

Fig. 10. Variation of collapse pressure with length of thinner pipe, according to model by Dvorkin et al. [17].
