Engineering Failure Analysis 16 (2009) 187–199

Self-ignition of natural gas inside pipes at a regulation station

Pablo G. Fazzini^{a,*}, Jose Luis Otegui^b

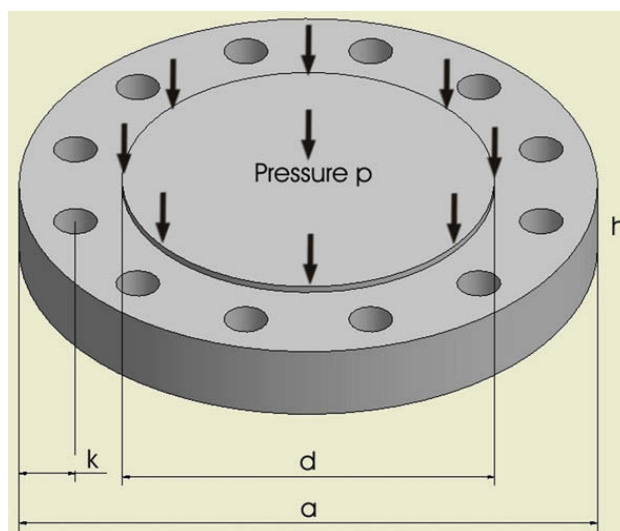
During plastic bending of the flat plate at the end flange the neutral plane is approximately at mid thickness. To find the maximum pressure underwent by the plate, it is modeled a circular plate of diameter d and thickness h , subjected to a uniform pressure in its surface, see Fig. 9, supported in its perimeter. Its solution is well known, given for instance in Table 19.1 of Ref. [1]. If simply supported, radial (S_r) and tangential (S_t) components of the stress state at the center of the plate are

When the plate begins to yield this stress is equal to the yield stress S_{and} , of the steel, this is, 408 MPa. The plate underwent important plastic deformations, thus its resistance to deformation is better represented by the flow stress, if taken as the average between yield and ultimate stresses, S_y and UTS, this is about 462 MPa. Then, the pressure necessary to deform the flange plate is

$$p = 37.5 \text{ MPa}$$

Fig. 9. End flange as a circular plate supported in its perimeter, subjected to uniform pressure.

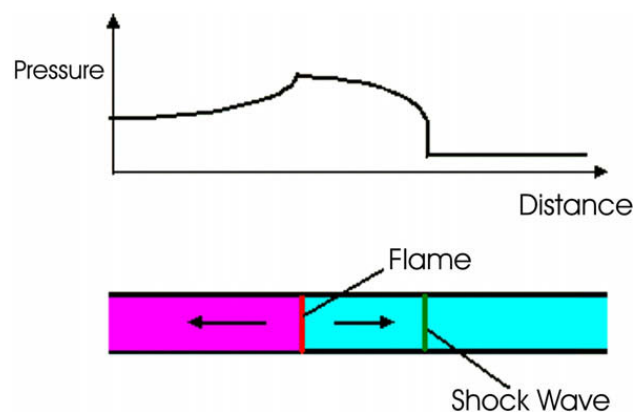
The pressure in combustion at constant volume is not the maximum attainable pressure in a gas explosion. Dynamic effects such as a pre-compression can cause much higher local explosion pressures. The energy released in the initial part of the explosion can pre-compress the gas still not burned, which allows pressure to surpass the attainable value from the original pressure [2]. A deflagration propagating in a collector pipe leads to the situation shown in Fig. 10.

Fig. 10. Deflagration propagating in a collector pipe.

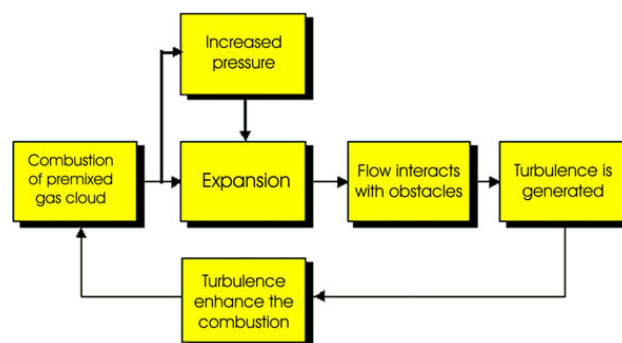
Turbulence is the main mechanism by which the flame is accelerated in collector pipes. When the gas is burned, it expands and pushes the gas without burning ahead of the flame front. The flow in the front can cause a boundary layer of increasing turbulent flow and this way the turbulence can reach burn speed. Experiments in literature [2] show the importance of edge conditions in a collector pipe (Fig. 11).

Fig. 11. Transition from deflagration to detonation in a collector pipe.

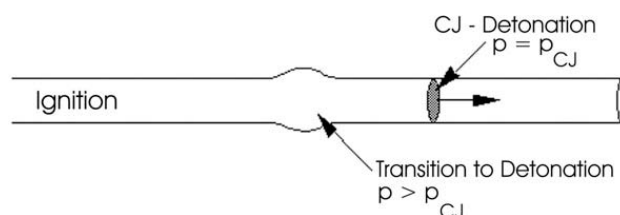
Transition from deflagration to detonation is characterized by very high local pressures, up to 50 times the initial pressure. In accidents, great damage can be observed in the place of transition. When detonation propagates the so called CJ (Chapman–Jouguet) condition develops, with smaller pressures than the maximum just defined [3], see Fig. 12.

Fig. 12. High local pressures in transition from deflagration to detonation, Chapman–Jouguet condition.

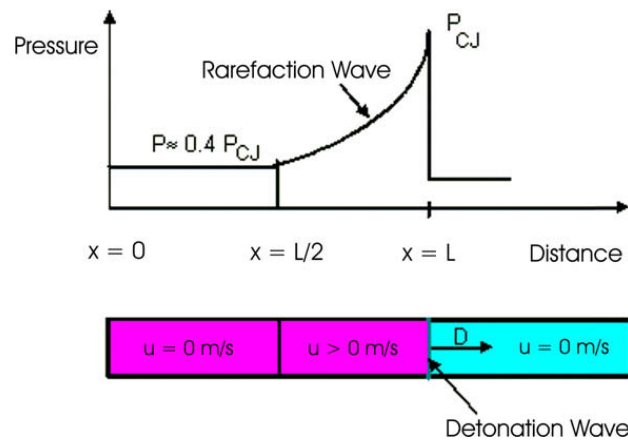
The mechanisms of transition to detonation are not yet completely understood. Fuel concentration is also an important factor. After the detonation front the combustion products expand and pressure drops, see Fig. 13. Pressure drop depends on edge conditions. The expansion of combustion products forms a propagating blast wave in the tube.

Fig. 13. Expansion of combustion products and detonation front.

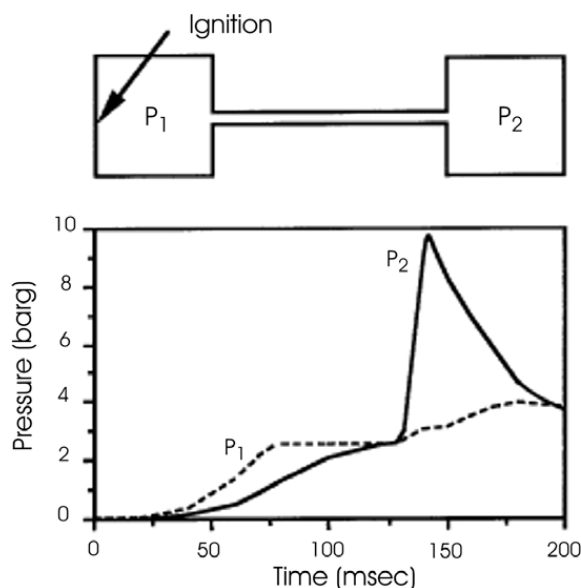
The “pressure pile up” effect considers two comparable volumes joined by a pipe, see Fig. 14. In our case, these are the filter and the portion of pipe from the Tee. With this configuration, different tests demonstrate that when ignition takes place within one of the volumes, pressure increase in the second volume is much larger than expected for an explosion at constant volume. When the flame enters volume 2, it does it as a “Jet” into the non-burning, pre-compressed gas mixture. The pressure developed in the deflagrations depends on pressure and on the speed of the flame front. The configuration at the failed collector does not allow the total development of the phenomenon, but does allow for an increase of pressure in the zone of the filter discharge Tee.

Fig. 14. Pressure pile up effect in two comparable volumes joined by a pipe.
