Engineering Failure Analysis

Challenges to the integrity of old pipelines buried in stable ground

Jose Luis Otegui¹

Y-TEC (YPF – CONICET), Argentina

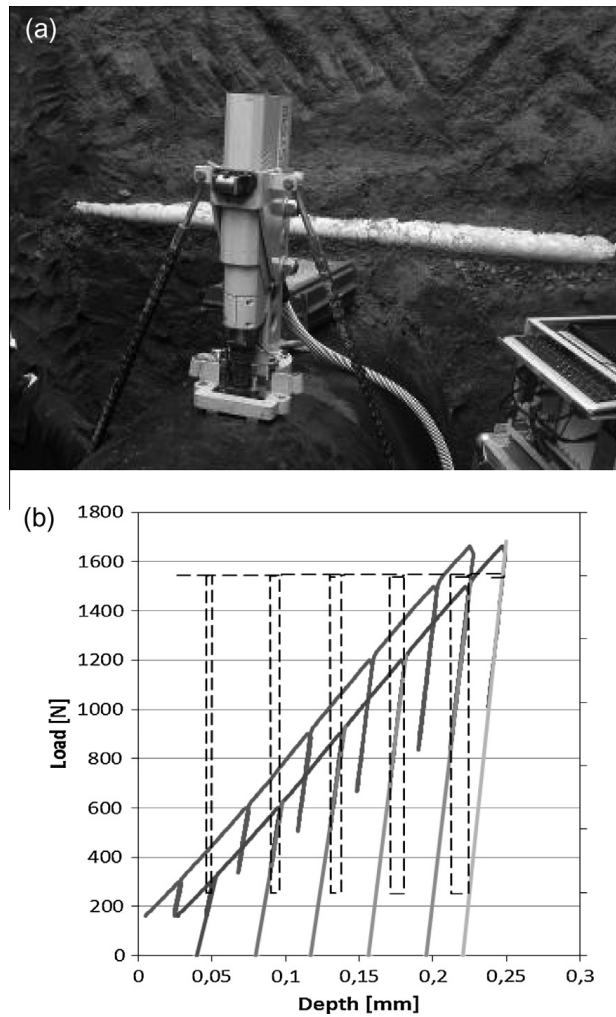
Another problem faced after privatizations was assuring fitness for purpose due to lack of information about pipe materials. The ABI (automated ball indentation) technique is a nondestructive test designed to determine yield strength of line pipes [17], which takes a few minutes and can be carried out, in most cases, while the equipment is operating. The test consists of a spherical tip indentation, carried out in a few cycles, while load and displacement of the tip are recorded through high precision and linearity sensors (Fig. 6). These data are then used to estimate material mechanical properties.

Fig. 6. (a) ABI test of a buried pipe and (b) typical load–displacement data for strength calculations [17].
