International Journal of Pressure Vessels and Piping 79 (2002) 767–775

Integrity and service life of LPG carafes

P. Fazzini*, O. Santi, J. Belmonte, J.L. Otegui

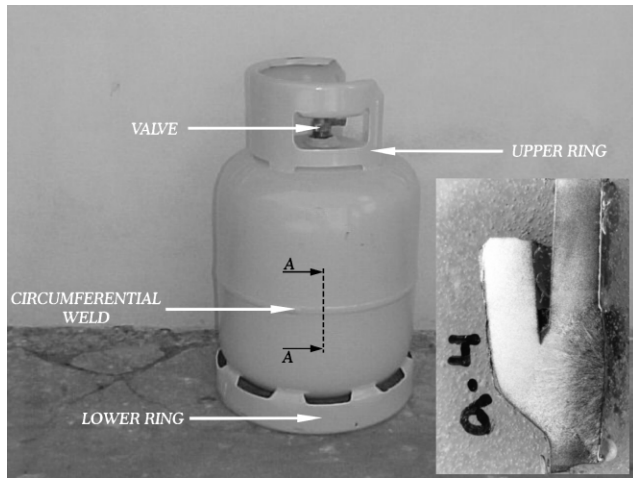
Fig. 1. 10 kg LPG carafe.

thereby generating moderate stress raisers. Other weld defects are potentially more dangerous. Cross-sections of all assessed welds were polished and subsequently etched with 5% Nital. The inset in Fig. 1 ($\times 5$, series 9) shows a cross-section of a good quality cap-to-cap circumferential weld. The backing strip is made by forming one of the caps, and the SAW weld is completed in one or two passes. There is a large tolerance in the width of the backing strip, provided that it gives an adequate geometry to the weld root. The groove formed in the outer surface of the cap in which the backing strip is formed is smooth and not very deep.
