# Engineering Failure Analysis

## Failures in cabin type hydrocarbon heaters due to inadequate fuel control

J. Booman<sup>a,b,\*</sup>, M.O. González<sup>b</sup>, J.L. Otegui<sup>c</sup><sup>a</sup> Universidad Nacional de Rosario, Av. Pellegrini 250, S2000BTP Rosario, Argentina<sup>b</sup> GIE S.A., Integrity of Oil & Gas Facilities, Galicia 52, B7608AUB Mar del Plata, Argentina<sup>c</sup> INTEMA (Universidad Nacional Mar del Plata – CONICET), J.B. Justo 4302, B7608FDQ Mar del Plata, Argentina

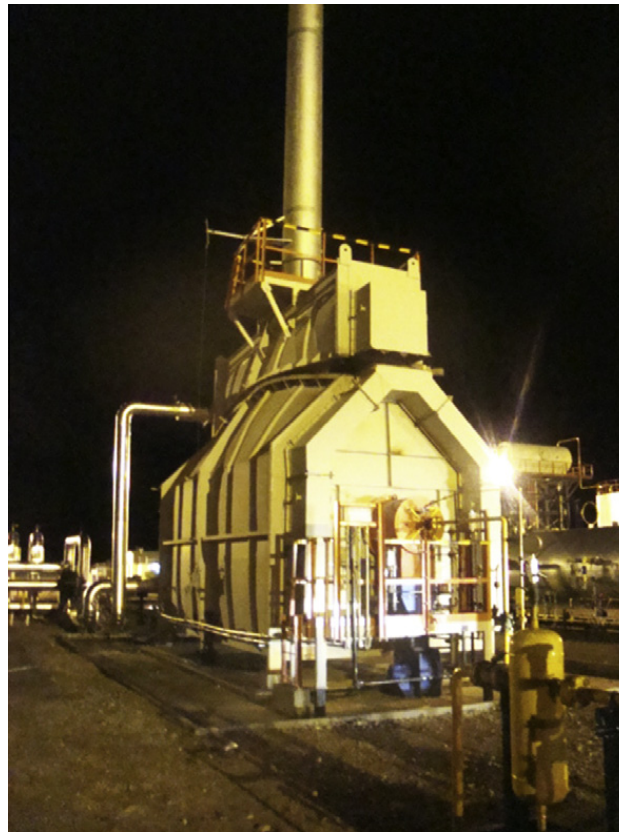
The most common geometry for medium and large capacity heaters is the so called cabin type, Fig. 1. The process hydrocarbon being heated flows through tubes alongside the walls and roof of the cabin, combustion of the fuel gas takes place in burners located either at the bottom or at the sides of the cabin.

Fig. 1. Cabin Type Heater.

Let us now analyze a different set of mishaps, related to programming and control. This area is not often analyzed in technical literature. Our first case study is a petroleum heater (seen in Fig. 1) that had been running for less than two years when the fire occurred. Serious problems had started after only a year of service, when modifications to original programming
