Intergranular susceptibility in failures of high pressure tubes

This work addresses the influence of metallurgical susceptibility to intergranular cracking on the repeated cracking and failure of thick wall curved steel tubes from a petrochemical reactor. These tubes are made of HP-4 steel, bent and heat treated, and then subjected to autofrettage. Internal pressure is around 250 MPa. All failures are characterized by strongly branched, mostly circumferential multiple intergranular cracks. Most cracks initiated in the outer surface, in contact with steam; these were related to stress corrosion cracking (SCC). Some cracks initiated in pre defects in the inner surface, in contact with a polymer, and in the mid thickness of the tube wall. This study includes the assessment of deformation and temperature induced embrittlement mechanisms, measurement of longitudinal residual stresses, and mechanical testing included tensile, Charpy and SCC tests. Susceptibility to intergranular cracking was experimentally assessed by recreating conditions of embrittlement by thermal treatments and tensile testing. Samples with 0, 3 and 5% plastic deformations were subjected to 24 h thermal treatments b

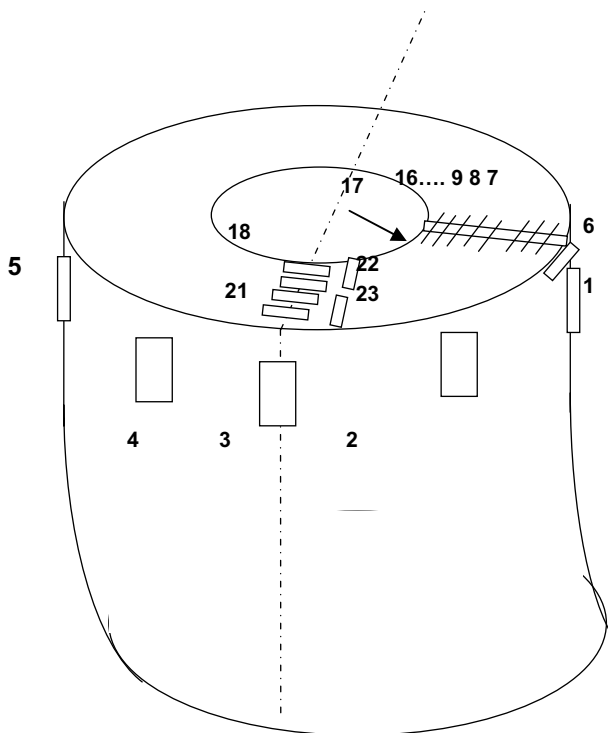
Another possible cause for the observed failures is the effect of manufacturing (both circumferential and longitudinal) residual stresses. Residual stress analyses were carried out placing strain gauges in sections of two curves where cracks were observed, see Fig. 9. Strain gauges were placed in the inner diameter, in the mid thickness and in the outer diameter. A 5 m long tube with a 3 m straight tract and a curved end was cut at the beginning of the curve for measuring residual stresses. This way, the obtained results correspond to the stresses originated by the manufacturing process (included autofrettage) and installation (curve of the original pipe). Strain gauges (1)–(5) were placed in the outer wall, to measure longitudinal residual stresses. Once these stresses were measured, strain gauges (6)–(8) were placed, in the neutral axis and at 90° , in a radius that contains the internal point (1). Radial stresses were detected in two positions with strain gauges (22) and (23), in the radius that contains the neutral axis (point (3)). Having fixed the longitudinal strain gauges, the section was transversely cut.

Fig. 9. Residual stress analyses were carried out placing strain gauges in sections of two curves where cracks were observed.

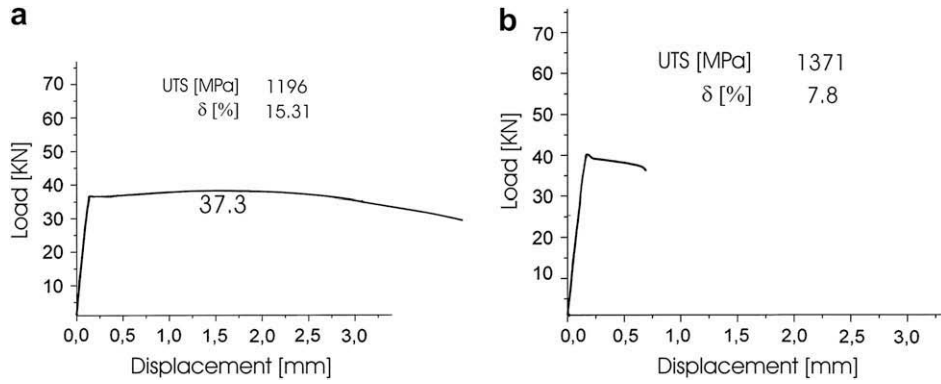
Fig. 11a shows the load–deformation curve of the material in its original state (specimen #1). The material shows low strain hardening which results in an ultimate tensile stress (UTS) very close to the yielding. The specimens subjected to plastic deformation and temperature show a tensile behaviour very different to that of the

original material. The specimens deformed 5% present a larger yield stress, as expected, but also showed some unexpected behaviour. For all maintenance temperatures, when reaching the yielding load the specimens destabilized, that is to say, yielding coincides with the peak load and in that point necking takes place. By way of example, Fig. 11b shows the load–elongation curve of specimen #4. Ductility is reduced in all cases down to 8%, from the original material ductility of almost 16%.

Fig. 11. (a) Deformation curve of the material in its original state, specimen # 1. (b) Load–elongation curve of specimen #4.

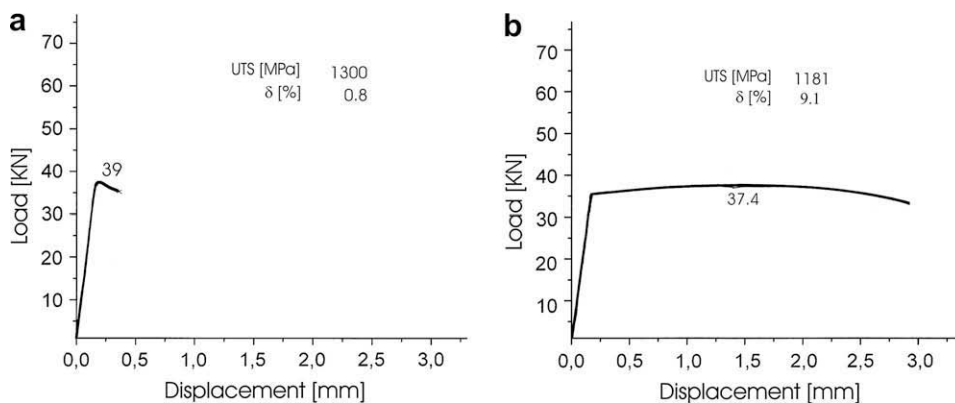
Fig. 12a shows the tensile curve. As in the previous cases, yielding coincides with the peak load and immediately later an abrupt fall of the load takes place. When imposing a restriction to necking the specimen breaks practically without plastic deformation (0.8%). In the same test in the original material (specimen #14, Fig. 12b), embrittlement is not evidenced; the reduction in elongation is due to the stress raising and triaxiality effect of the slot.

Fig. 12. Tensile curve.

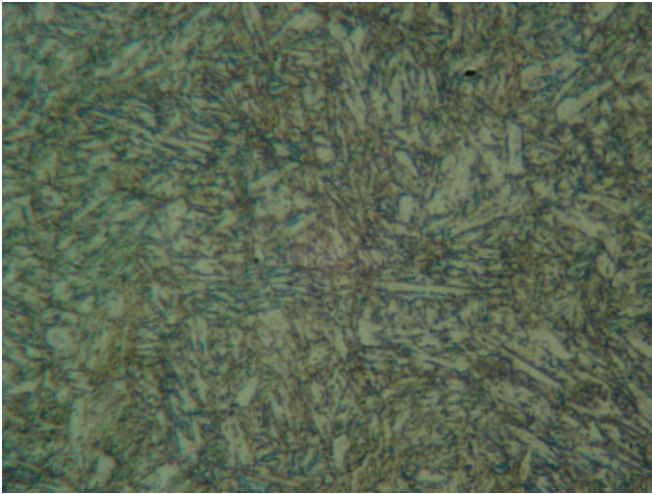
Fig. 13 ($\times 1000$) shows the microstructure of the original material, characteristic of the quenched and tempered steels with this chemical composition. This microstructure was not modified when subjecting the specimen to plastic deformation and temperature. The microstructure continues being typical of tempered martensite; consequently, the changes taking place in the material should be at a sub-microscopic level, not being possible to identify them under the available laboratory conditions.

Fig. 13. Microstructure of the original material ($\times 1000$).

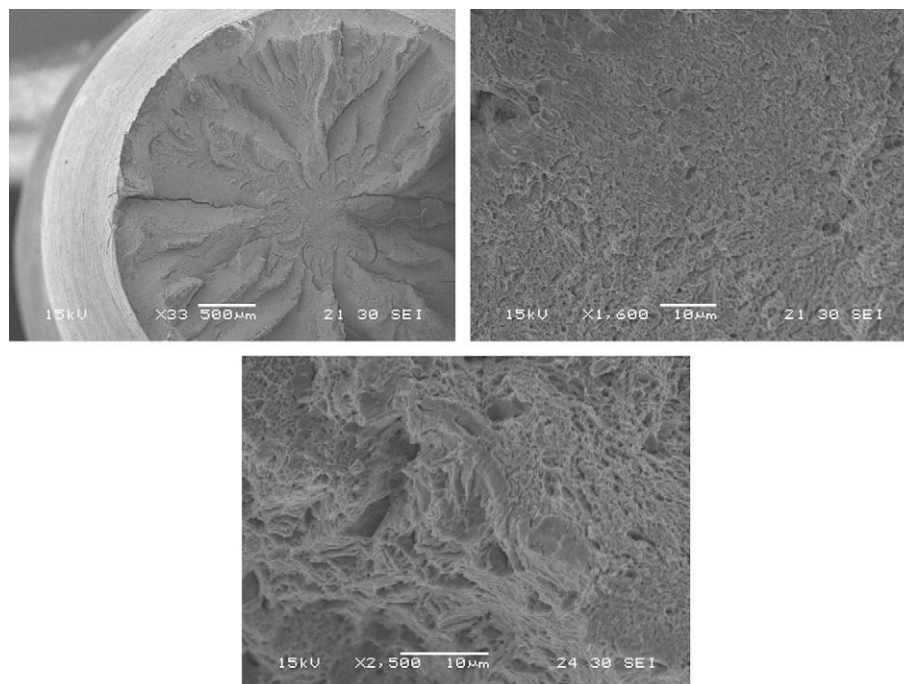
Fracture surfaces in the original material show a rosette fracture type, typical in steels subjected to tension (Fig. 14). It exhibits three areas clearly distinguishable: a planar and fibrous inner area (A), a radial buffer area (B) and an outer ring (C).

The fibrous central area is where the fracture originates; it is the region of slow and stable (sub-critical) growth of the crack, which requires high energy. It has an appearance of fibres at random with micro voids in the whole surface. This area is seen at larger magnifications in Fig. 14a; longitudinal cracks are revealed. This is a characteristic peculiar of this material and it does not fit bibliographical descriptions. The radial area (B) is where the crack growth rate becomes fast or unstable. These marks trace the crack growth direction, both from the borders of the fibrous area or from their own origin, see details in Fig. 14b.

Fig. 14. Rosette fracture type.
