Influence of old rectangular repair patches on the burst pressure of a gas pipeline

Pablo Gabriel Fazzini, José Luis Otegui *

Mechanical Engineering, INTEMA, University of Mar del Plata, Juan B. Justo 4302, 7600 Mar del Plata, Argentina

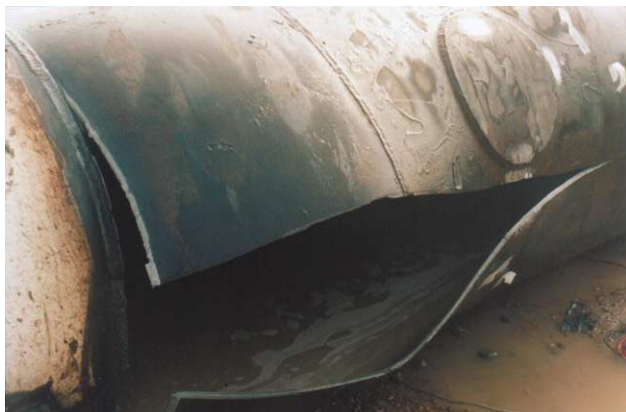
test was stopped when the pressure was almost 13.72 MPa. The square patch in pipe 3, although of poor geometry, did not fail. Final fracture started in a small corrosion defect, located close to the patch but not within the stress field of the fillet welds. Fig. 6 shows the circular patch in pipe 4 (repair 4A), and the fracture that ended the test. Again, initiation of this fracture was not related to the repair.

Fig. 6. Circular patch in pipe 4 (repair 4A).

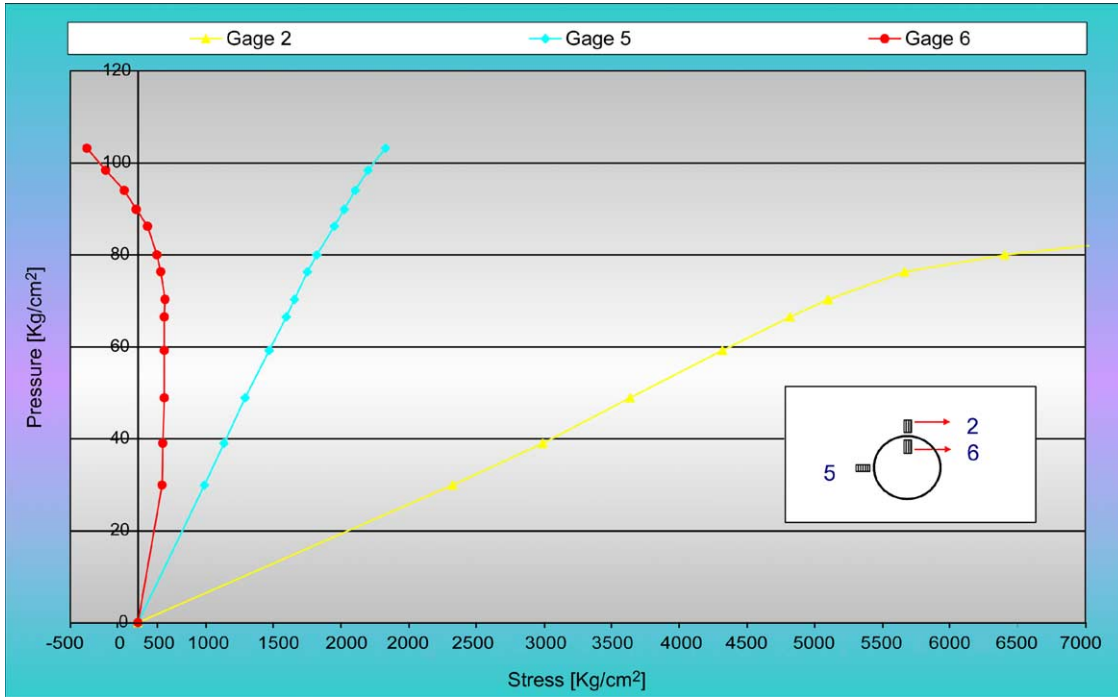
The longitudinal and circumferential stresses, S_l and S_c , are obtained from the values of circumferential, ϵ_{circ} , and longitudinal, ϵ_{long} , strains, using Hooke's law for plane stress. Figs. 10 and 11 show as an example the variations of S_l and S_c with test pressure, for the strain gauges in pipes 4 and 5. In the inset of the figures, sketches of the repairs present in the pipe are shown with the position and orientation of the strain gauges. Linear elastic behaviour is considered, therefore, the curves are valid only up to P_{yield} . When these two strain components are not available at a determined point, the criteria for sites far from stress raisers is used. Considering $S_l = S_c/2$, the von Mises equivalent stress is $S_{\text{vm}} = 0.87S_c$.

Fig. 10. Circumferential and longitudinal stresses versus pressure, during test of pipe 4.

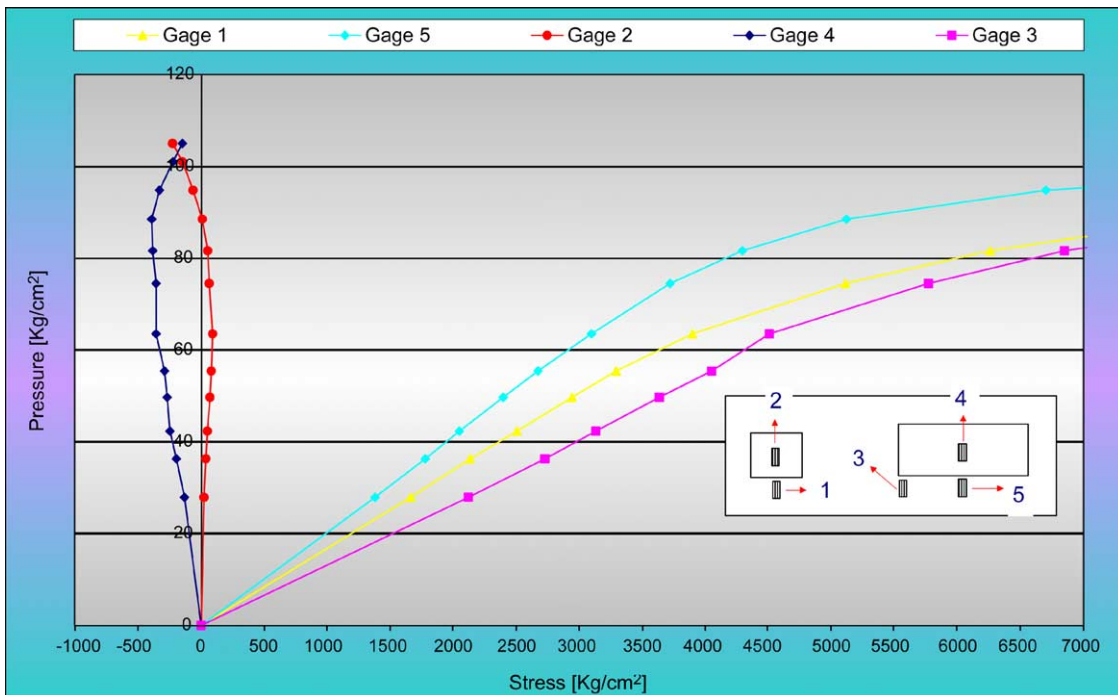
Fig. 11. Circumferential and longitudinal stresses versus pressure, during test of pipe 5.
