Study of the corrosion products formed on a multiphase CuAlBe alloy in a sodium chloride solution by micro-Raman and in situ AFM measurements

The corrosion products formed on a multiphase Cu–11.40Al–0.55Be (wt.%) alloy in 3.5% NaCl at open circuit potential, and their evolution with immersion time were studied mainly by micro-Raman and in situ AFM measurements. The aluminium content of each phase affects the formation of the corrosion products on them. After 1 day of immersion, γ_2 precipitates were more susceptible to dealuminization, while α' phase exhibited a high corrosion stability. The corrosion products evolved with immersion time, and CuCl_2 and a $\text{Cu}_2\text{O}/\text{CuO}$ double layer film were the stable products formed on all the phases after long times.

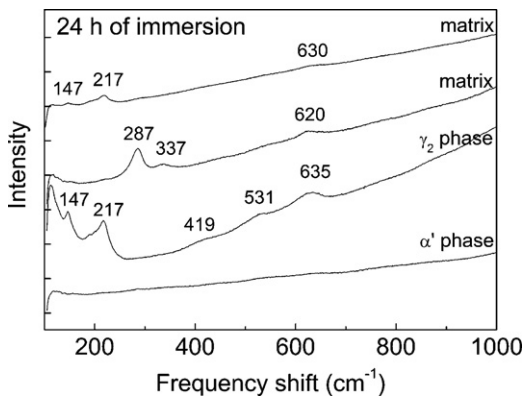
Fig. 7. Micro-Raman spectra collected from sample after 24 h of exposure to a 3.5% NaCl solution.

For a better identification of the corrosion products formed on each phase at each immersion time, micro-Raman spectra were measured after 24 h of immersion at open circuit potential. At least three spectra of each phase were measured with very good reproducibility. Fig. 7 shows representative spectra corresponding to the β matrix, γ_2 precipitates and α' phase. The frequency shift of the main peaks is indicated in the curves. The presence of the peaks at 337 and 620 cm^{-1} and the absence of the peaks at around 150 and

220 cm^{-1} on the matrix surface indicated the formation of CuO [16]. However, Cu_2O could be also identified in spectra corresponding to other zones of the matrix (peaks at 147, 217 and 630 cm^{-1} [16]), which is consistent with the XRD patterns indicated the formation of $6\text{CuO}\cdot\text{Cu}_2\text{O}$ (Fig. 2c). Then, the results suggest the existence of a duplex film. The formation of this $\text{Cu}_2\text{O}/\text{CuO}$ double layer has been reported previously in copper samples immersed in chloride containing solutions [17,18]. The presence of CuCl_2 was also identified on some zones of the matrix (peak at 287 cm^{-1} [19]), in agreement with XRD measurements (Fig. 2c). No chlorine compounds could be detected by EDX (Table 1), which would indicate that CuCl_2 is present in small quantities in some zones or forming a very thin film. From the results, the decrease in surface roughness on the matrix measured by AFM would be attributed to the formation of a surface film composed of CuO, Cu_2O and CuCl_2 .

The existence of Al_2O_3 (peak at 419 cm^{-1} [19,20]) and Cu_2O (peaks at 147, 217, 531 and 635 cm^{-1} [16]) on γ_2 precipitates was confirmed by micro-Raman measurements (Fig. 7). Corrosion products containing Cl were measured by EDX (Table 1), while they were not detected by micro-Raman measurements. Based on the fact that the measurements obtained by micro-Raman are more superficial

It was not possible to identify corrosion products on α' phase (Fig. 7), which is in agreement with the high stability found by SEM, EDX and AFM measurements (Table 1 and Figs. 3–6). If there was a film of corrosion products on α' phase, it would be very thin.

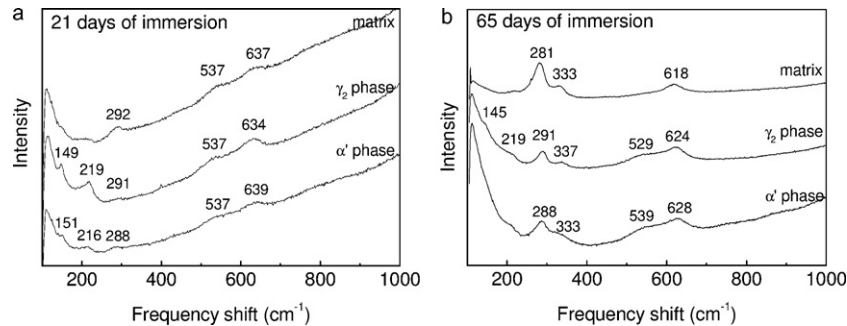
Fig. 9. Micro-Raman spectra collected from samples after (a) 21 days and (b) 65 days of exposure to a 3.5% NaCl solution.

To study the evolution of the corrosion products formed on the surface samples after long immersion times, microscopical and micro-Raman measurements were done after 21 and 65 days of immersion. It could be observed that the β matrix suffered a visible corrosion process (Fig. 8), but it seems not to be so severe as the single β phase samples submitted to a similar solution and conditions after 40 days [8]. A surface film composed of CuO (peaks at 333 and 618 cm^{-1} [16]) and CuCl_2 (peak at 281 cm^{-1} [19]) was identified on it (Fig. 9b).

α' phase still seemed to remain almost unchanged (Fig. 8), but the formation of some corrosion products could be detected after 21 days: Cu_2O (peaks at 151, 216, 537 and 639 cm^{-1} [16]), and CuCl_2 (a slight peak at 288 cm^{-1} [19]) (Fig. 9a). They evolved with the immersion time, and the presence of CuO (peaks at 333 and 618 cm^{-1} [16]) and CuCl_2 (peak at 288 cm^{-1} [19]) was identified after 65 days (Fig. 9b).

After 21 days, Cu_2O (peaks at 149, 219, 537 and 634 cm^{-1} [16]) and CuCl_2 (a slight peak at 291 cm^{-1} [19]) could be identified on

γ_2 phase (Fig. 9a), and the presence of Al_2O_3 could not be detected (Fig. 9a). This compound seemed to have been detached from those precipitates. A similar behaviour has been reported previously in a ($\beta + \gamma_2$) sample [8]. After 65 days, CuCl_2 (peak at 291 cm^{-1} [19]) was detected, peaks associated to Cu_2O (at 145 and 219 cm^{-1} [16]) became weaker and the presence of a peak at 333 cm^{-1} suggested the existence of CuO [16] (Fig. 9b).
