# Fractographic analysis of austempered ductile iron

D. O. FERNANDINO and R. E. BOERI

*Metallurgy Division, INTEMA – National University of Mar del Plata – CONICET, Mar del Plata B7608FDQ, Argentina*

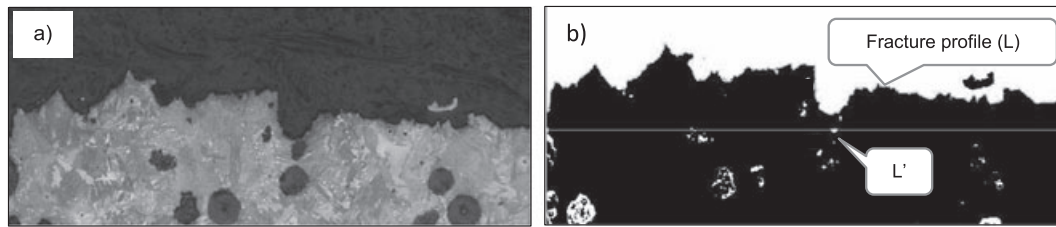
**Fig. 1** Schematic representation of the roughness parameter used, following the methodology reported by Fernandino *et al.* (2015). Fracture profile resulting of Impact test at  $-20\text{ }^{\circ}\text{C}$  on ADI<sub>360</sub> (100 $\times$ ). a) Optical micrograph; b) quantification of digitalized image using Image-Pro Plus software.

where the  $L_t$  value is the measurement of the actual length of the fracture profile, whereas the  $L'$  value is the projected length of the fracture profile. From the measurement of  $L_t$  and  $L'$  on the fracture profiles,  $Rl$  and  $R_s$  values were calculated, in each case, using Eqs. (1) and (2), respectively.  $R_s$  give a measure of the surface roughness. Additionally, the height of the highest peak ( $Y_{\max}$ ) and the height of the deepest valley ( $Y_{\min}$ ) of the fracture profile are measured, and the  $R_y$  values were calculated from Eq. (3). A schematic representation is shown in Fig. 1

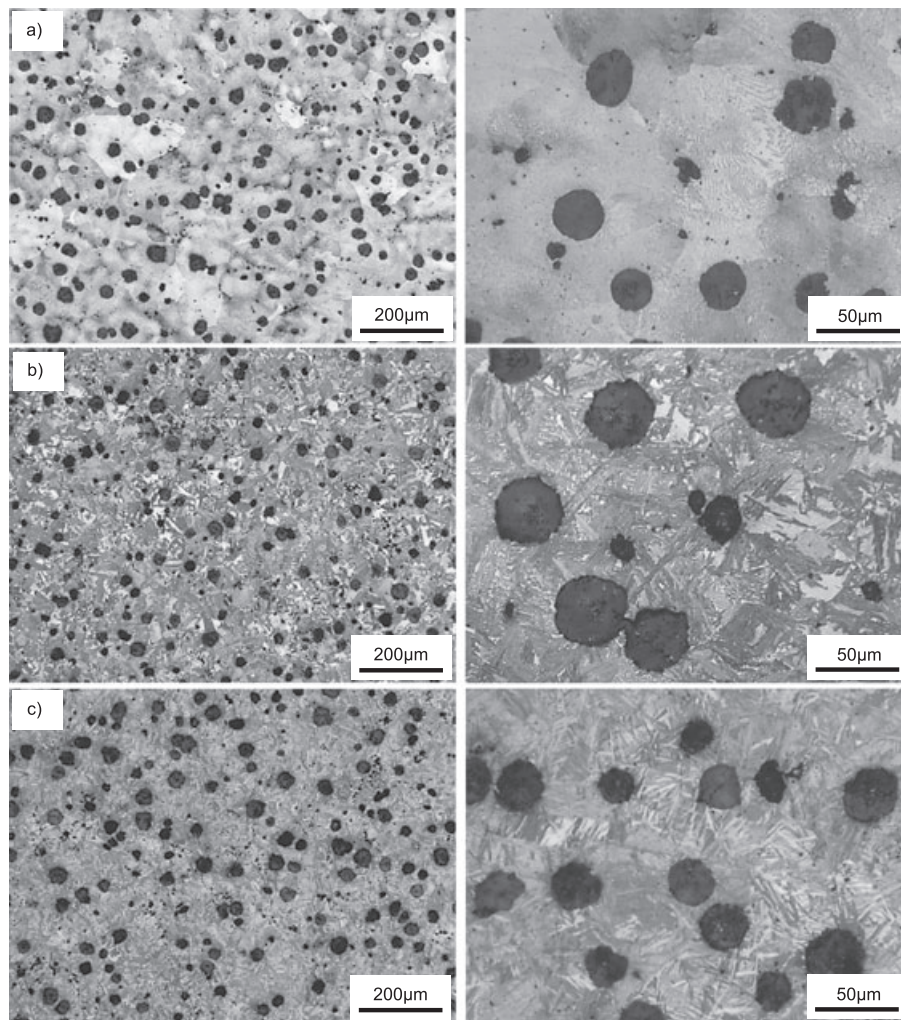
**Fig. 2** Optical micrographs at magnifications of 100 $\times$  and 200 $\times$  respectively. a) Pearlitic (As-Cast); b) austempered at 360 °C (ADI<sub>360</sub>); c) austempered at 280 °C (ADI<sub>280</sub>).

The microstructures resulting from as cast condition and after the austempering heat treatment cycles are shown in Fig. 2. The mechanical properties of each microstructure are listed in Table 3. According to ASTM A897M-03, ADI grades 150-110-07 (ADI<sub>360</sub>) and 200-75-02 (ADI<sub>280</sub>) are obtained. The results are in concordance with the data reported in specific literature for this kind of DI.<sup>1</sup>

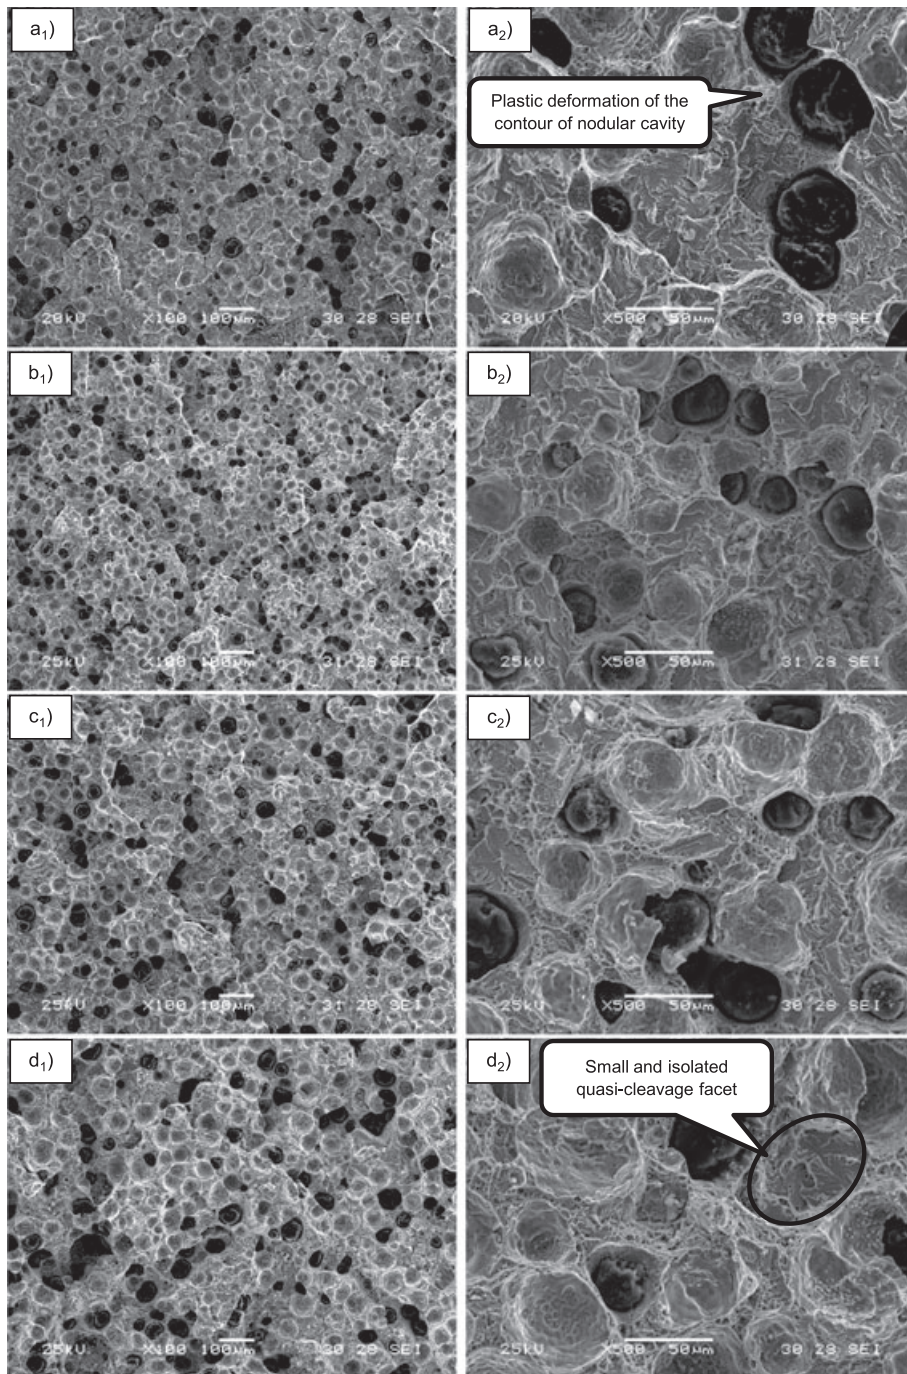
Fig. 3 SEM image of the fracture surface resulting of impact tests at different temperature on ADI<sub>360</sub>. a) -20 °C; b) 0 °C; c) 20 °C; d) 60 °C.

The fracture surfaces resulting from impact loading on ADI<sub>360</sub> and ADI<sub>280</sub> samples are shown in Figs. 3 and 4 respectively. As a general feature, graphite nodules and nodular cavities free from graphite nodules were observed at all temperatures. At  $-20\text{ }^{\circ}\text{C}$  (see Fig. 3a), the fracture surfaces show a dominating brittle failure mode consisting of quasi-cleavage facets and some areas of plastic deformation (dimples) mainly located on the contour of the nodular cavities and at planes joining different cleavage facets. An important characteristic that must be noted is that all graphite nodule cavities have expanded,

and the nodules appear to be separated from the matrix. This has been so even for the harder ADI<sub>280</sub> grade (Fig. 4a). It is also important to note that for these grades of ADI, the lower and upper shelf temperatures are approximately located at  $-120\text{ }^{\circ}\text{C}$  and  $60\text{ }^{\circ}\text{C}$  respectively.<sup>9,16</sup> Consequently, a temperature of  $-20\text{ }^{\circ}\text{C}$  is located within the ductile to brittle transition temperature range. This could justify the observation of brittle and ductile fracture mechanisms simultaneously; however, the characteristic failure mode reported at lower shelf temperatures is also quasi-cleavage. As the test temperature increases, a greater deformation of the nodular contour is observed. In addition, larger areas of extensive plastic deformation of the metallic matrix are found. At  $60\text{ }^{\circ}\text{C}$  (see Figs. 3d & 4d), growth of the nodular cavities, inclusions and eventually nucleated microvoids became more notorious. This is shown in better detail in Fig. 5. This has been the case for both ADI grades investigated.

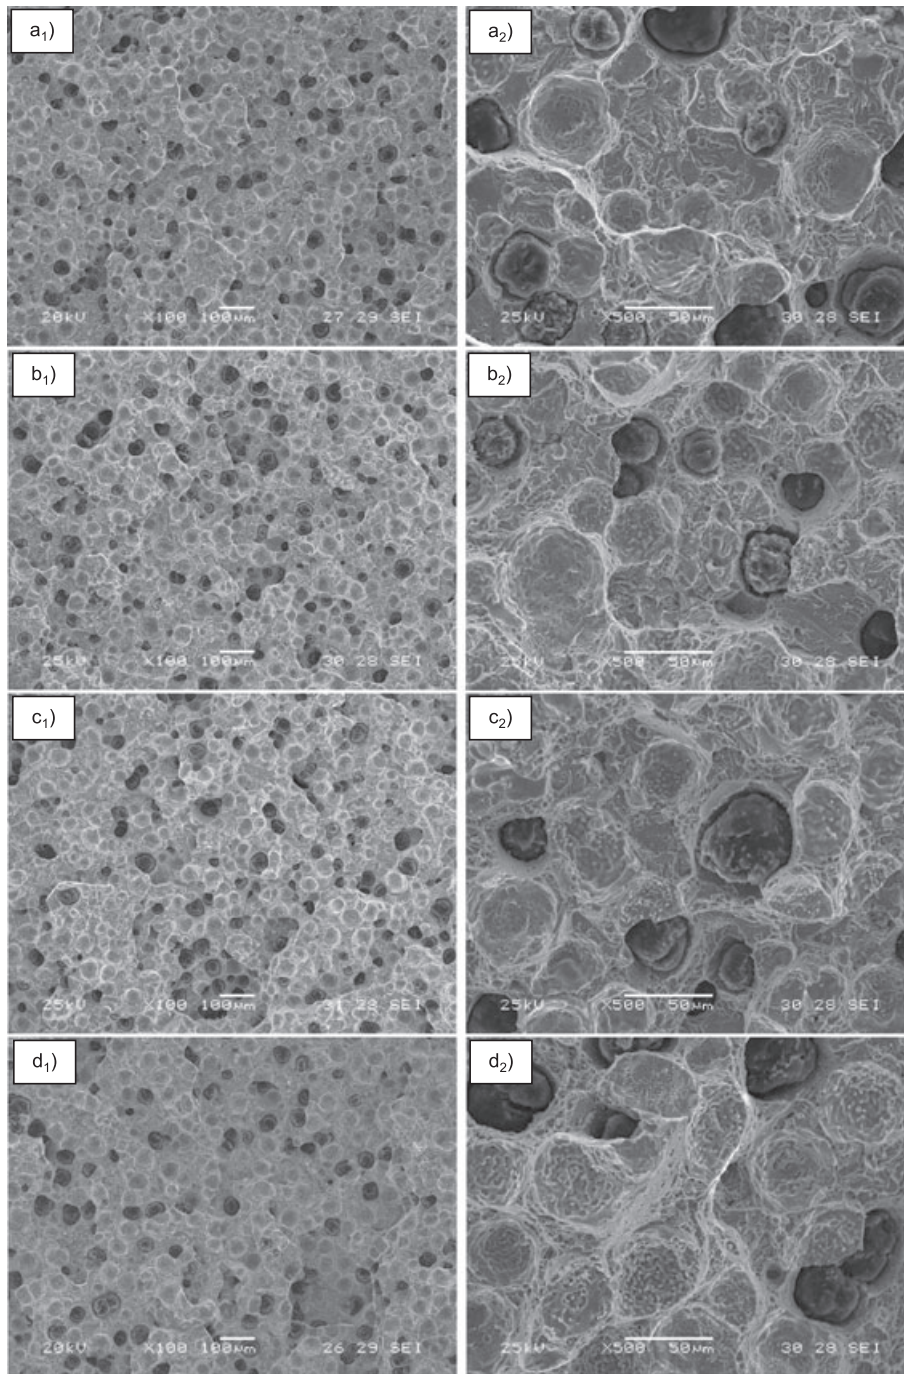
**Fig. 4** SEM image of the fracture surface resulting of impact tests at different temperature on ADI<sub>280</sub>. a)  $-20\text{ }^{\circ}\text{C}$ ; b)  $0\text{ }^{\circ}\text{C}$ ; c)  $20\text{ }^{\circ}\text{C}$ ; d)  $60\text{ }^{\circ}\text{C}$ .

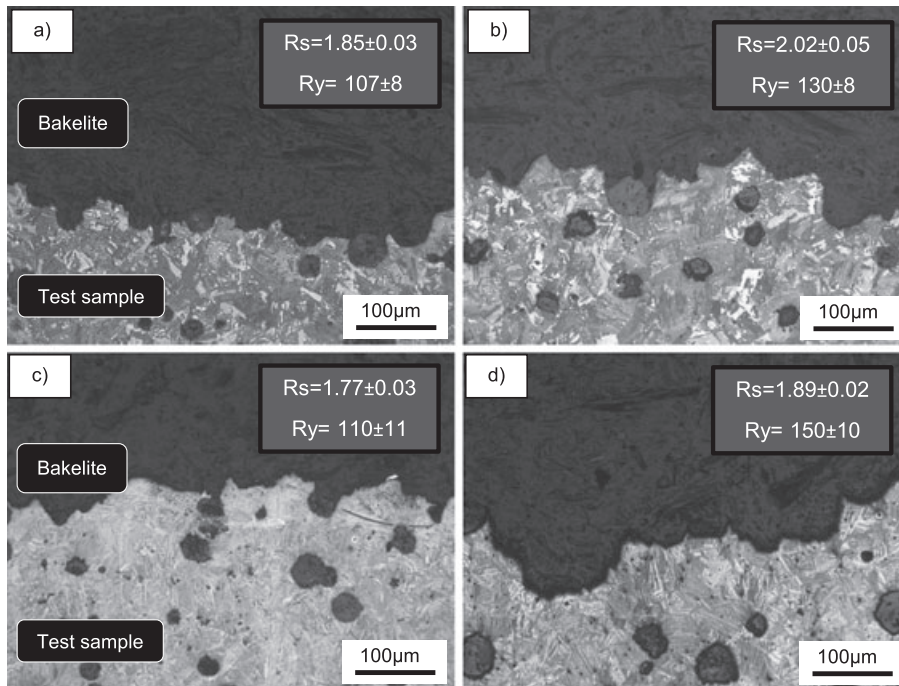
**Fig. 6** Optical micrographs of the fracture profile resulting of impact test at (100x). a) ADI<sub>360</sub>  $-20\text{ }^\circ\text{C}$ ; b) ADI<sub>360</sub>  $60\text{ }^\circ\text{C}$ ; c) ADI<sub>280</sub>  $-20\text{ }^\circ\text{C}$ ; d) ADI<sub>280</sub>  $60\text{ }^\circ\text{C}$ .

Profiles of fracture surfaces resulting of impact tests of ADI<sub>360</sub> at  $-20^{\circ}\text{C}$  and  $60^{\circ}\text{C}$  were examined by optical micrography on samples mounted in bakelite. The resulting roughness values are shown in Fig. 6a and b

respectively. Note that both  $R_s$  and  $R_y$  values increase by approximately 10% and 18% respectively as the test temperature increases. Similar results are obtained for ADI<sub>280</sub> samples, where the increase in  $R_s$  and  $R_y$  reaches 7% and 21% respectively. These results are in concordance with the SEM images and allow concluding that the crack propagation path follows more tortuous patterns as the temperature increases.

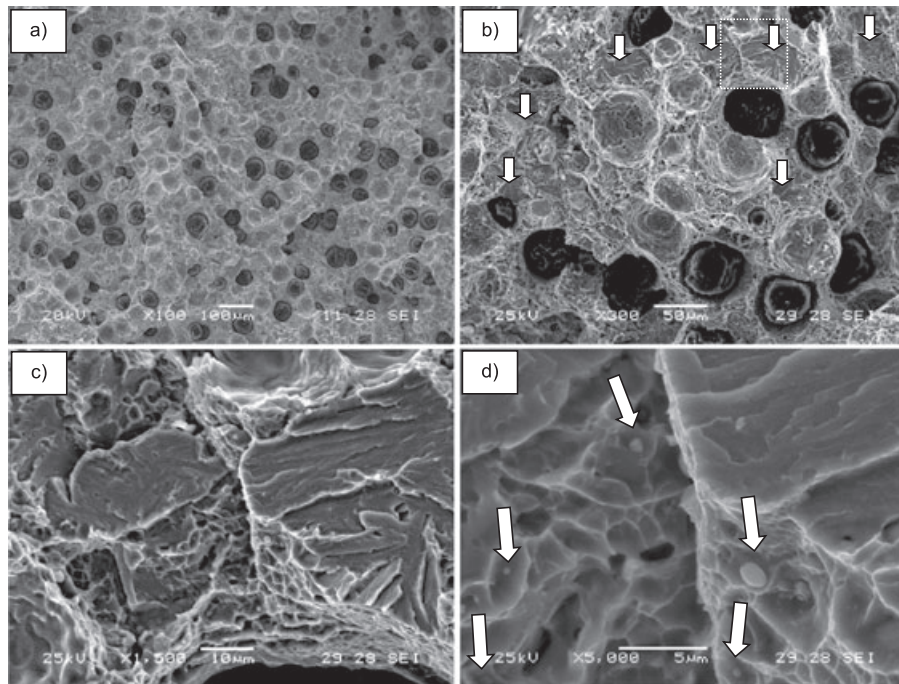
**Fig. 7** SEM image of the fracture surface resulting from bending tests at room temperature on ADI<sub>360</sub>. Different magnifications.

The fracture surfaces resulting from three point bending tests under quasi-static loading conditions at room temperature are shown in Figs. 7 and 8 for both ADI grades tested. As reported above for impact tests, the fracture surface is characterized by plastic deformation of the contours of nodular cavities and portions of the matrix,

mixed with isolated quasi-cleavage facets (marked by white arrows), as shown in Fig. 7a and b. Figure 7c shows a detail of a quasi-cleavage zone marked by a dotted square in Fig. 7b. Extensive plastic deformation is found, as revealed by the noticeable formation of microvoids, Fig. 7d. Similar results were found ADI<sub>280</sub> samples (see Fig. 8). These results are similar to those reported by

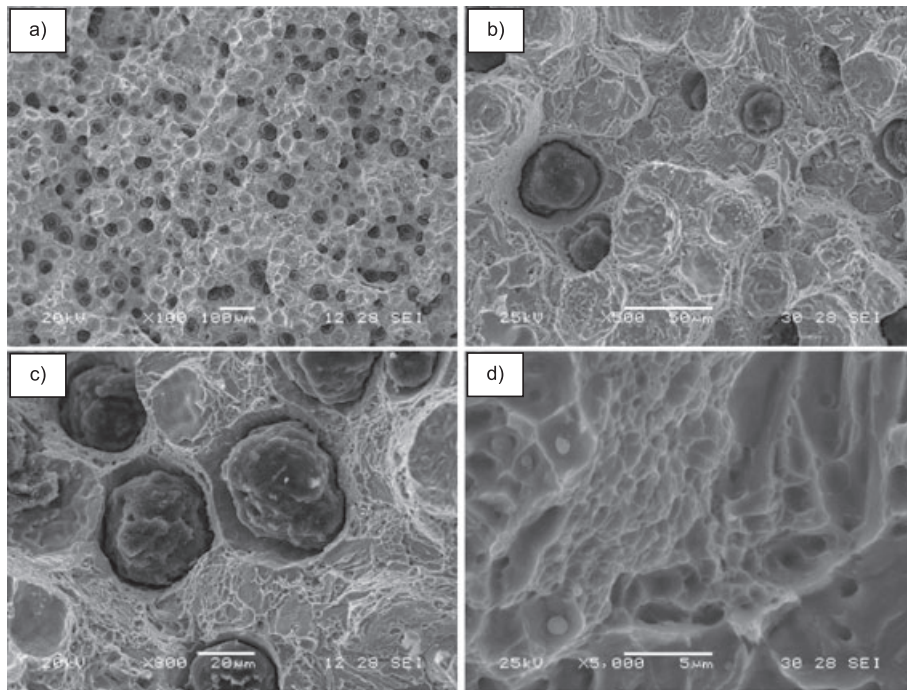
Fig. 8 SEM image of the fracture surface resulting from bending tests at room temperature on ADI<sub>360</sub>. Different magnifications.

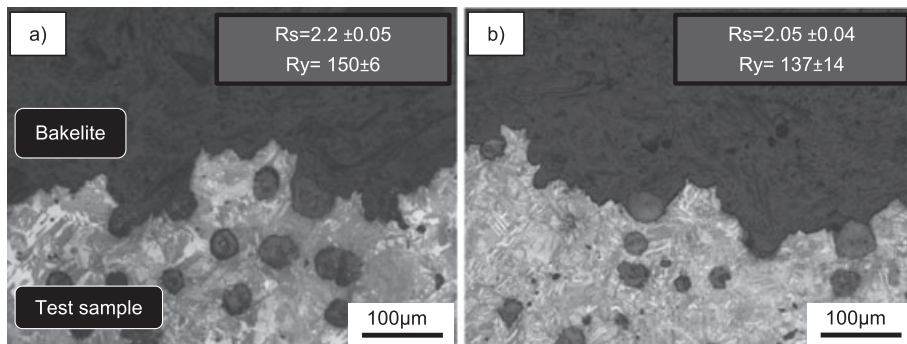
Fig. 9 Optical micrographs of the fracture profile resulting of bending test at room temperature (100×). a) ADI<sub>360</sub>; b) ADI<sub>280</sub>.

The optical micrographs of fracture profiles resulting from bending tests at room temperature and the corresponding roughness values are shown in Fig. 9. Both,  $R_s$  and  $R_y$  values are between approximately 20% and 10% greater than those measured on samples

broken by impact testing at  $-20^{\circ}\text{C}$  and  $60^{\circ}\text{C}$  respectively. Similar results were obtained for ADI<sub>280</sub>. These results show that the quasi-static loading condition promotes fracture surfaces of greater roughness, mainly as a result of a greater plastic deformation along the metallic matrix and the contour of the nodular cavities.

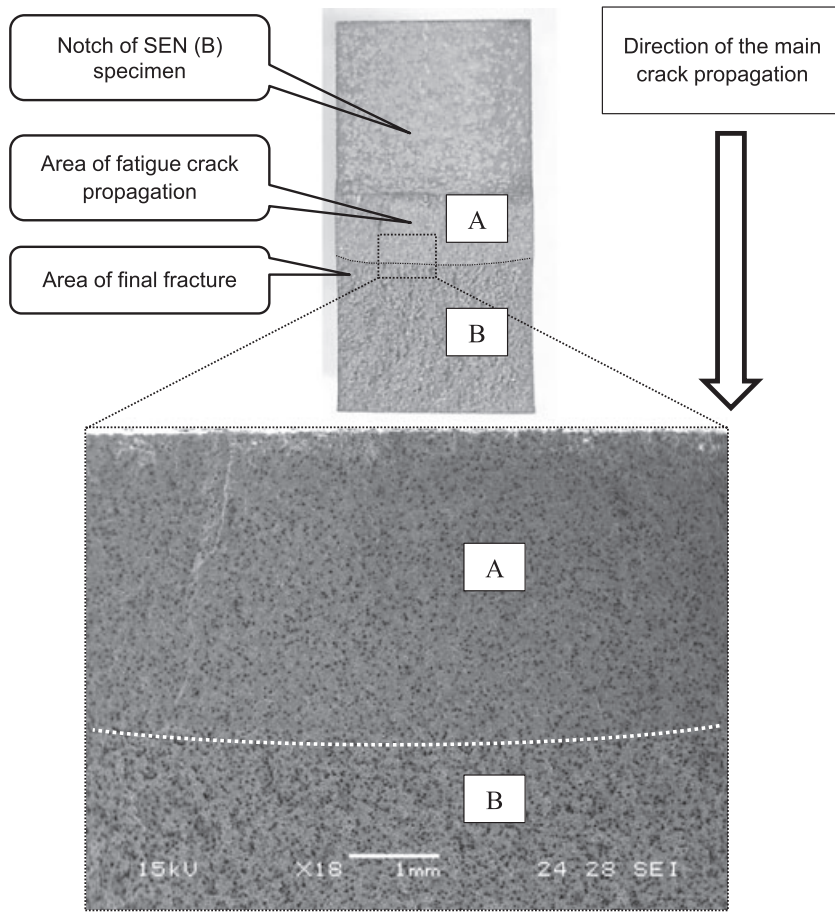
Fig. 10 Fracture surface resulting of fatigue test at macroscopic level.

The fracture surface resulting from three point bending tests with cyclic loading conditions at room temperature of ADI<sub>360</sub> after  $1.6 \times 10^5$  fatigue cycles is shown in Fig. 10. It is possible to identify a change in the fracture surface topology related to differences between the fatigue crack propagation zone (A) and the final fracture region (B).

identified in this study. On the other hand, in this case fractographic features at macroscopic level allowed differentiating fatigue propagation regimes from final fracture as was shown in Fig. 10.

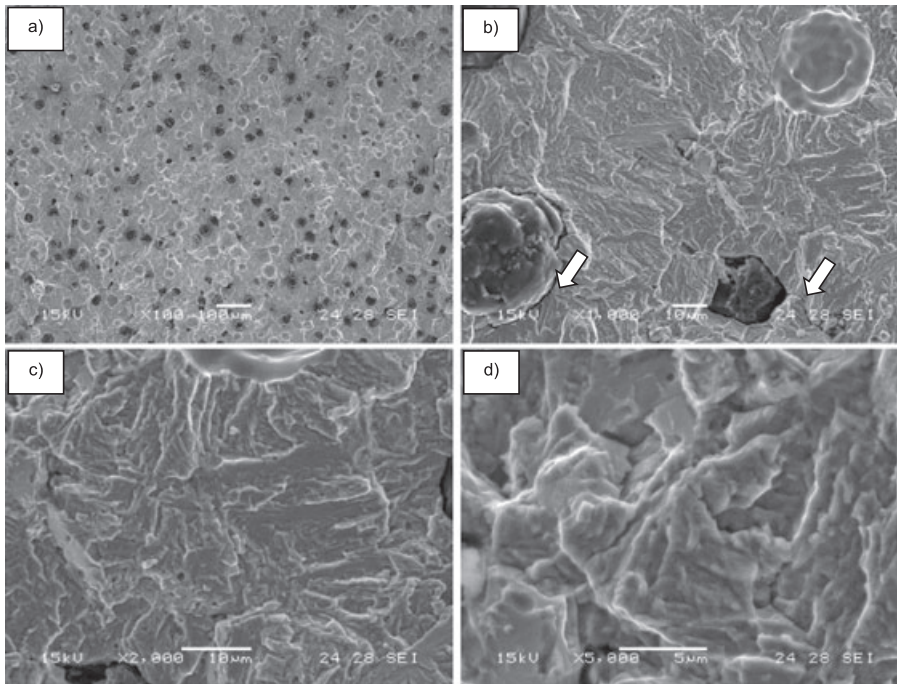
Fig. 11 SEM image of the fracture surface resulting of fatigue tests at room temperature on ADI<sub>360</sub>. Different magnifications.

Figures 11 and 12 show the fracture surfaces after fatigue testing for ADI<sub>360</sub> and ADI<sub>280</sub> respectively. At low magnification the surface of the fatigue grown crack shows graphite nodules and nodular cavities free from graphite nodules exposed and an apparently flat fracture surface topology (see Figs. 11a & 12a). As the magnification is increased (see Fig. 9b), the surface shows some secondary cracks (marked by white arrows). Different from the observations for impact and bending, in this case, the contours of the graphite nodule cavities show very little plastic deformation. The fatigue crack propagation along the matrix, Figs. 11c and d and 12c and d, does not follow the striation mechanism, but is characterized by a cleavage-like fracture surface. Both, the lack of striations and the cleavage-like mechanism of fatigue fracture advance are commonly described in the literature for high strength metallic alloys.<sup>21–25</sup> Some authors

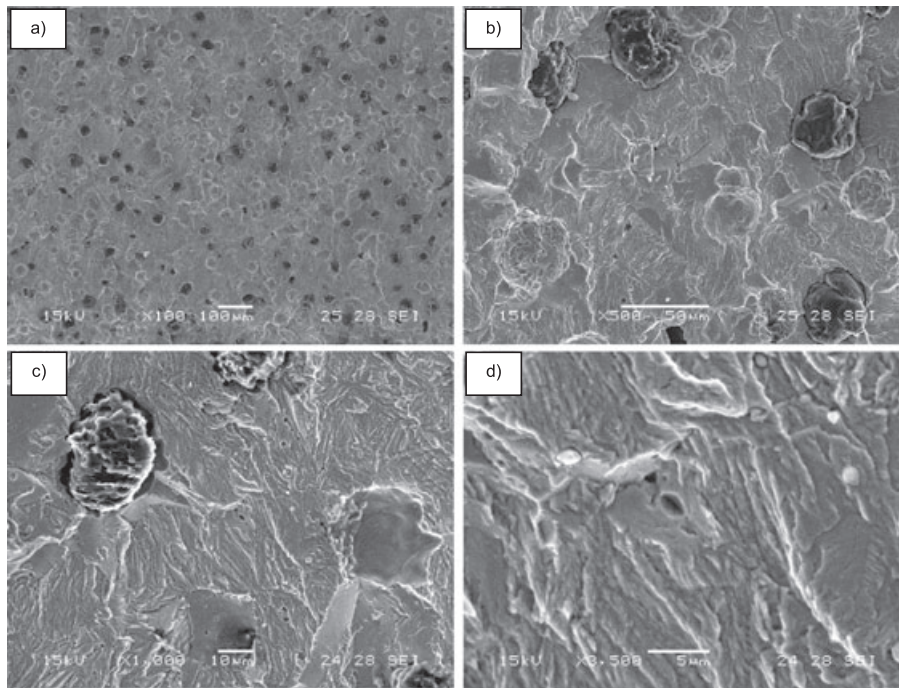
Fig. 12 SEM image of the fracture surface resulting of fatigue tests at room temperature on ADI<sub>280</sub>. Different magnifications.

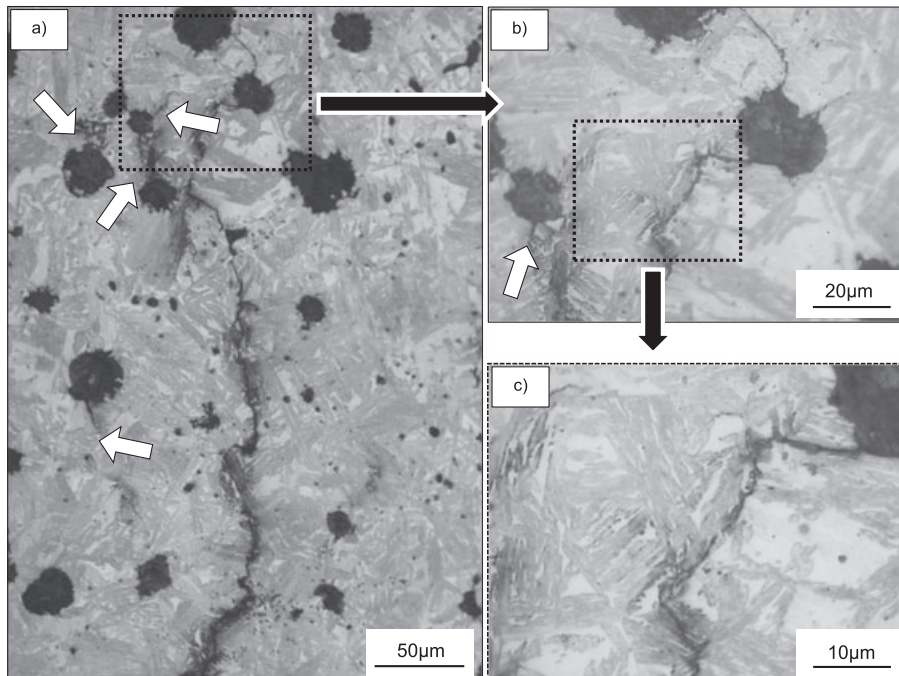
Fig. 13 Optical microscopy images. Main crack propagation under fatigue test on ADI.

involves stopping the tests after several pre-established times before breaking the samples and then, obtaining the optical micrograph of the crack path as shown in Fig. 13. Secondary microcracks that emanate from the nodules (marked by white arrows) and the propagation of microcracks from the nodules towards the main crack (indicated by a black arrow) were observed in Fig. 13a. The crack path shows frequent small changes of direction, apparently indicating that the crack follows the orientation of ausferritic laths, which have a very small microstructural dimension (see Fig. 13b and c). A crack branching phenomena and secondary cracks that emanate from graphite particles are also observed (marked by white arrows). These observations are in concordance with the results reported by different authors. The ausferrite packet boundaries were assumed to act as

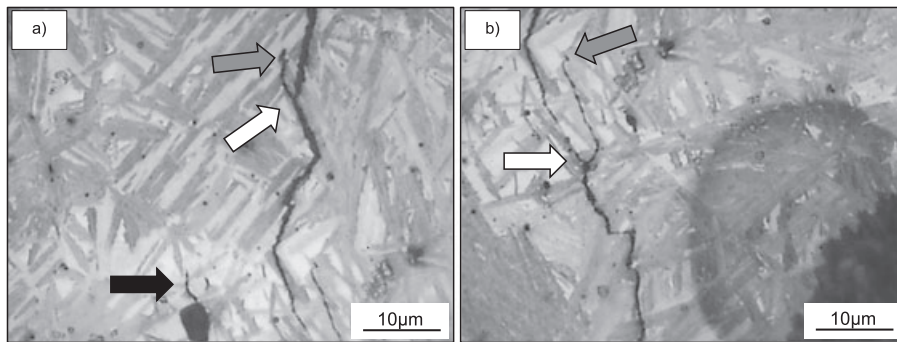
Fig. 14 Detail of the crack propagation at high magnification.

Figure 14 shows a detail of the crack propagation on ADI<sub>360</sub> at high magnification. A crack branching

phenomena (marked by white arrows), crack propagation preferably through the ausferritic lath and a crack that emanates from the graphite nodule (marked by black arrow) are observed. The observation of crack arrest phenomenon in the retained austenite (marked by grey arrows in Fig. 14a and b) supports the hypothesis about the influence of the orientation of ausferritic laths in the fatigue crack propagation path and its influence on the fracture surface morphology.

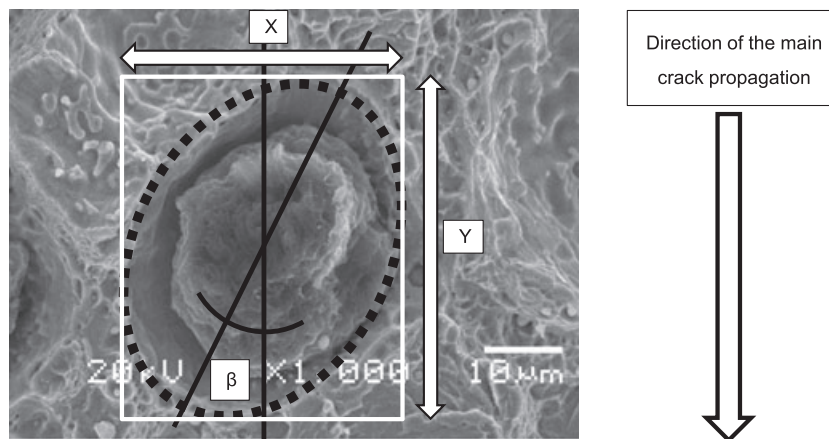
Fig. 16 Schematic representation of the parameters measured by using the ductile failure mode methodology.<sup>12</sup>

For each nodule present at the fracture surface, an ellipse is manually defined with the best possible fit to the deformed nodular contour. Then, the length of the nodular contour in axes parallel (Y) and perpendicular (X) to the main crack propagation direction, and the angle formed between the major axis of the ellipse and the main crack propagation direction ( $\beta$ ) are measured. More details can be found in a recent paper by the authors.<sup>12</sup> A schematic representation of the parameters measured is shown in Fig. 16.
