Evaluation of environmentally assisted fracture of austempered ductile iron (ADI) under cyclic load bearing

ABSTRACT This paper aims to characterize the behaviour of austempered ductile iron (ADI) under cyclic load bearing and its surface in contact with water. The first part is devoted to verifying the drop in Ultimate tensile strength and the elongation that takes place when ADI tensile samples are tested submerged in water as compared to values obtained in dry condition. Focus of this work is placed on crack initiation and propagation when submerged SEN (B) samples are tested applying cyclic loads. Different test stages of fissure nucleation and propagation on the lateral face of the sample were documented by microscopic imaging during the test, thereby allowing to characterize the manner in which failure occurred. The resulting fracture surfaces were analysed by scanning electron microscopy (SEM), and possible fracture mechanisms are discussed. The main contributions of this work include characteristic values of the time of crack initiation, crack growth rate and a methodology to study some particularities of the operating fracture mechanisms based on lateral observations and

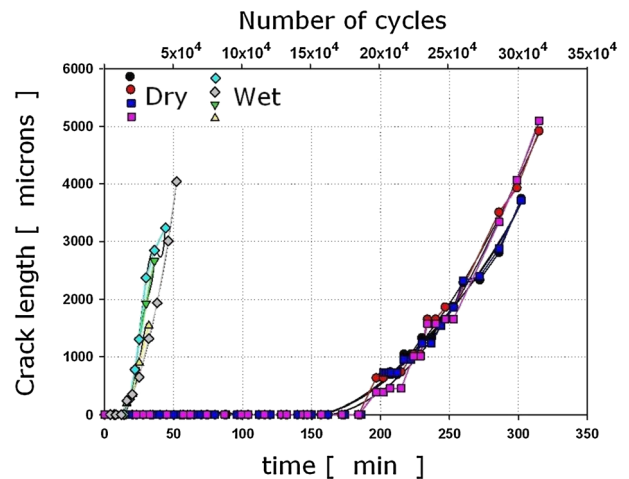
Fig. 5 Crack behaviour on the lateral surfaces of SEN (B) samples, tested applying cyclic loads.

Crack behaviour on the lateral surfaces analysed, tested applying cyclic loads, is displayed in Fig. 5. The crack length is plotted against a number of cycles (or test time). As it can be noticed, submerged samples nucleate observable cracks earlier than those tested in dry condition, probably generated by the interaction of water with some defects on the surface that favours earlier nucleation.

Figure 5 also demonstrates that the crack growth rate is higher in the submerged sample test, a fact noticed by the steeper slope of the curve.

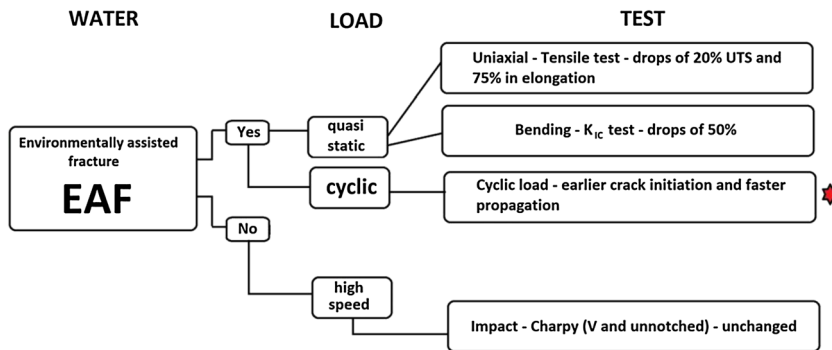
Fig. 7 Mechanical properties of ADI evaluated in aqueous environment. State of the art.

Figure 7 places the new advance obtained in this work with the existing knowledge including the embrittlement effect of water at a low load application rate (tensile and three-point-bending tests)^{3,4,7} and not evident at high speed load applications (impact test).⁴
