Journal of Materials Engineering and Performance

Evaluation of the Role of Metallic Matrix on Environmentally Assisted Embrittlement of Austempered Ductile Iron (ADI) Using High Si Steel

Ricardo A. Martinez

The objective of this work stems from the environmentally assisted embrittlement suffered by austempered ductile iron (ADI) when its surface is submerged in water. This phenomenon leads to a drop in elongation and ultimate tensile strength of about 75% and 10%, respectively, while the 0.2% offset strain stress remains unaffected. Heat-treating a high Si steel, an ausferritic matrix similar to that present in the ADI under study is obtained, yielding giving a very good combination of tensile strength and elongation. In this manner, it was possible to examine the influence of the metallic matrix such as that present in ADI, though without nodules and cell boundaries, also called last to freeze zones (LTF). Tensile test evaluations on ADI and steel samples under dry and wet conditions were carried out. Additionally, a very specific test, introducing surface cracks, was conducted with the purpose of expanding the current knowledge on this particular kind of fracture. Earlier inve

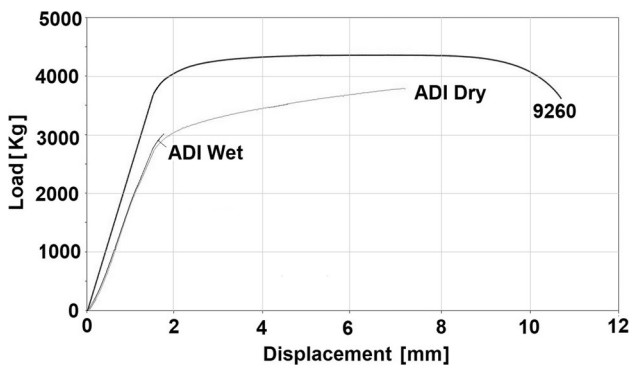
Fig. 7 Representative plot of tensile tests

carried out. Table 2 shows the results obtained for both materials under evaluation, and Fig. 7 displays a load–displacement representative plot.
