# Fracture of pearlitic ductile cast iron under different loading conditions

**ABSTRACT** In this study, fracture surfaces of pearlitic ductile iron generated under impact, bending and fatigue tests were characterised and compared. The fracture mechanisms in each case were identified from the observation of scanning electron microscopy images, and the characteristic topographic features were quantitatively and qualitatively evaluated. Cleavage was the predominant fracture mechanism for impact loading at all test temperatures and for slow bending testing. On the other hand, under fatigue loading, the fracture surfaces showed a mix of cleavage and ductile striation areas. A complex but reliable methodology for the determination of the direction of propagation of the main crack was also proposed, based on a careful analysis of the river patterns along the cleavage planes.

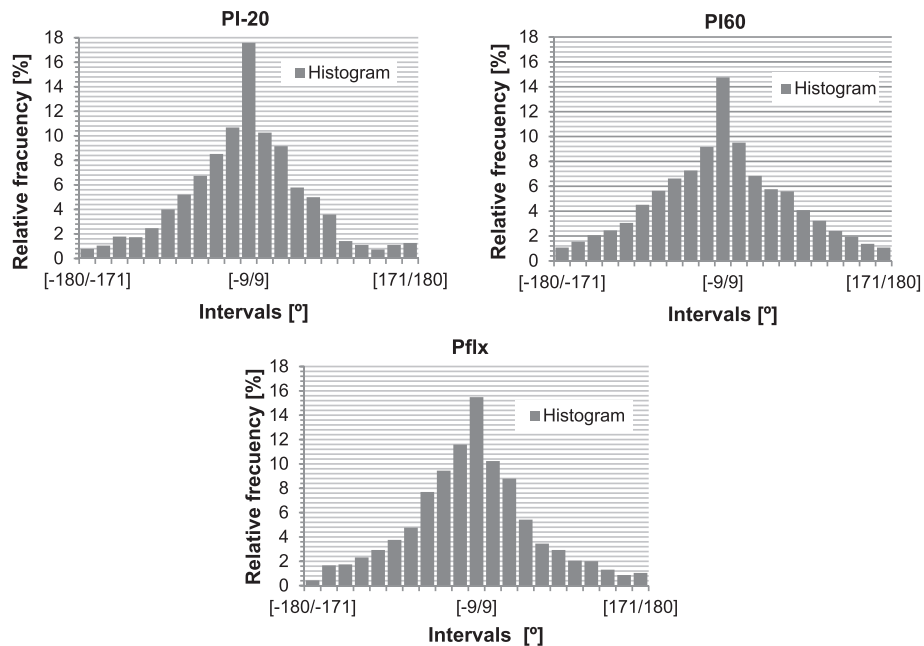
Fig. 15 Histograms from dataset.

An example of one of the SEM fractographies analysed for impact test at 60 °C is shown in Fig. 14. The results of the statistical dataset are listed in Table 4. In all cases, the mean ( $\bar{X}$ ) of the dataset was between  $-10^\circ$  and  $10^\circ$ , and the mode value ( $Mo$ ) of the distribution was  $0^\circ$ . These results not only show that the average of local propagation vectors reveals the predominant propagation direction, but also, at the local analysis, it was observed with higher relative frequency in this direction. For a better interpretation of the dataset, histograms of relative observation frequencies are also plotted in Fig. 15. The local directions were grouped into 20 intervals ranging from  $-180^\circ$  to  $180^\circ$  in concordance with the reference system used in the present methodology.

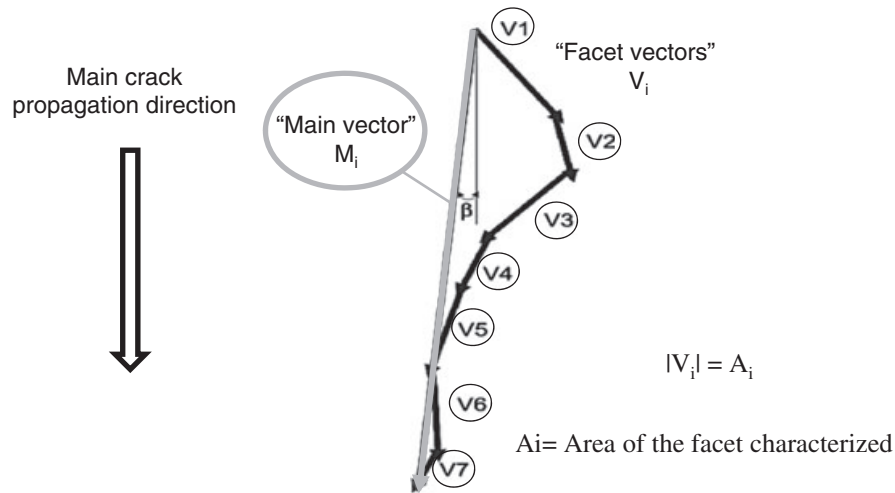
**Fig. 16** Methodology to obtain the ‘main vector’ from the composition of each  $V_i$ .

*Methodology 2.* In the second methodology, the direction of the vectors formed by the joint of river patterns was measured as in method 1. However, in this case, all vectors belonging to the same cleavage facet were added, as shown in Fig. 16. The resulting vector for each facet is called ‘facet vector’ ( $V_i$ ), and it is given a module magnitude proportional to the size of the facet area that it characterised ( $|V_i| = A_i$ ). Later, a ‘main vector’ ( $M_i$ ) is calculated as the resulting of the addition of the facet vectors, and its direction is characterised by the angle defined by the main vector with respect to the main crack propagation direction, called  $\beta$ . Figure 17 shows the calculated  $V_i$  for different cleavage facets present on a fracture surface. The values of the main vector direction resulting from the measurements of five fields of observation at 300x for each test conditions are listed in Table 5.
